## Geophysical Investigation of Road Failures in the Basement Complex Areas of Southwestern Nigeria

**Abstract:** Causes of failures on three roadways located in the Precambrian Crystalline Basement Complex area of Southwestern Nigeria have been investigated in this study. The electrical resistivity method involving dipole-dipole and Wenner Vertical Electrical Sounding (VES) techniques were utilized. The failed segments of the roadways are characterized by relatively low resistivity (mostly  $< 200 \Omega\text{-m}$ ) with the stable zones typically resistive ( $>> 400 \Omega\text{-m}$ ). Forms of road failures identified from the study are failures arising from differential settlement on road cut sections that intercept clayey saprolite with high moisture content as observed on Igbaraoke-Igbaraodo roadway; failures precipitated by differential settlements associated with significantly thick, low resistivity clay topsoil as observed on Itaogbolu portion of the Akure-Ado Ekiti roadway and failures initiated and sustained by geological features such as lithological contacts/faults, inclined interfaces between basement rocks and or collapse subsurface strata (e.g., cavity or sinkhole

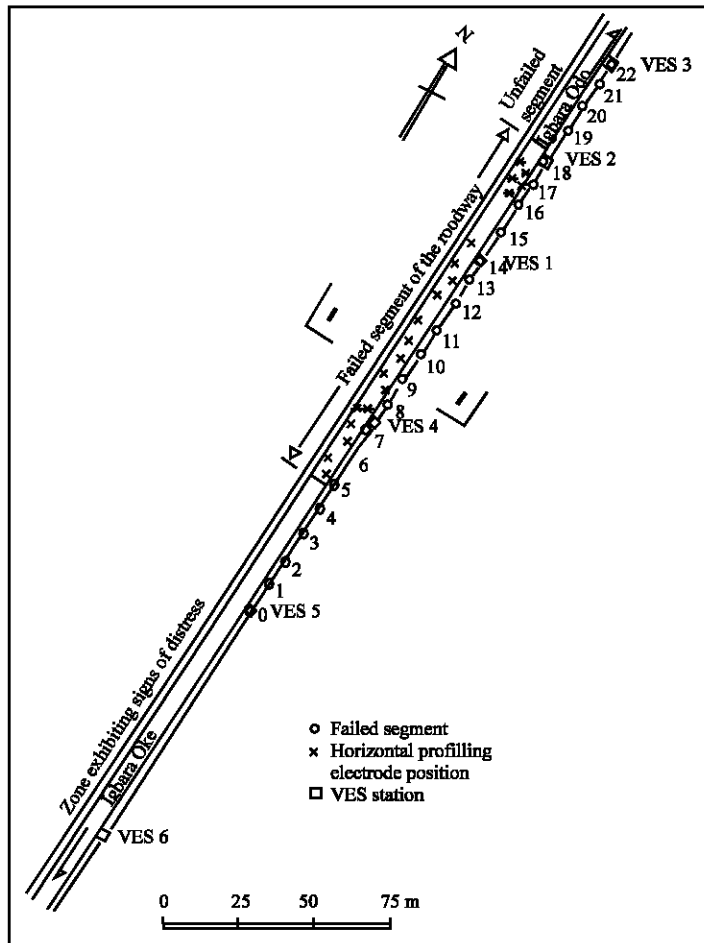
Fig. 2: Site layout at location 1

**Location 1: (Igbara Oke-Igbara Odo Roadway):** This location is situated at 7 km, along Igbara Oke-Igbara Odo Roadway in Ekiti State. The failed segment at the site selected for this study stretches over a distance of 144 m on a straight portion of the roadway (Fig. 1 and 2). Evidences abound at the site that the pavement structure had been repaired severally. Haunchings, potholes, ruts and cracks characterize the failed segment.

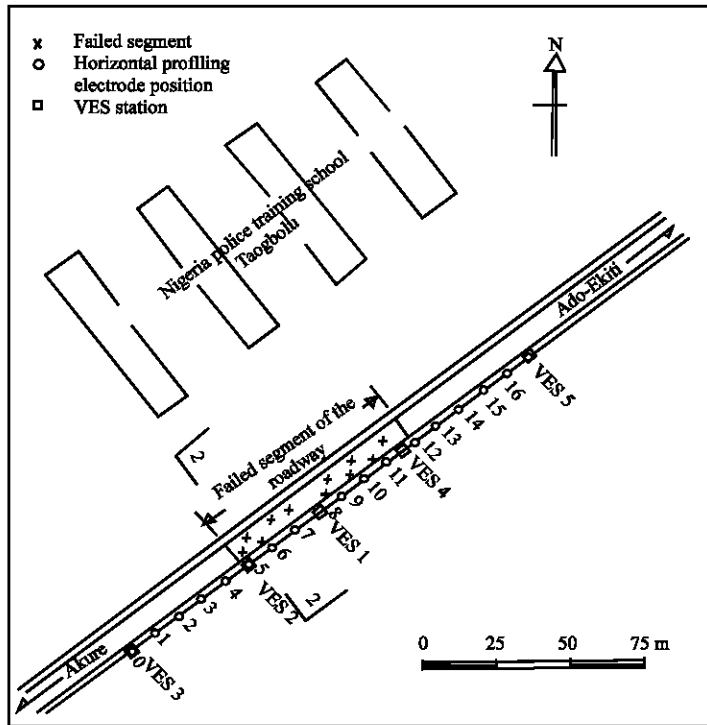
Fig. 4: Site layout at location 2

**Location 2: (Akure-Ado Ekiti Federal Roadway):** Location 2 is situated at 10 km, along Akure -Ado Ekiti Federal Roadway in Ondo State (Fig. 1). The failed segment selected for studies covers a distance of 71 m on a straight portion of the road (Fig. 4). Potholes, ruts and cracks characterize the roadway within the study area.

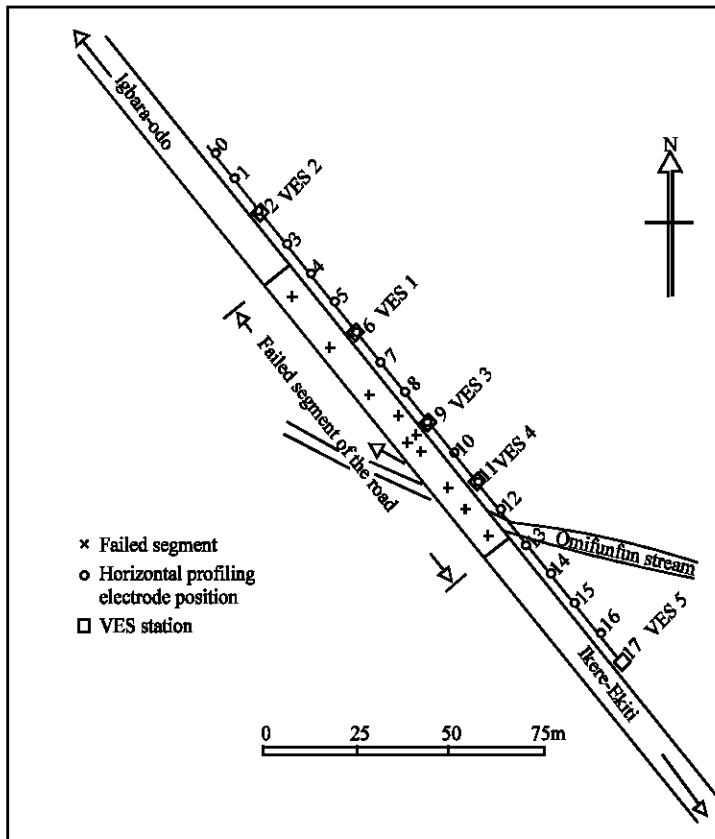
Fig. 5: Site layout at location 3

**Location 3: (Igbara Odo-Ikere Ekiti Roadway):** Location 3 is situated at 3.7 km along Igbara Odo-Ikere Ekiti Roadway in Ekiti State. The selected failed segment which forms part of road cut to grade hillside from Stations 0-12 and embankment over River Omifunfun valley from Stations 12-17 (Fig. 5) is located on a slope. The failed segment covers a distance of 94 m (Fig. 5). Ruts and cracks characterize the roadway at the failed segment.

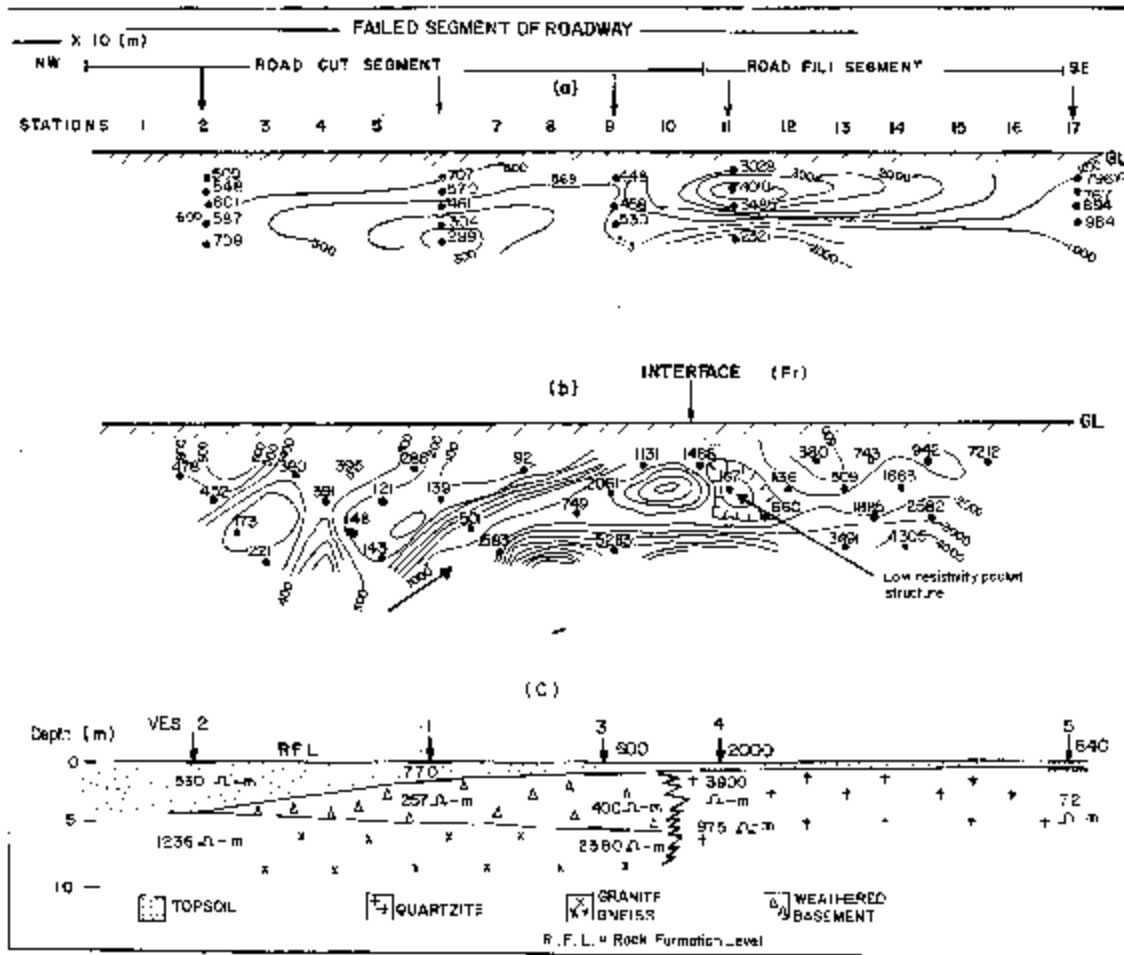
Fig 10: (a) Werner pseudosection (b) dipole-dipole pseudosection and (c) geoelectric section at location 2

**Location 2 (Akure -Ado Ekiti Roadway):** The Wenner pseudosection (Fig. 10 a) presents apparent resistivity whose values range from 50-1062  $\Omega$ -m. The resistivity values generally decrease with depth. Such characteristic is diagnostic of decrease in layer competence with depth. Beneath stations 5-12, low resistivity contour lines are predominant indicating high moistening. This zone coincides with the southwestern end of the failed segment of the roadway.

The pseudosection (Fig. 10b) shows resistivity variations that ranged from 31-5805  $\Omega$ -m. The northeastern flank of the traverse beginning from station 4 is characterized by low resistivities (mostly < 200  $\Omega$ -m). The low resistivity zone has relatively shallow depth extent between station 0 and 6 and significant depth (minimum of 11.7 m, using Roy and Apparao (1971) depth of investigation equation) from station 6 north-eastwards. These low apparent resistivities are typical of clay/sandy clay. The failed segment of the road is typified by low resistivity values. The existence of thick column of clay/sandy clay beneath a significant stretch of the investigated roadway probably accounts for the incessant failure of the roadway in the area. However, high apparent

resistivity values (up to 5805  $\Omega$ -m) were recorded beneath station 0 to 5 at depth. This is presumably due to presence of near surface basement rock which invariably accounts for the stability of the road pavement structure in the southwestern section.

The geoelectric section along the investigated segment of the road is shown in Fig 10 (c). The topsoil resistivities range from 330-1150  $\Omega$ -m while its thickness varies from 1.05 m beneath VES 5 to 2.9 m beneath VES 1. The lithology varies from clayey sand to lateritic topsoil. The failed segments of the roadway recorded lower topsoil resistivities of 330-460  $\Omega$ -m.

The topsoil is underlain by clay/sandy clay whose resistivity values range from 21-128  $\Omega$ -m. The bottom of the layer could not be delineated because of the short sounding spread. The failure along this segment of the road is apparently precipitated by differential settlement induced by the clayey substratum.

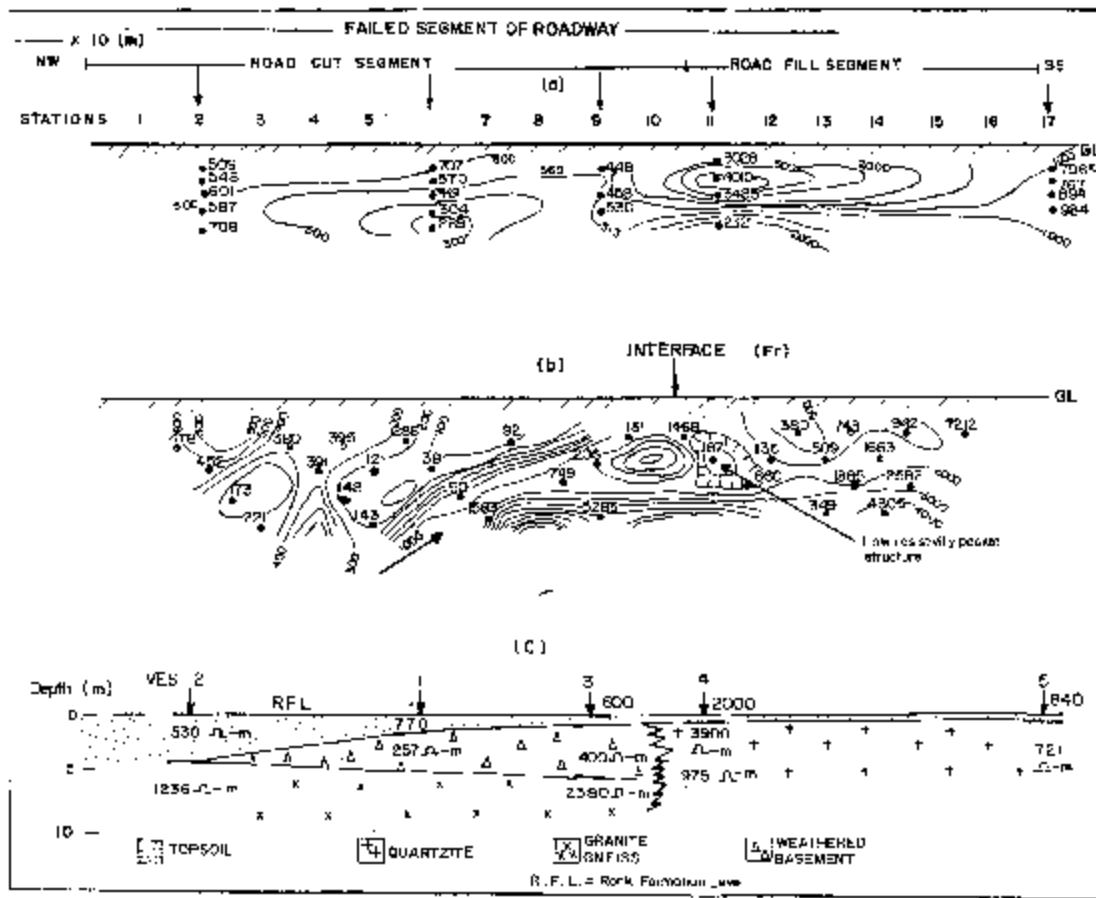
Fig 11: (a) Werner pseudosection (b) dipole-dipole pseudosection and (c) geoelectric section at location 3

**Location 3 (Igbara Odo -Ikere Ekiti Road):** The Wenner pseudosection (Fig. 11 a) displays two distinct resistivity characteristics within the study section. The northwestern flank (stations 0-10) is generally characterized by

resistivity values that are lower than  $800 \Omega\text{-m}$  while the southeastern flank (stations 10-17) is characterized by higher resistivity values ( $> 1000 \Omega\text{-m}$ ). The northwestern flank is underlain by gneiss while quartzite underlies the southeastern segment. A lithological boundary exists around station 10.5 (southeastern end of the failed segment) of the study segment of the road. Hence, the road failure is most probably precipitated and sustained by this geological feature which is a plane of weakness where high moisture is retained in all seasons.

The pseudosection (Fig. 11 b) shows a resistivity distribution that varies from  $50\text{-}12923 \Omega\text{-m}$ . A sharp resistivity contrast exists between the low resistivity (mostly  $< 500 \Omega\text{-m}$ ) residual soils of the northwestern flank and the high resistivity (up to  $12923 \Omega\text{-m}$ ) quartzite of southeastern flank. The interface F (marked with arrow in Fig. 11 b) is a lithology contact which is possibly a fault plane. The plane has a surface expression at around

station 10.5 about the southeastern end of the failed segment. Within the high resistivity zone in the southeast is a low resistivity zone that delineates the buried stream channel of River Omifunfun. The southeastern end of the failed segment of the roadway is located on this geological structure.

The geoelectric section is shown in Fig 11c. The topsoil has layer resistivities and thicknesses of  $600\text{-}2100 \Omega\text{-m}$  and  $0.24\text{-}4.2 \text{ m}$ , respectively. The relatively high topsoil resistivity values may have arisen from its high sand/gravel content. The second layer of the geoelectric section has variable resistivity values occasioned by the structural setting of the underlying basement rocks. On the southeastern flank, the second layer is quartzite with expressions of fractures manifesting as relatively low resistivity values ( $721\text{-}975 \Omega\text{-m}$ ) within highly resistive ( $2100\text{-}3900 \Omega\text{-m}$ ) host rock. On the northeastern flank, the second layer resistivity values are

relatively lower (257-400  $\Omega$ -m) thus indicating possibility of presence of weathered granite gneiss basement rocks.
