Catastrophe of Flood 2010 at Taunsa Barrage; Review of Technical Findings of Punjab Judicial Tribunal Report

¹Zulfiqar Ali Chaudary and ²Muhammad Kaleem Sarwar

Key words: Taunsa barrage, tribunal, flood 2010, LMB, sub-weir

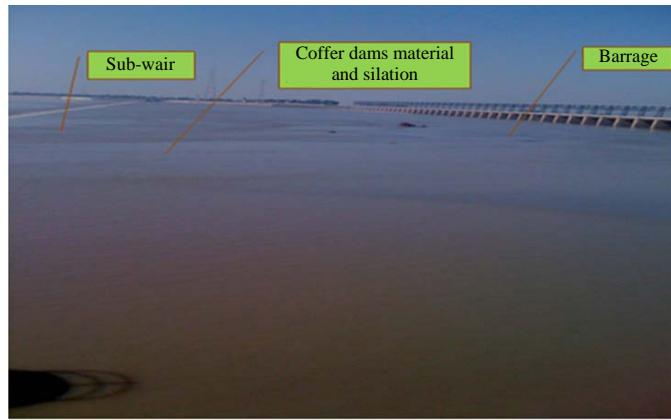
It is still unclear that a barrage having 8 ft high sub-weir/wall on its downstream side and leftover material of coffer dams may have the same discharge capacity. Flood affectees and private complainants submitted that there was a head up on upstream of the barrage; resulting in increased pressure and consequently a collapse of LMB. However, the Tribunal Report is silent regarding this very important fact that the head up may be due to the sub-weir and leftover material of the coffer dams, which is still lying downstream of the barrage.

Fig. 1: Material of coffer dams and siltation

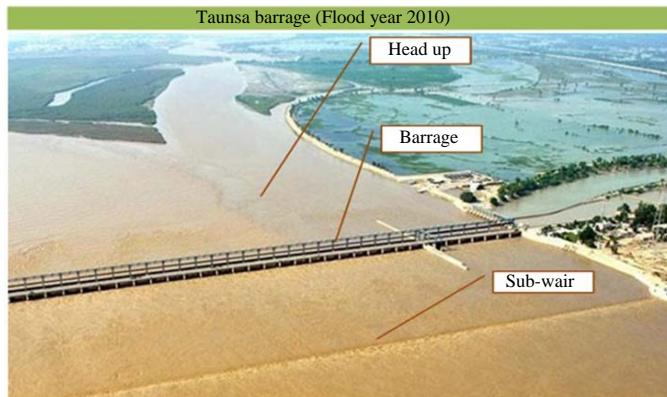
Fig. 2: Sub-weir developed confinement and head up (Flood 2010)

During the years 2005-08, this very important diversion structure has been remodeled in the name of its rehabilitation and modernization, by spending more than 11 billion rupees borrowed from the World Bank (Chaudary and Sarwar, 2014). As stated earlier, an 8 ft high sub-weir/wall was constructed at about 900 ft distance downstream of the barrage. Moreover, massive coffer dams were constructed to carry out the construction works of sub-weir and remodeling of the stilling basin. The leftover material of coffer dams still lying up to the crest level of sub-weir had developed a reverse slope downstream of the barrage (Fig. 1). A snap of barrage (Fig. 2), taken during flood year 2010, showed that the river course on downstream of the barrage was blocked and the water level upstream and downstream of the barrage had almost the same.

water level upstream of the barrage was EL 446.00. Figure 2 clearly shows that the water level upstream and downstream of the barrage became almost the same during flood year 2010. The level difference of 5.50 ft. (EL 446.0-440.50) and 7.10 ft (EL 440.5-EL 433.40) envisaged by the designers of the rehabilitation project may not have any logical grounds. Moreover, the crest level of barrage under-sluches (EL 425) was almost the same as of the sub-weir (EL 424), which had developed channel flow through under-sluches; consequently, the discharge capacity of the barrage got reduced.

This research study emphasized that remodeled Taunsa barrage is hydraulically different as compared to the barrage before its remodeling. The cause of LMB collapse may be the extraordinary rise in water; whereas extraordinary head up could be due to 8 ft high sub-weir constructed downstream of the barrage and left over material of coffer dams along with few partially closed gates. The Irrigation Department may constitute a team of hydraulic experts to revisit reasons for head up so that such catastrophe can be avoided in future.
