## **Electric Power Transmission Line Faults in Nigeria: A Case Study of Benin-Irrua 132 KV Transmission Line**

A.O. Osahenvenwem and O. Omorogiuwa

**Abstract:** This study highlight the faults analysis on Benin-Irrua 132 KV transmission line, associated with Benin District of Power Holding Company of Nigeria (PHCN). Data used for analysis covers a period of a year (July 2006 to June 2007). The analysis revealed the causes of different types of faults and problem associated with the 132 KV feeder between Benin-Irrua transmission line. A total of 71 faults occurred in a year, fault A has the highest frequency of occurrence. The month of January has the highest faults. The total duration of power outage in a year was 151 h. 06 min and also the month of October has the highest duration of power outage followed by July. The causes of faults on an Electric Power Transmission Line and the possible solution to reduce these faults will be of relevance to Power Holding Company of Nigeria (PHCN) and Power System Engineers.

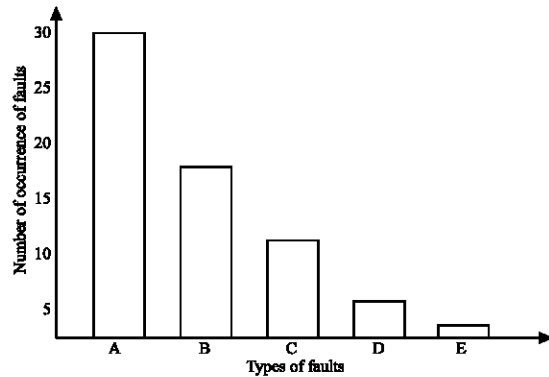
Fig. 8: The bar chart of fault frequency

The fault analysis chart Fig. 8 shows that fault A has the highest occurrence which is 34 from Table 2. Fault A are faults base on outage, to enable the (PHCN) staff work on the 132 KV transmission line, to replenish the circuit breaker with gas, replacement of cross-arm, isolators, poles and any fault equipment.

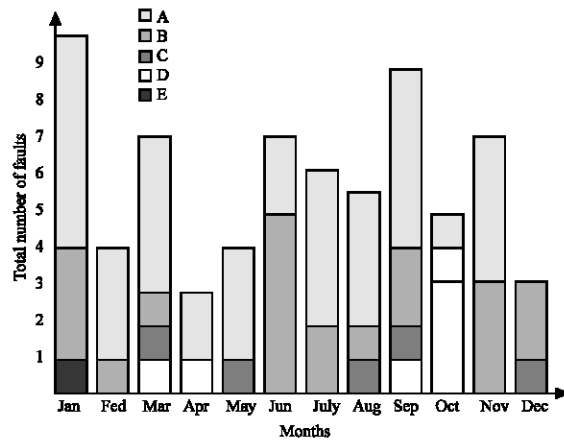
Fig. 9: Component bar chart of each months and types of fault

Figure 9 shows that the month of January has the highest faults. The reason is that this month usually witnesses high bush burning leading to burnt poles, cracking of porcelain insulators, carbon particles in the smoke do short-circuit the conductor and may bridge the conductors to ground and damage of other power supply equipment.

The second highest faults in Fig. 9 were recorded in September when the rainy season is setting out. During at this time, there is more increase in lighting, strong winds and thunders storms which make the distribution network highly vulnerable to faults.

The analysis showed that the month of January has the highest faults in a year. This was closely followed by

- All fault equipments or component such as cross arms, cracked insulators, circuit breaker etc should be replaced on time.
- The supply authority (PHCN) should put contingency plan in place to reduce the fault level at that particular month of the year.
- Replacement of faulty components or equipment before the rainy season sets in.
- As a matter of urgency, another feeder should be created from Benin-Irrua region.
- Proper vegetation management to reduce the problem of short-circuit and earth faults also animal guard should be provided on towers to prevent short-circuit and open-circuits.

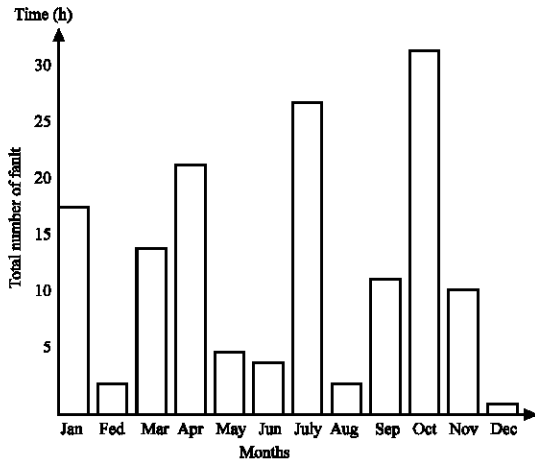
Fig. 10: Bar chart of time duration outage of various months

Figure 10 shows that the month of October has the highest time duration outage. The reason is that this month usually witnesses replacement of damage equipment from the passed rainy season resulting from lighting, strong wind, etc. this led to frequent power outage in that particular month. The second highest time

duration outage was recorded in July this is due to heavy rainfall in the month of July resulting from short-circuit, lightning problem, cracking of insulator etc.

September as shown in Fig. 9. The month of October has the highest time duration outage on the bar chart on Fig. 10 therefore we suggest that:
