## Failure of Superstructures after the “February 03, 2002 Sultandagi-Cay, Earthquake”

M. Y. Kaltakci, M.H. Arslan, H.H. Korkmaz and M. Kamanli  
 Department of Civil Engineering, Faculty of Engineering and Architecture,  
 Selcuk University, Konya, Turkey

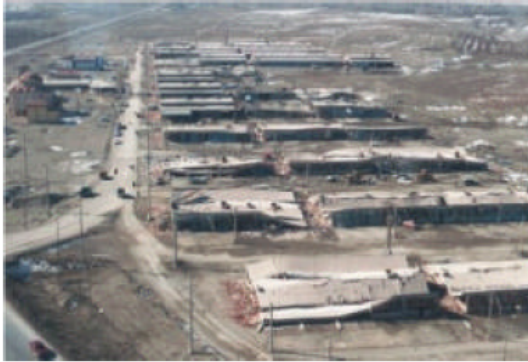
**Building type-1 (industrial type of buildings):** Estimated Peak Ground Acceleration (PGA) in Cay, which is approximately 10 km away from the epicenter, is around 0.20-0.25g. The industrial zone of Cay was deeply affected. Some factories or workshops were heavily damaged. Figure 3 (Erdik *et al.*, 2002) shows heavily damaged industrial facility of Cay Town (Kaltakci *et al.*, 2002; Erdik *et al.*, 2002; Gulkan *et al.*, 2002). Most of the

Fig. 3: Industrial facility of Cay town

solidated. All these conditions related with the site of industrial facilities magnify the effects of the earthquake. It must be said that, this factory was built at very unsuitable site.

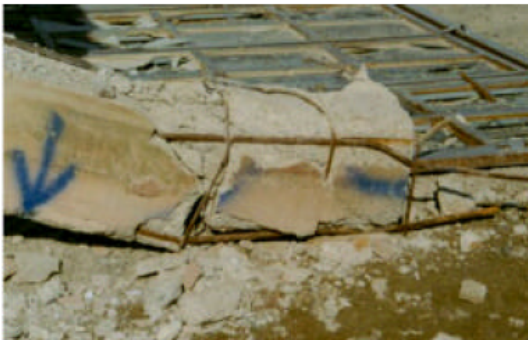
Fig. 4a: Insufficient material and detail in a beam

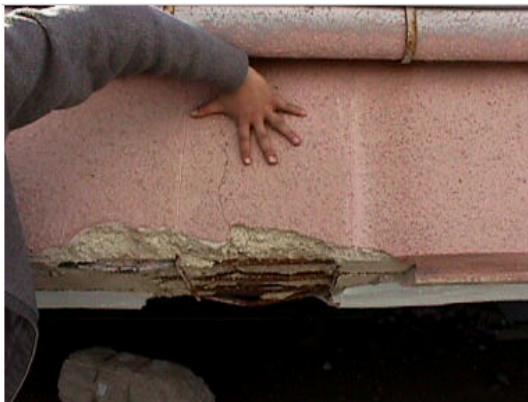
Fig. 4b: Insufficient material and detail in a column

Figure 4b was taken from damaged beams that had no adequate transverse ties in any section of it. Figure 5 shows damages that were occurred from insufficient material and detail on a beam-column connection.

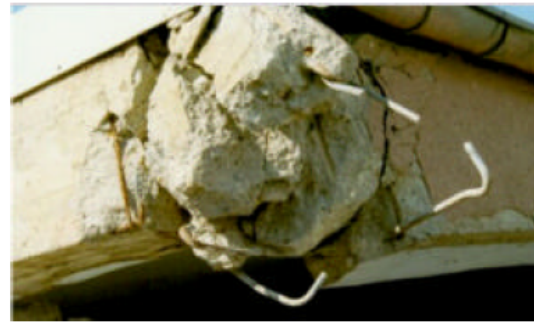
Fig. 5: Insufficient material and detail in a joint

The mentioned facility was constructed during 1991-1996 and consisting of 4 spans in one direction and 5 spans in perpendicular direction. The typical RC system is repeated for the whole structure. Upper and intermediate floors were made of RC and infill walls were existing between end axes. The lateral rigidity and longitudinal and transverse steels were found to be inadequate. There was also lack of longitudinal reinforcement anchorage and transverse reinforcement spacing was too wide Fig. 4a and b. The concrete quality varies strongly and is poor. Figure 5 shows used big aggregate in concrete mixture. The average strength was calculated as 10-12 MPa. Because of observed concrete degradation, it is concluded that sand and aggregate are dirty and river aggregates were generally used. Although TEC-98 and TEC-75 code's had brought significant restrictions about material quality (for instance, according to TEC-98, in all buildings to be built in seismic zones, concrete with strength less than that of C16 (compression strength of concrete is 16 MPa) shall not be used. However it is mandatory to use C20 (compression strength of concrete is 20 MPa) quality or higher strength concrete in below defined buildings to be built in the first and second seismic zones.), the reconnaissance team of Selcuk University documented that poor quality of concrete is major default of buildings. Concrete quality is about 10 MPa which was also observed after the 1998 Adana, 1999 Marmara and 2003 Bingol (Sezen *et al.*, 1999; Adalier and Aydingun, 2001; Celep and Ozer, 1998). Aggregate granulometre is not suitable, water/cement ratio is very high causing a lower compressive strength of concrete (Fig. 5).

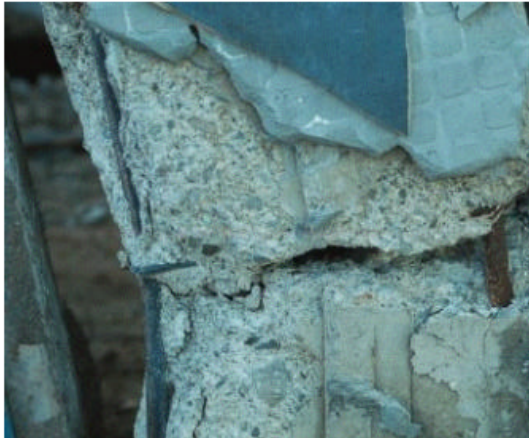
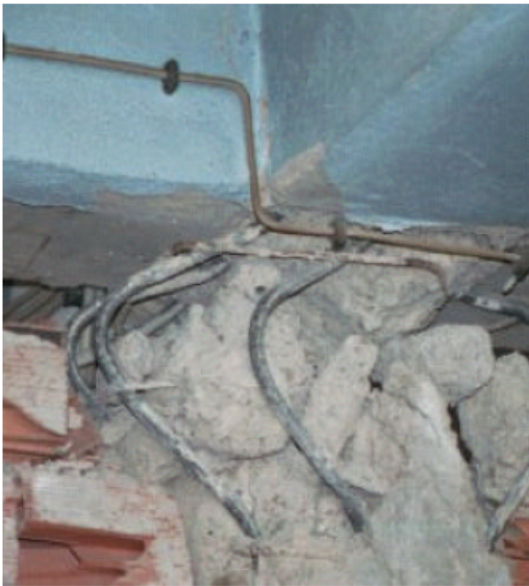
In damaged columns and beams, the transverse ties are smooth rebars of 6-8 mm diameter with 90-degree hooks. The spacing of transverse ties is between 300 mm

Fig. 6: Insufficient material and detail in a column

and 400 mm and there is no confined region. Further, anchorage length,  $l_b$ , is less than code's requirement's. In addition, the poor concrete affected anchorage length negatively. The majority of moment-frame component failures was in columns and was due to the use of nonductile details and unconfined lap splices (Fig. 4a and b). Also in columns clear cover was inadequate, plain reinforcing bars were used and hoop angles were  $90^\circ$  instead of  $135^\circ$ . Figure 6 (Erdik *et al.*, 2002) shows insufficient material and detail in a column. According to TEC-98, the longitudinal rebar ratio ( $\rho_l$ ) ranges between 1% and %4. The authors have observed that in seismic regions column's  $\rho_l$  is ranges less than 1%. 12-16 mm diameter smooth rebar are generally used but with respect to TEC-98 minimum bar diameter must be 14 mm. For instance, Fig. 7 shows that the damaged column's  $\rho_l$  is less than 1% and the spacing of transverse ties is between 300 mm.

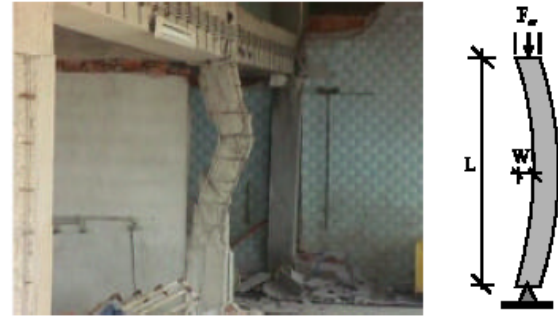
Fig. 7: Buckling column damage in industrial facility of Cay

Some columns have met the buckling damages in this area. During the earthquake, this kind of failure type has been seen rarely. But in this sample, critical load acting on weak column is exceed the limit value of buckling. The limit (critical) buckling load level (Euler's Formula) is given in Eq. 1. In this formula, it is obvious that the critical buckling load decreases with the square of the column length. Figure 7 shows buckling RC column damage in industrial facility of Cay.

From the Eq. 2, it can be easily seen that, the increase of  $w$  causes increasing of second degree moment. In the structural calculation, columns are assumed having small mid-deflection ( $w$ ), but the column that is represented in Fig. 7 have 35-40 cm deformation and this deformation caused the columns collapse.

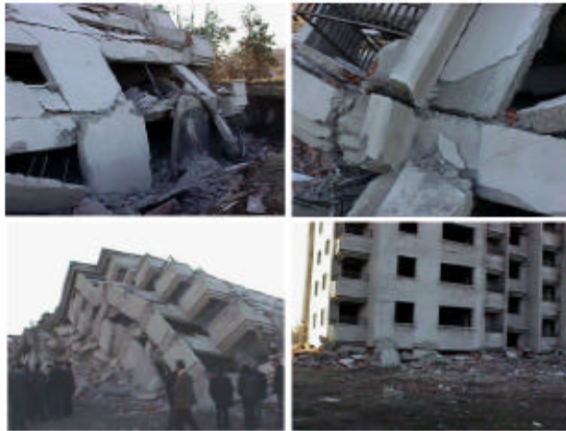
**Building type-2 (tall buildings):** In the west of Cay-Bolvadin highway there were 3 RC structures which were ground floor+7 floors and not occupied at the time of earthquake (S.S. Yesil Cay Dwelling Construction Cooperative). One of them failed and another one is heavily damaged by failing ground and first floor. The third structure was damaged due to differential settlement and rotation of the foundation (Fig. 8).

Fig. 8: Damaged multistory structure

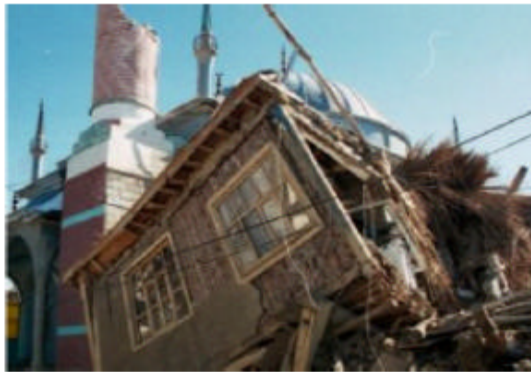
Fig. 9: Highly damaged non-engineered structure

condition. The minarets of some mosques failed due to low quality of mortar (Fig. 9). In this region, the number of stories is generally 2 and the building stock consists of traditional building type that are made with rural and traditional materials. The neighboring structures are adjacent at one side. The materials used are sun dried earthen bricks and wood. The damage was concentrated on non-engineered structures which were one story and earthen adobe or two story wooden structured and infilled with mud. The roof system was, 7 cm clay laid on a 6-8 cm bamboo and wooden beams. After the decay of wooden roof beams, they could not withstand the load of the heavy roof. The walls of damaged buildings were also decayed due to ground water and atmospheric conditions. Also minarets of mosques failed. In this town, there was almost non-engineered structure.

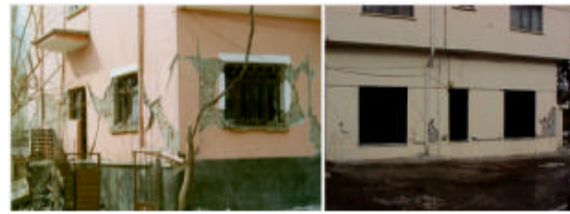
Fig. 10: X Cracks in a masonry structure

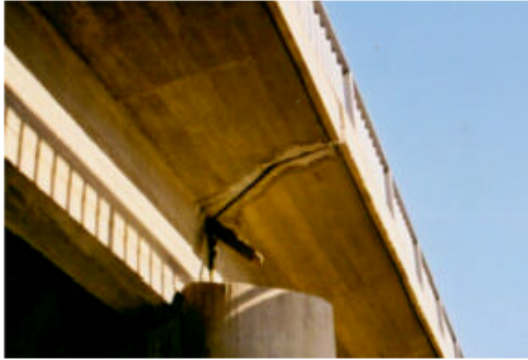
Fig. 11: Bridge damage

**Building type-5 (lifelines, bridges):** The behavior of major lifelines of the earthquake stricken region consists on roads. The damage to the roads of the region was very low and most of them remained operational. At the bridge, which is on the road of Afyon-Konya, the following damages were observed, shear cracks at the lateral beams, crushing of concrete in longitudinal beams, 2-5 cm lateral displacement and settlement of infills in longitudinal directions were observed (Fig. 11). The earthquake load acted on bridge caused some lateral displacement. But in this case the most important problem arisen is exceed earthquake codes displacement limits. For a bridge type superstructures this limit is (Eq. 3).
