Geophysical Investigation of Road Failures in the Basement Complex Areas of Southwestern Nigeria

Abstract: Causes of failures on three roadways located in the Precambrian Crystalline Basement Complex area of Southwestern Nigeria have been investigated in this study. The electrical resistivity method involving dipole-dipole and Wenner Vertical Electrical Sounding (VES) techniques were utilized. The failed segments of the roadways are characterized by relatively low resistivity (mostly $< 200 \Omega\text{-m}$) with the stable zones typically resistive ($>> 400 \Omega\text{-m}$). Forms of road failures identified from the study are failures arising from differential settlement on road cut sections that intercept clayey saprolite with high moisture content as observed on Igbaraoke-Igbaraodo roadway; failures precipitated by differential settlements associated with significantly thick, low resistivity clay topsoil as observed on Itaogbolu portion of the Akure-Ado Ekiti roadway and failures initiated and sustained by geological features such as lithological contacts/faults, inclined interfaces between basement rocks and or collapse subsurface strata (e.g., cavity or sinkhole structure)

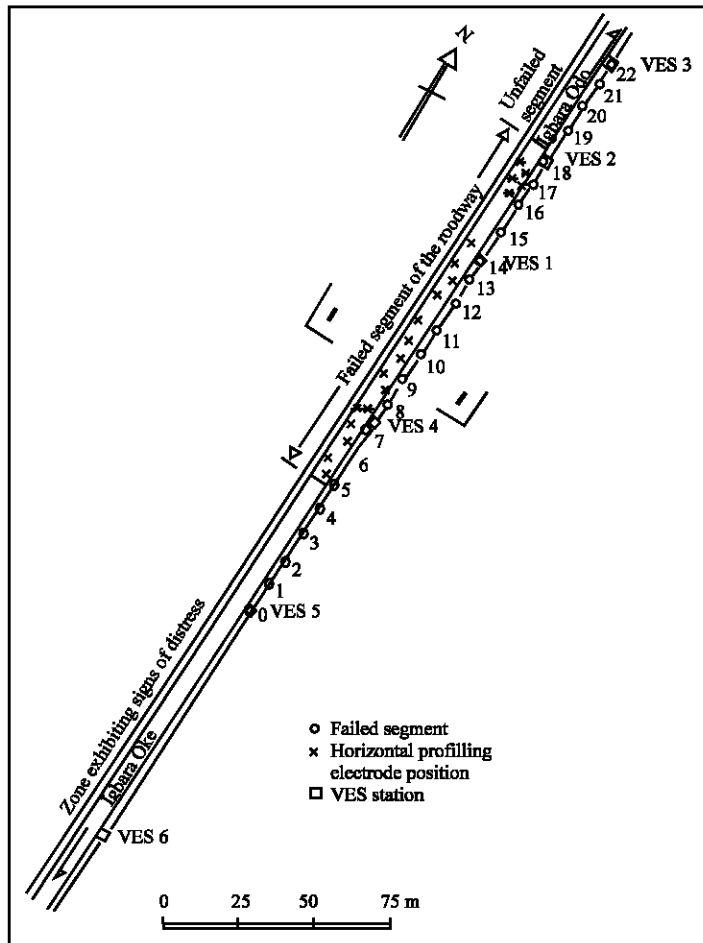
Fig. 2: Site layout at location 1

Location 1: (Igbara Oke-Igbara Odo Roadway): This location is situated at 7 km, along Igbara Oke-Igbara Odo Roadway in Ekiti State. The failed segment at the site selected for this study stretches over a distance of 144 m on a straight portion of the roadway (Fig. 1 and 2). Evidences abound at the site that the pavement structure had been repaired severally. Haunchings, potholes, ruts and cracks characterize the failed segment.

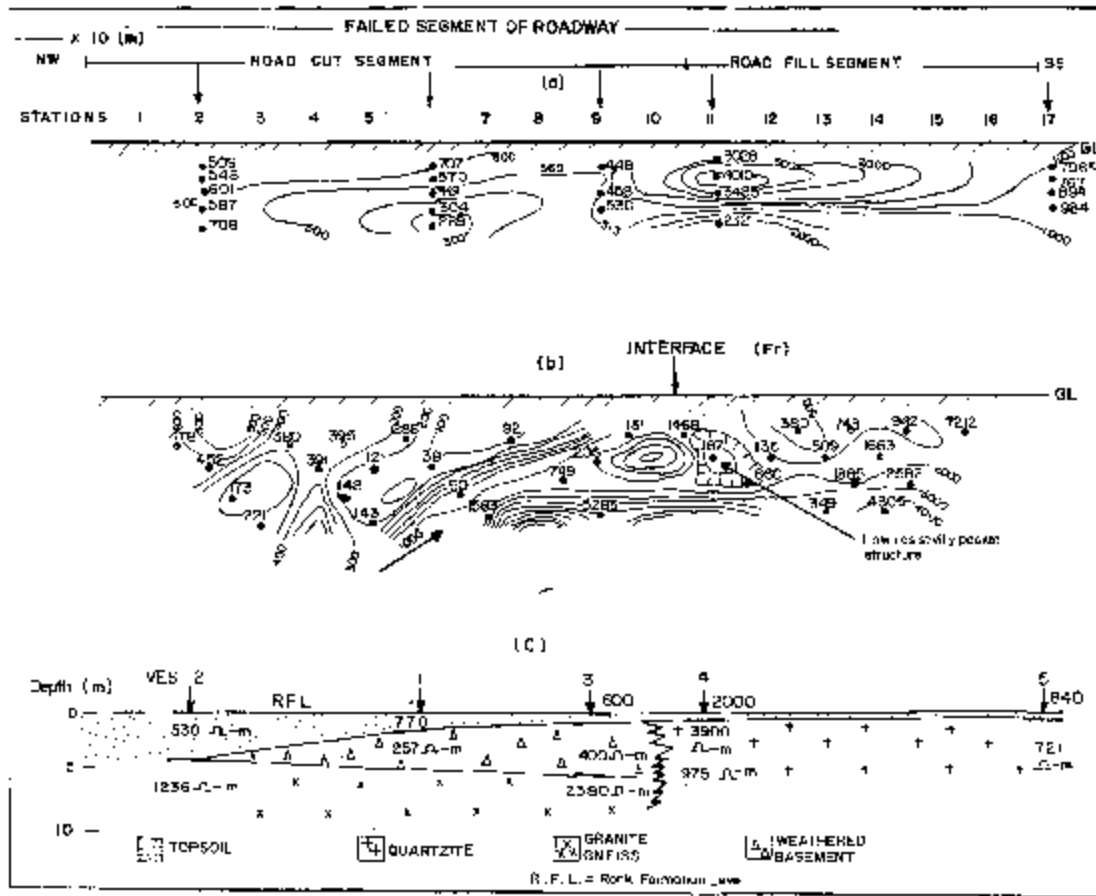
Fig 11: (a) Werner pseudosection (b) dipole-dipole pseudosection and (c) geoelectric section at location 3

Location 3 (Igbara Odo -Ikere Ekiti Road): The Wenner pseudosection (Fig. 11 a) displays two distinct resistivity characteristics within the study section. The northwestern flank (stations 0-10) is generally characterized by

resistivity values that are lower than $800 \Omega\text{-m}$ while the southeastern flank (stations 10-17) is characterized by higher resistivity values ($> 1000 \Omega\text{-m}$). The northwestern flank is underlain by gneiss while quartzite underlies the southeastern segment. A lithological boundary exists around station 10.5 (southeastern end of the failed segment) of the study segment of the road. Hence, the road failure is most probably precipitated and sustained by this geological feature which is a plane of weakness where high moisture is retained in all seasons.

The pseudosection (Fig. 11 b) shows a resistivity distribution that varies from $50\text{-}12923 \Omega\text{-m}$. A sharp resistivity contrast exists between the low resistivity (mostly $< 500 \Omega\text{-m}$) residual soils of the northwestern flank and the high resistivity (up to $12923 \Omega\text{-m}$) quartzite of southeastern flank. The interface F (marked with arrow in Fig. 11 b) is a lithology contact which is possibly a fault plane. The plane has a surface expression at around

station 10.5 about the southeastern end of the failed segment. Within the high resistivity zone in the southeast is a low resistivity zone that delineates the buried stream channel of River Omifunfun. The southeastern end of the failed segment of the roadway is located on this geological structure.

The geoelectric section is shown in Fig 11c. The topsoil has layer resistivities and thicknesses of $600\text{-}2100 \Omega\text{-m}$ and $0.24\text{-}4.2 \text{ m}$, respectively. The relatively high topsoil resistivity values may have arisen from its high sand/gravel content. The second layer of the geoelectric section has variable resistivity values occasioned by the structural setting of the underlying basement rocks. On the southeastern flank, the second layer is quartzite with expressions of fractures manifesting as relatively low resistivity values ($721\text{-}975 \Omega\text{-m}$) within highly resistive ($2100\text{-}3900 \Omega\text{-m}$) host rock. On the northeastern flank, the second layer resistivity values are

relatively lower (257-400 Ω -m) thus indicating possibility of presence of weathered granite gneiss basement rocks.
