Damage Inspection and Analysis of an Expressway Partial Cable-stayed Bridge

¹Yunjing Nie, ¹Tieying Li and ²Xiuying Liu

Abstract: Damage inspection and cable force test were discussed for an expressway partial cable-stayed bridge in a practical project in this study. Furthermore, the causes of damage were analyzed. The results showed that the repair and maintenance measures should be taken. Finally, the repair and maintenance measures were proposed for the damage of the expressway partial cable-stayed bridge. The cable forces were tested at 2 year (or less) intervals. And the health records of cable forces should be established to provide reliable scientific basis for the analysis of stay cable distribution, structural condition assessment, as well as maintenance and management of the bridge. The box girder of the bridge should be repaired, reinforced and the degree of inclination of the pylons be regularly measured. Anti-corrosion measures should be taken on the various components of stay cable systems. Grease should be filled in the anchorage components. The change in the relative position between the HDPE pipes and the guide pipes should be focused on. These results could also

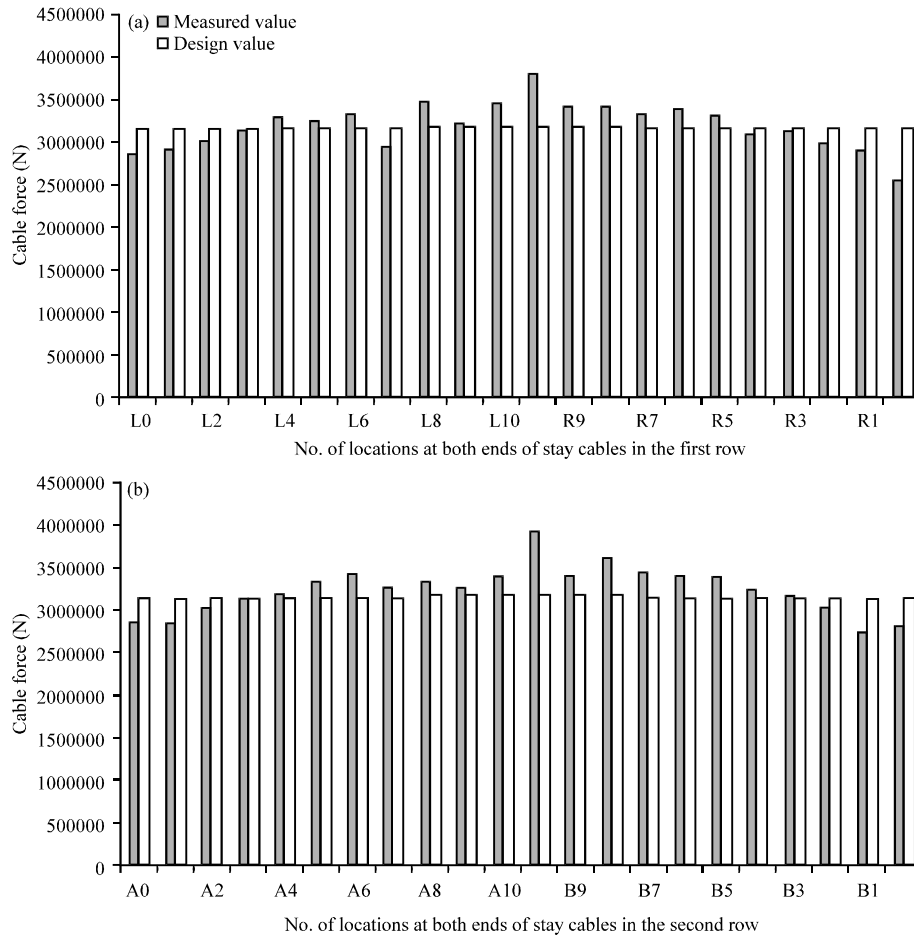
Fig. 3(a-b): Comparison of the measured values with design values of tensions for the cables through pylon 1 (a) Cables in the first row and (b) Cables in the second row

For the corresponding cable forces at both ends of the first row of cables and of the second row of cables through Pylon 1, it is indicated that most of deviation rates of the measured values are less than $\pm 3\%$ from Fig. 3a-b. The maximum cable force deviation is 9.61%.

In order to prevent ploys from further tilting, the box girder of the bridge should be repaired, reinforced and the degree of inclination of the pylons be regularly measured. With respect to the stay cables, the health records of cable forces should be established. The cable forces are tested at 2 year (or less) intervals to monitor the development of the stay cable tension. On the basis of the monitoring results, the cables internal force can be adjusted to meet the use requirements.

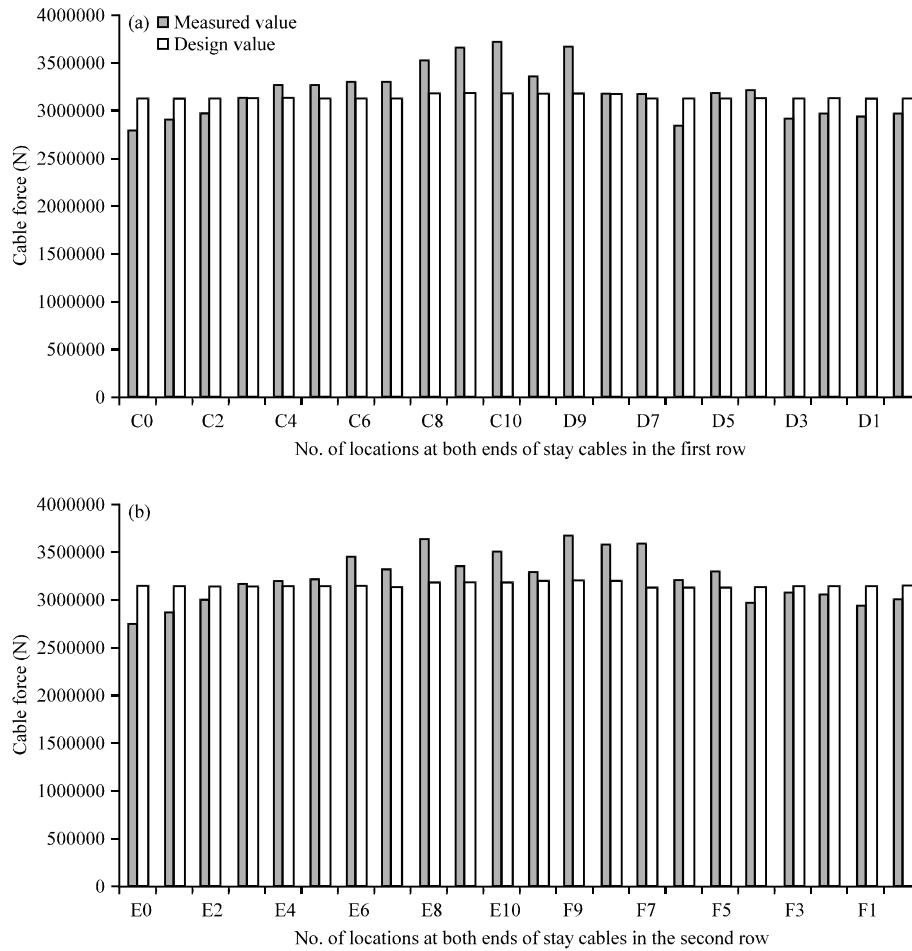
Fig. 4(a-b): Comparison of the measured values with design values of tensions for the cables through pylon 2 (a) Cables in the first row and (b) Cables in the second row

Comparing the measured values for the corresponding cable forces at both ends of the first row of cables with those of the second row of cables through Pylon 2, it can be found that most of deviation rates are less than $\pm 3\%$ from Fig. 4a-b. The maximum cable force deviation is 11.33%.

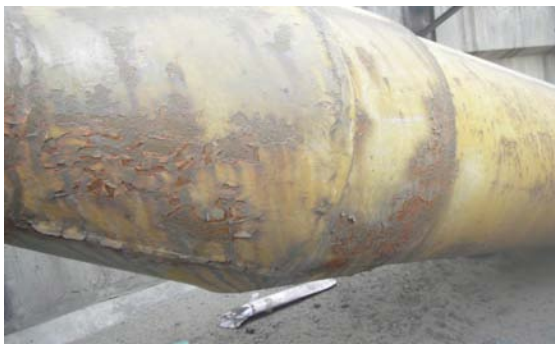
Fig. 5: Rusty spots on the outer surface of guide pipe

random selection. Four stay cables, respectively chose from both ends of each pylon for the damage inspection. From the inspection results, it can be found no stagnant water within the selected guide pipes but rusty spots on the outer surface of the guide pipes, as shown in Fig. 5. The rust-resisting paint falling off causes rust

In view of the damage of the inspected stay cable systems, the other stay cable systems should be inspected for damage. And rust removal is performed on the rusty guider pipes and bearing plates of the anchorage systems. Then rust-preventing paint is repainted. The broken seals of the grouting mouths should be replaced. Grease should be filled in the anchorage components. Replace all missing nuts in the end caps of the anchorages. Because sliding of the stay cables may relate to the loads acting on the partial cable-stayed bridge, regular observations should be made to monitor its damage development after the repair and reinforcement of the main girder.

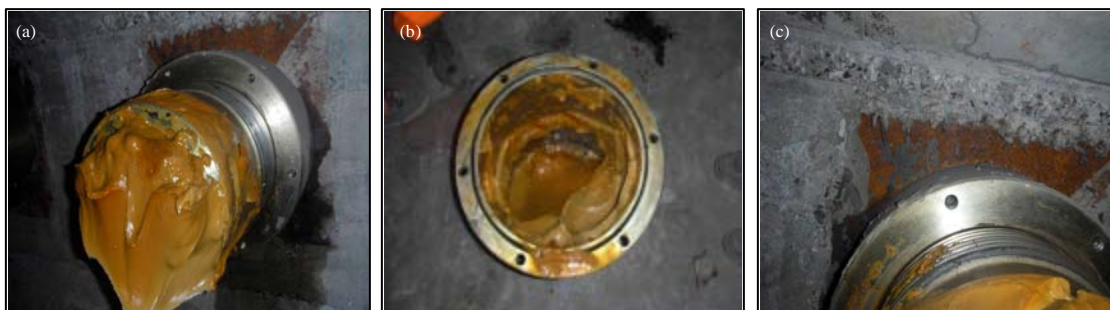
- **Anchorage systems and the end strands:** By random selection, anchorage systems and the end strands are examined for damage. Eight stay cables, respectively selected from both ends of each pylon for the damage inspection. Typical damage of anchorage systems is shown in Fig. 6. The examination results show that the seals of the grouting mouths have been broken, not playing a role in sealing. Grease exiting in the anchorage components seepages, as shown in Fig. 6a. But the end stands are wrapped by grease and have not suffered any significant damage (such as corrosion). Water exists in the end cap of the anchorages, as shown in Fig. 6b. It is founded that there is rust in all steel anchorage plates of the examined stay cables. And rust water is found to outflow from the anchorage plates and rings, shown in Fig. 6c

Fig. 6(a-c): Typical damage of anchorage systems (a) Ends of the anchorage, (b) End cap and (c) Corrosion of the bearing plates

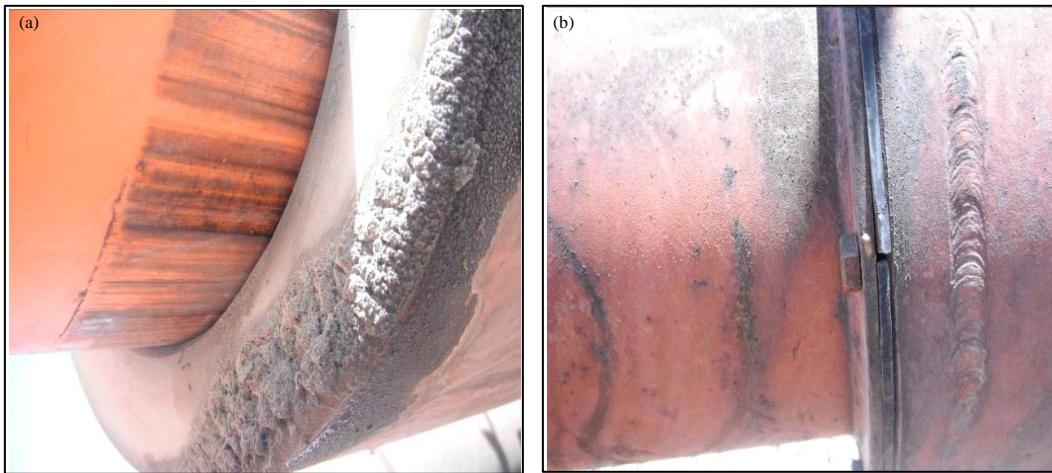
- **HDPE pipe:** Guide pipes of the selected stay cables inspected, the HDPE sheathings of the cables are simultaneously examined for bulging. No HDPE sheathings are found bulging. However, there are the following problems: sliding of the stay cables obviously in the anchorage areas at the top of pylon 1 and 2, rust of the guide pipes, deterioration of neoprene rings, grease seepage, as shown in Fig. 7. Due to vehicles and concrete creep, the change take places in the relative position between the HDPE pipes and the guide pipes, causing the HDPE pipes sliding. Damage of neoprene washers, gaps between the neoprene rings and the cables along the perimeter, result in seepage of grease

Fig. 7(a-b): Damage of HDPE pipe (a) Skid marks of a guide pipe and seepage of grease and (b) Damage of neoprene washer

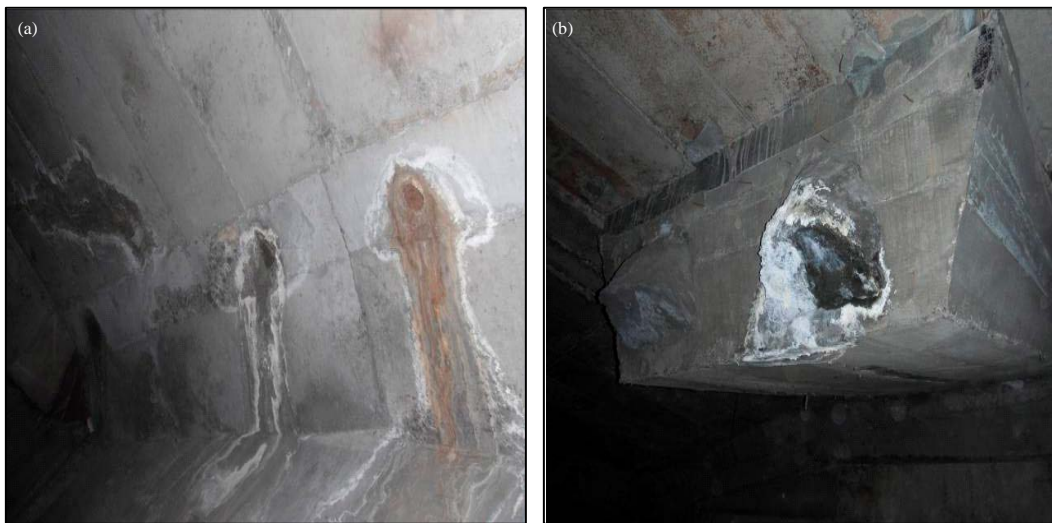
Fig. 8(a-b): Damage of girders (a) Girder roof and (b) Water erosion in the anchorage of girder roof

- Cracks in girders and local damage of concrete of girders. The inside of box girders is examined for damage through manholes. Based on this field inspection, no cracking is found in the anchorage areas of both longitudinal prestressed strands inside the box girder and the stay cables. But there is water seepage in the roof of the box girder, stagnant water inside and water erosion in the anchorages, as shown

in Fig. 8. Construction holes not being closed, the inside of the box girders suffers from the damage. By inspecting the whole box girder, there are some transverse cracks in the top and bottom slabs, longitudinal cracks in the bottom slabs. The maximum width of transverse crack is 0.29 mm. The maximum width of longitudinal crack is 0.27 mm. Moreover, the box girders suffer from spalling and scaling exposed tendons. The main causes of damage of the whole box girder are overloaded vehicles, corrosion of embedded reinforcements, concrete shrinkage, poor maintenance and management

The cracks in concrete, of width beyond limit requirements, can be sealed by high-pressure injection of epoxy resin. The cracks in concrete, of width in the allowable range, can be bonded by injection of epoxy resin. The concrete components with spall are patched by epoxy resin mortar after removing the deteriorated concrete and cleaning the steel reinforcements.
