## Phenomenon of Slope Failure Occurrences along Gerik-Jeli Highway, Malaysia

Muhammad Barzani Gasim, Mohd Ekhwan Toriman and Hafizan Juahir

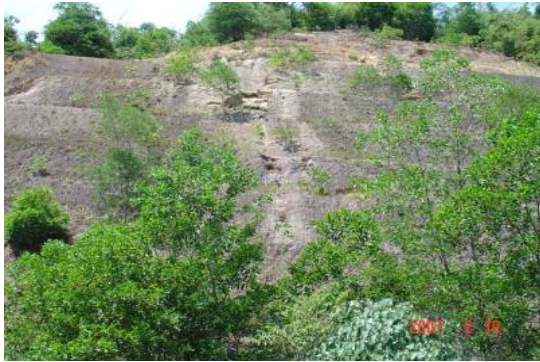
**Site description:** After the 1999 major landslide, slope rehabilitation was carried out in the study area by terracing the slope. The present study emphasises the rock characteristics of each terrace (berm) that have an impact on soil erosion and minor slope failure and which cause the slope to potentially lose its strength. The variation of each berm, from the bottom (B.1) to the top (B.13), is characterised by varying lithologies, rock hardness, structural patterns and weathering grades

(Fig. 3). Most of the beds have been deeply weathered to clayey soil and the rock weathered to orangey-brown silty clay or Grade III. These varying degrees of weathering are controlled by percentage concentration of structural discontinuity planes from one berm to another. The whole area on the top surface of the slope (berm 13) consists of soil (Grade V). The grade of weathering decreases from berm 12 (weathered rock) through berm 10 (intact weathered rock or Grade III) but in the middle of the slope, from berm 8 to berm 4, the exposure consists of complex structures of metamorphic rock, which may have caused the development of weak zones. Failure also commonly occurred via sliding along the wedges that plunge easterly, due to the intersection

Fig. 3: Slope profile of the study area consists of 13 berms

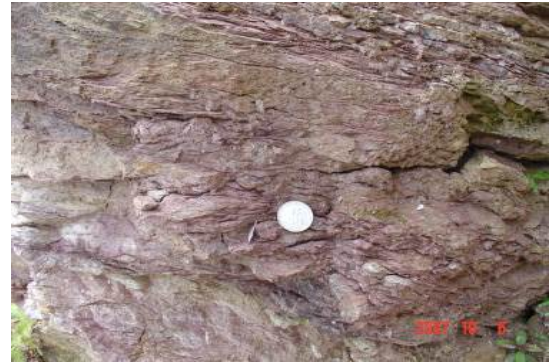
Fig. 4: Parallelism between the cleavage planes (top) and bedding planes

second deformation was P2 with an E-W (90-270°) direction; this direction correlated with the development of a series of reverse faults in this area, in which the tensional joint had an orientation to the west, with higher dips (75-85°). The cleavage planes and foliation are sub-parallel to the bedding planes due to the same compression history and contortions give rise to warping of the strata (Fig. 4).

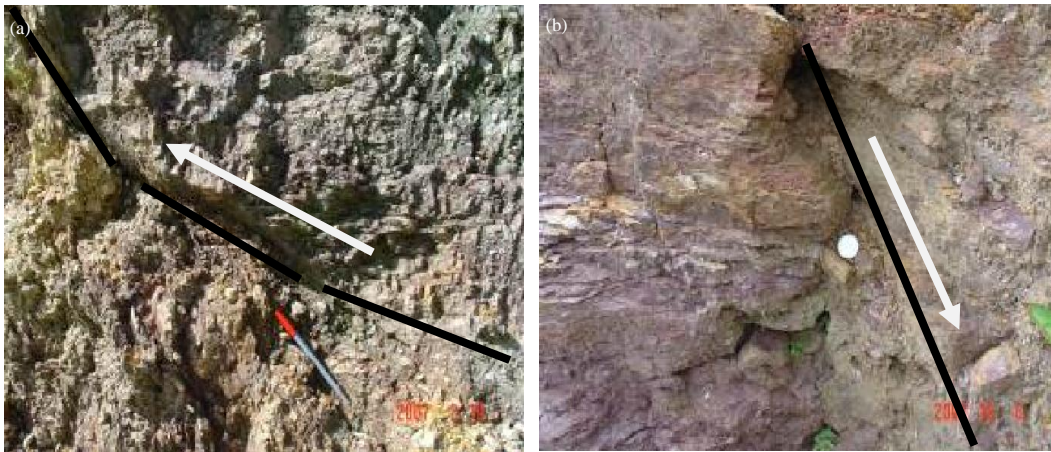
Although, the strata are irregular, they generally have a dip direction to the SW and NE. Reverse faults (55°/26°, 85°/45° and 87°/28°) (Fig. 5a) are thought to have occurred during the second deformation; they cut across the beddings (352°/24° and 235°/25°) and right-lateral fault plane (10°/88°). Development of the normal fault (155°/70°) at the end of the deformation (during brittle deformation) was characterised by a decrease in the stability of the rock components (Hobbs *et al.*, 1976); it cut perpendicularly across the beddings, reverse faults and foliation planes and is considered to be the beginning of the development of the failure planes for the slope instability in the study area (Fig. 5b).

Fig. 5(a-b): Reverse fault was upthrust the beddings to the (a) Left and (b) Normal displacement due to gravitational force

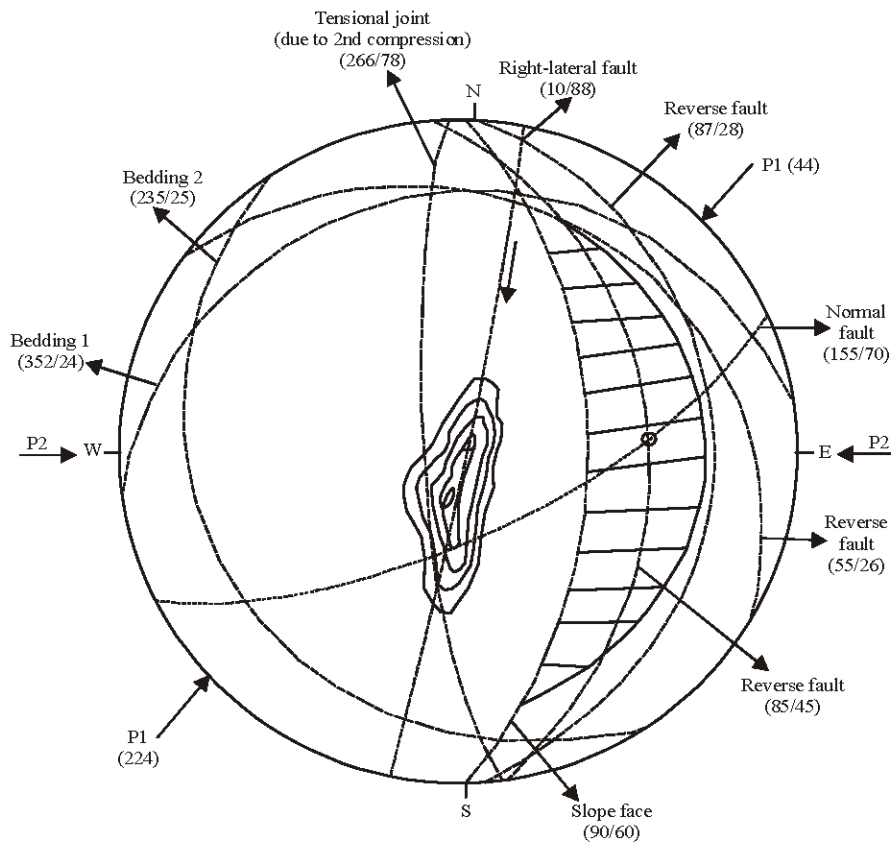
Results of the measurements show that the slope face has dipped 60° and the dip direction is to the east, while the plunge of intersection is 45°, with an assumed friction angle of 30° located inside of dashed line (Fig. 6). The slope stability in the area is in the critical range, as  $\psi_i$  has a value between  $\psi_f$  and  $\phi$ . In addition, the dip direction of  $\psi_i$  is parallel to the direction of

Fig. 6: A critical condition of slope, whereas, plunge of intersection located between slope face and friction angle

the slope and seepages flow out of the slope in several areas. Based on this concept, it was predicted that the slope would fail eastward, which is really occurred.

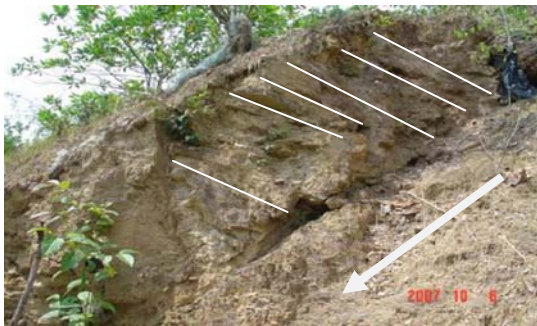
small landslides occurred in the form of wedge and toppling failures at berms 4 and 8. An additional concern is the slope face erosion, which can be seen as sand and clay accumulation along the slope drains. Dips of the slope face in the study area are in the easterly direction and the bedding plane has dips in the opposite (westward) direction (Fig. 7). Therefore, the problem associated with the “Day lighting” of a major

Fig. 7: Slope face dips to the east and the bedding plane dips to westward direction

discontinuity plane does not arise. However, due to the multiple deformations of the rocks, there exist a number of foliation and fracture planes with different orientations, resulting in the instability of the slope.
