## Soil Erosion Problems in Upper Ala Watershed, Southwestern Nigeria

**Abstract:** Soil erosion problems at the headwater of Ala watershed which drains a rural community north of akure, southwestern Nigeria, was investigated. The watershed was listed as one of the focal points of UNDP's programme on Sustainable Agriculture, Environment and Rural Development in Nigeria. Baseline survey of the watershed reveals that the following environmental factors contributed to the observed erosion problems: Long, gentle to relatively steep slopes; low infiltration capacity; heavy and prolonged rainfall; highly erodible soils; inadequate and blocked storm drains and unplanned land use types. Indicators of soil erosion identified in the area also include: Detrital materials and coarse sand deposits; bare unvegetated surfaces devoid of top soil; stone capping of soil pedestals; exposed building foundations. These factors and indicators have combined to produce rapidly incising gully systems along some long slopes. At some midslopes and southern basal positions currently being opened-up for various developments, small and few storm drains have promoted sheet erosion and street floods that often i

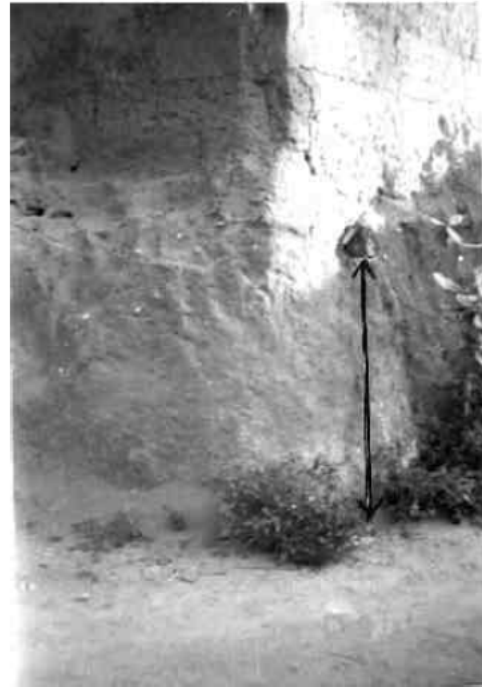
Discrete, snap shot measurements of exposures of tree root and building foundations are good indicators of soil loss and ground surface lowering by sheet erosion. This is more prevalent within the built-up areas of the community where exposed building foundations averaged 20 cm and are only delicately supported by outcropping duricrust concretions (Fig. 2). In some locations root exposures also vary from 20-30 cm.

Fig. 2: Foundation of a mudhouse exposed by 1.2 m (shown with arrow) by sheet erosion and street floods over duricrust concretions within the built-up areas (site A in Fig. 1)

approach to make them effective. Drainage systems that have been blocked must be reactivated and maintained to discourage sheet erosion and street floods. More drainage and channelisation systems must be put in place to ensure undisturbed routing of runoff water during storm-runoff events (Olatunji, 1998a).

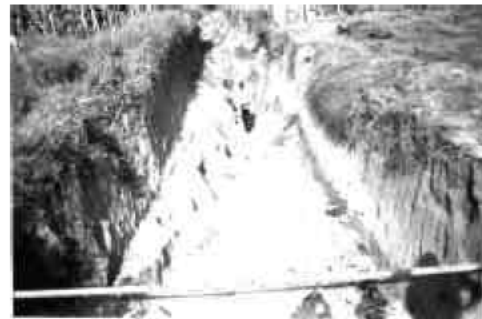
Within the watershed, the midslope positions where most of the built-up areas are situated are the most prone to erosion. Several types of gullies at different stages of development with differing shapes and sizes were observed especially beside major roads. Depending on the dictates of the prevailing factors and processes of erosion, depths of most gully systems are small at the upslope positions where erosion processes begin and advance. Gullies attain active and rapidly incising depths towards the midslopes positions. They then reduce towards the basal slopes where some deposition has taken place. In some mid-slope positions, especially beside roads development of gullies are much more prevalent spatially than sheet erosion. Towards the basal position in the study area, some arable agriculture are practiced and recent expansion of the community is in

Fig. 3: An abandoned chmelisation project overtaken by gullies in a downslope position currently undergoing various developments (site B in Fig. 1). An exposed pipe and the author were shown at the background

In parts of the midslope and basal positions where some agriculture is being practiced, good practices that will ensure slope protection, stabilization of gully advances and enlargement and system construction should be adopted. This, according to Olatunji and Ibimilua (2001) should be done without endangering, damaging or destroying the natural resource base. Increasing plant cover and adjusting agricultural practices (such as organic farming) that will improve soil fertility and soil protection should be encouraged (Olatunji, 2001).
