Retrofitting Techniques in Conservation Management of a Balinese Historical Building

Kusno A. Sambowo, I. Ketut Bagiarta and Mukahar
Department of Civil Engineering, Faculty of Engineering, Sebelas Maret University,
Jalan Dr. Sutami 36a, 57126 Surakarta, Central Java, Indonesia

Key words: Building conservation, precast concrete, reinforced concrete, cultural heritage, reconstruction, conservation principles

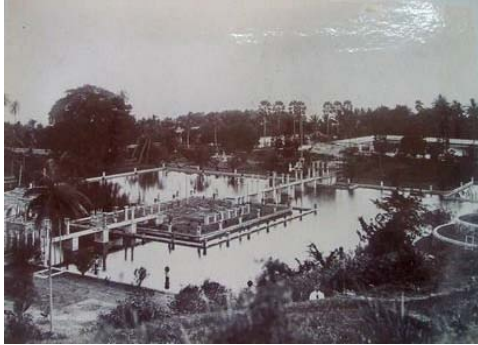
Fig. 1: The Taman Ujung before the conservation

This research aims to determine the effectiveness of conservation management that has been done at Taman Soekasada Ujung, especially the conservation of Bale Kapal building. Bale Kapal is one of the existing buildings on this site which did not have the physical handling of the reconstruction and is left in its state of existence (Fig. 1).

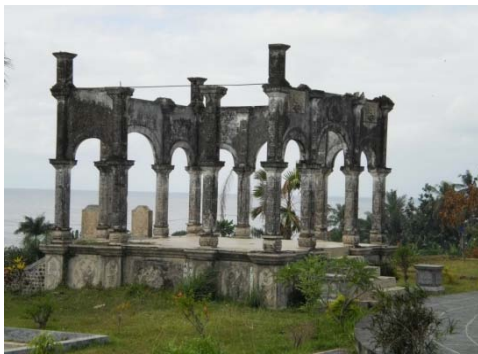
Fig. 2: Existing condition of the Bale Kapal

In the early planning, Bale Kapal was included as one of the buildings which would be renovated. World Bank through its consultant, Kantrika Ebbe of the Social Development Department of the World Bank, recommended to let the element that exist on the Bale Kapal as it is (Fig. 2) (Anonymous, 2003).

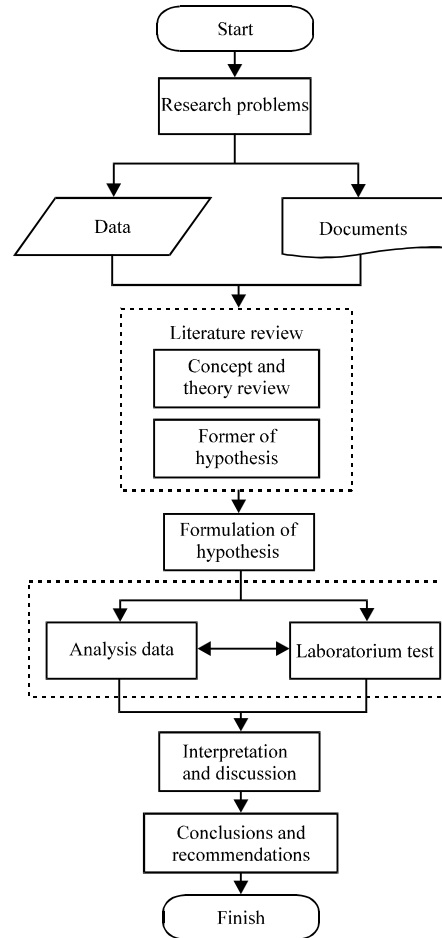
Fig. 3: Research process flowchart

descriptive and comparative manner. The evaluation method to solve the problems is based on qualitative data. Research process flow chart is presented in Fig. 3.

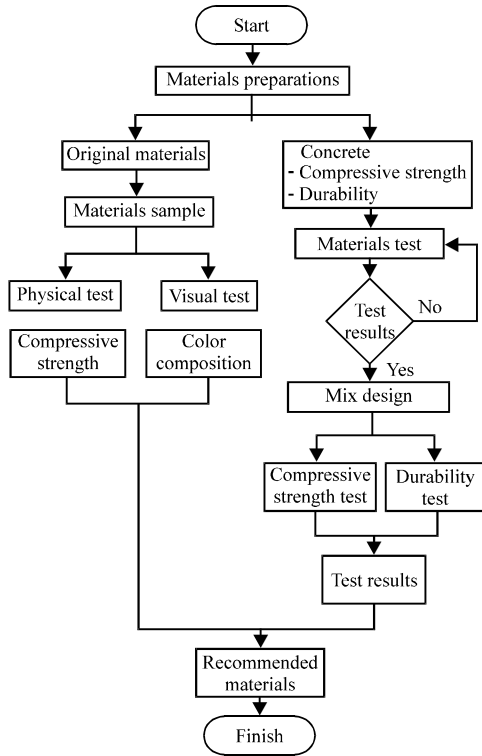
Fig. 4: Process flowchart of the laboratory test

The experiment process at the laboratory consists primarily of 2 testing processes. First, the testing of samples and objects was taken from the location of the Bale Kapal at the TSU site. The second process is the testing of samples conducted at the laboratory which include the compressive strength and durability test. The experiment process at the laboratory is shown in the Flowchart depicted in Fig. 4.

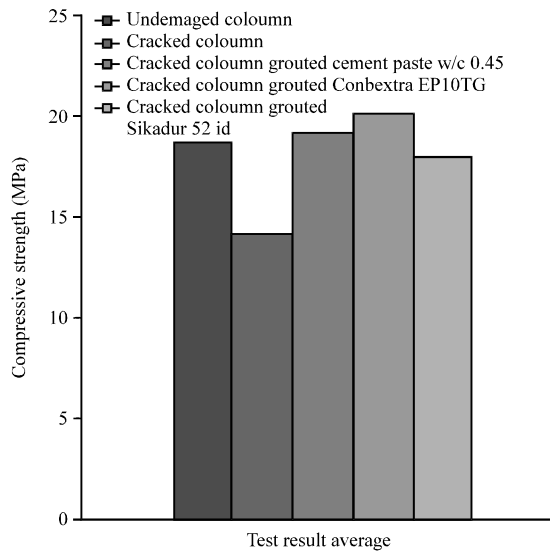
Fig. 5: The compressive strength test result of the grouting material

of Bale Kapal is by strengthening the columns with crack grouting technique. Test results, such as the grouting material evaluation is shown in Table 1. The mean compressive strength of the samples is shown in Fig. 5.

Based on the results of the field tests on samples which have three variants of grouting material, high strength grouting epoxy is a grouting material that gives the effect of compressive strength improvement at both the broken columns.

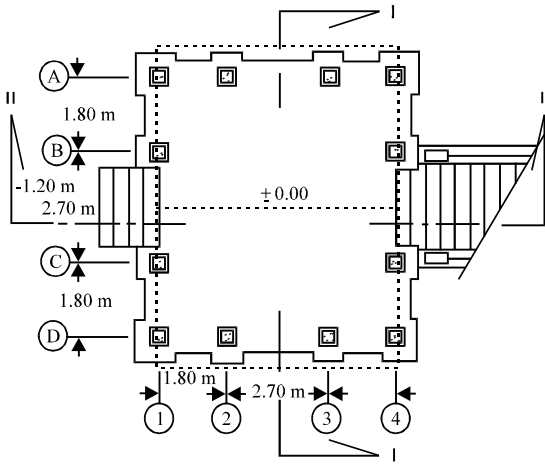
Fig. 6: Bale Kapal floor plan

Based on the calculation, the biggest dead load on Bale Kapal column is 3227.78 kg in columns B1, B4, C1 and C4 (Fig. 6).

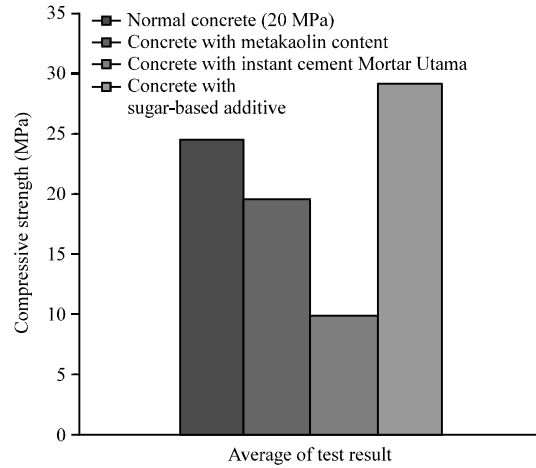
Fig. 7: The compressive strength results of different grouting material

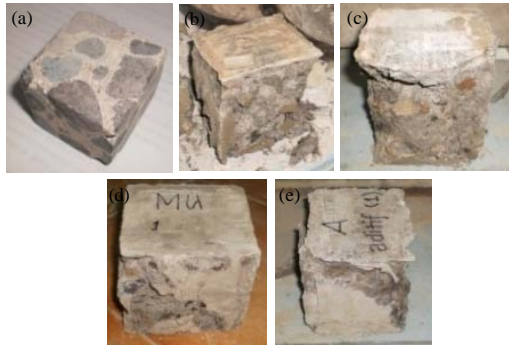
Fig. 8: Visualisation of samples colour and texture: a) Samples column of the existing object; b) Normal concrete with compressive strength 20 MPa; c) Concrete with cement substitution, as much as 15% using metakaolin; d) Concrete with cement instant; e) Concrete with added redients (additives) are based on sugar

The character color and texture of the original sample and all samples of alternative materials are visually similar. This means that the consideration of the color and texture do not become the dominant determinant for all alternative materials to produce color and texture characteristics which is similar to concrete (Table 10).

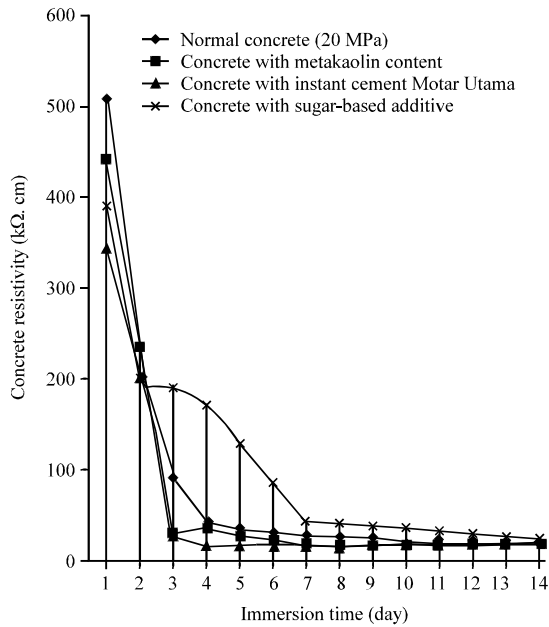
Fig. 9: Concrete resistivity of material soaked in fresh water

Tests/measurements carried out on concrete resistivity which indicates the rate of corrosion that occurs in the backbone. Results of testing by immersion in fresh water samples is shown in Table 5 and immersion in sea water samples is shown in Table 11. The resistivity in both tests are shown in Fig. 9 and 10.

The immersion in water up to the normal day to 4 has not shown a significant level of corrosion. It is negligible in all variants of the material because the resistivity is still above 20 kΩ cm. Until the 14th day of immersion, the corrosion rate is still low and does not mean that the differences are not significant numbers of resistivity.

The test result shows that the influence of fresh water immersion from day 1-14 against all variants of the material is not significant in increasing the corrosion rates. With the assumption that the fresh water immersion test conditions is similar to the condition of the open building in a normal environment, the durability of concrete component material variants in protecting the reinforcement against corrosion is equal.

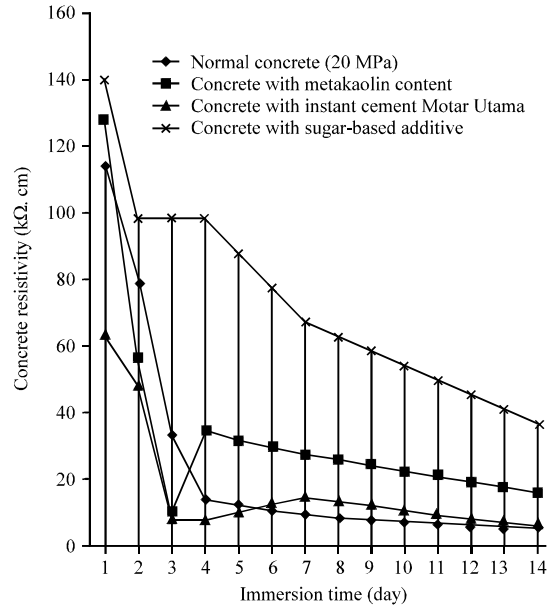
Fig. 10: Concrete resistivity when soaked in sea water

The immersion in sea water up to the day 4 in samples of normal concrete and the main mortar shows a low corrosion rate (resistivity 10-20) while the sample of concrete with metakaolin and sugar-based additives does

At the age of 14 days of immersion, samples of normal concrete and the main mortar shows higher corrosion rates compared to the samples of concrete with metakaolin having a low corrosion. Meanwhile, the concrete samples with sugar-based additives shows that the corrosion is insignificant (resistivity >20).
