## Investigate the Geological Conditions of Eyvashan Reservoir Dam Site and the Reasons for Choosing the Best Type of Dam Building

**Abstract:** The under construction Eyvashan dam site in Lorestan Province is located in 57 km Northeast of the Khorramabad city on Hored River. The site of this dam, from geological point of view is in bedrock ranging that is composed of conglomerate rocks. Conglomerate rocks of abutments range have protrusions. Young alluvial deposits covered the bedrock surface in valley floor. The aim of this study is to investigate the geological parameters of Eyvashan dam site and the reasons for choosing the best type of dam building and also the stability of the structure in order of size motechinque. The study method has done based on research, data collection in library studies, field and laboratory ways. After identification and evaluation of geological and geotechnical of dam structure, litho logy and tectonic characteristics were studied by using satellite data. In choosing the type of dam issues and several factors such as the shape of the valley, engineering geological conditions and results of exploration drilling and geotechnical studies, site conditi

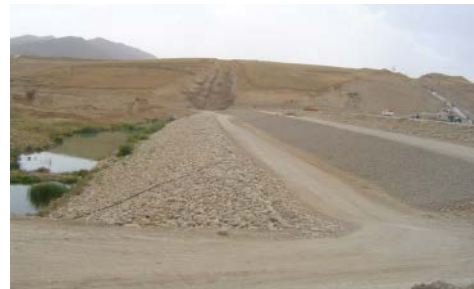
Fig. 1: Cofferdam upstream of Eyvashan is building

The study area is known as the Draught of Eyvashan dam in Lorestan Province, the geographic coordinates of the under construction Eyvashan dam is bound between the lengths of 48° , 37', 30 and 48° , 52', 30" East and width of 33° ,25',00" and 33° ,37',30" North. Herod is the only important river in this area that flows from South East to the North and North West. In order to make maximum use of stream flow and water supply requirements of different regions of Lorestan Province, Eyvashan Dam is under construction on the Herod River (Fig. 1) (Faraz, 2001, 2003).

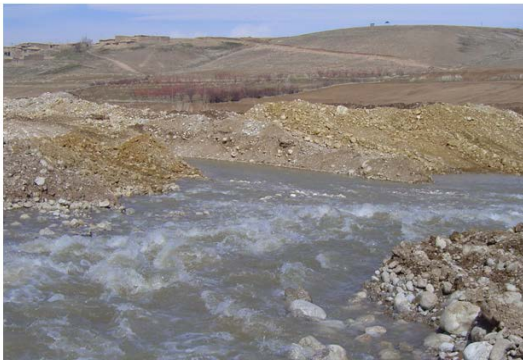
Fig. 3: Pleistocene conglomerate in the place of Eyvashan dam site on Herod river in the Southern village of Eyvashan

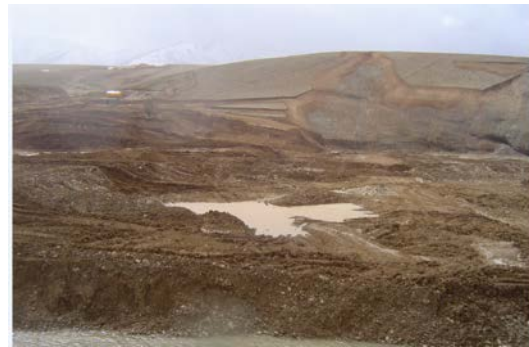
Fig. 4: View of the under construction dam site conglomerate of Eyvashan

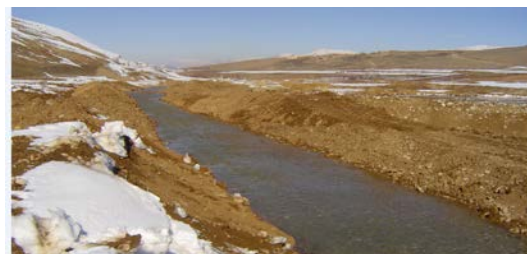
Fig. 5: The pleistocene conglomerate

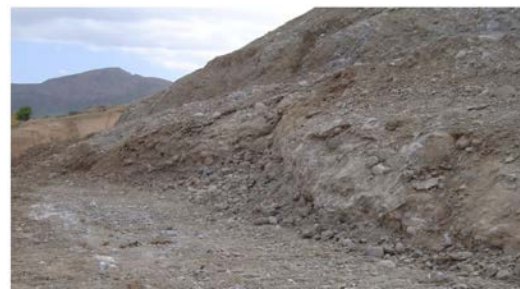
Fig. 6: Close view of polio pleistocene conglomerate protrusions in the south of the case study area in the picture the texture of the conglomerate and litchis fragments are visible

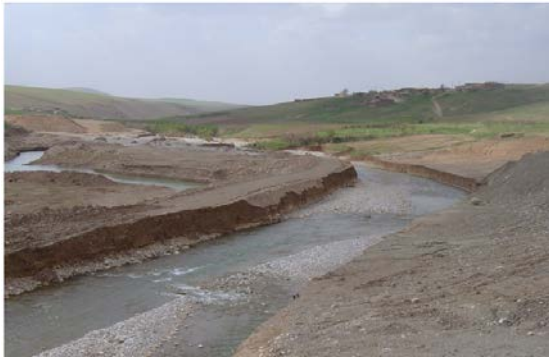
Fig. 7: Conglomerate walls with a slope of 40 with a series of closed joint linear that their path is determined by herbaceous plants that is visible on the riverbank of Herod

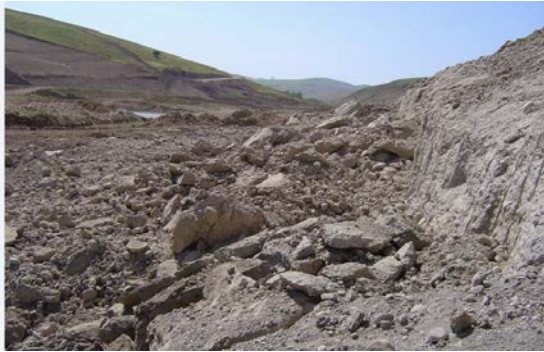
Fig. 8: View of South East conglomerates that are very similar to the Bakhtiari conglomerate

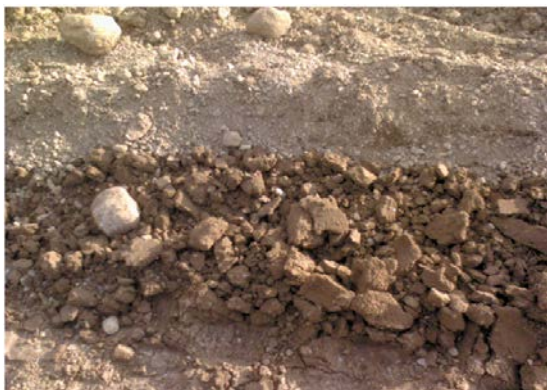
Fig. 9: The progress and fine-grained sedimentary cover of antiquity (Qt) on the conglomerate (PLQc) on the right-hand edge of khoram Abad-Brojerd road not far from the bridge Herod

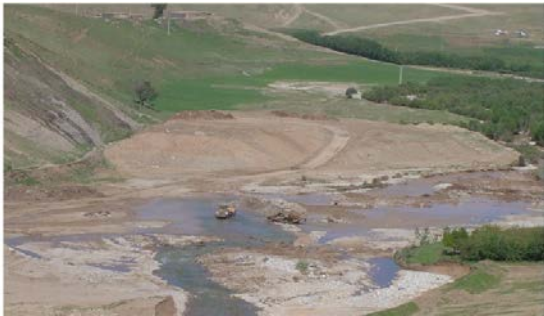
Fig. 12: View of the sediments of the surface of Herod River

These deposits are the creature of a lacustrine environment because fossils and ear of fish can be seen in them; these fine-grained sediments as a source of credit are studied. The way of Eyvashan river is covered by sediments of sand and boulder up to a diameter of about 1 m (Fig. 12). The maximum thickness of the sediments in the area around the dam and in the lake is about 6 m. The deposits are predominantly made of limestone but parts of igneous, metamorphic consists of Andesite, basalt, slate can be seen in them. The sediments are the source and aggregate gravel shell of Eyvashan dam.
