## Compression Zone Rehabilitation of Damaged RC Beams Using Polyester Glue Line

Nabeel Hasan Ali Al-Salim, Rafea Flaih Hassan and Muna H. Jaber  
Department of Civil Engineering, College of Engineering, University of Babylon, Hillah, Iraq

**Key words:** RC beams, polyester glue line, rehabilitation, flexural, experimental, connectors

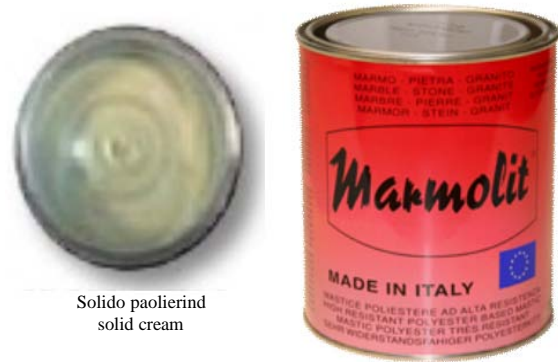
Fig. 2: Polyester glue line

**Polyester glue line:** The properties of polyester glue line is straw solid cream polyester resin processed with suspended minerals as shown in Fig. 2. It is especially recommended for gluing, repairing or making stuccowork. The characteristics are strong binding power, rapid hardening, easy application, very good polish and homogeneous color. The physical properties obtained from manufacturing data (<http://www.b-chem.net/>) are listed in Table 3.

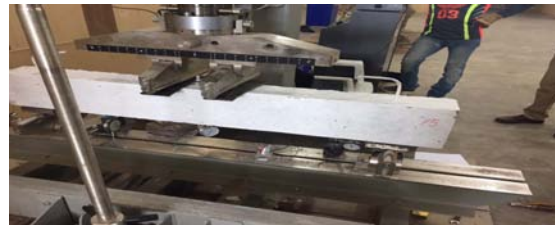
Fig. 3: Testing machine of RC beams

**Instrumentation and test setup:** After curing and rehabilitation mechanical testing of the beams was carried out (ASTM C192/C192M-02) (Anonymous, 2001, 2002a-c). Vertical deflections were measured near the

supports and at midspan using three dial gauges so that the net displacement can be obtained by deducted midspan displacement from the average of displacements close to supports as shown in Fig. 3.

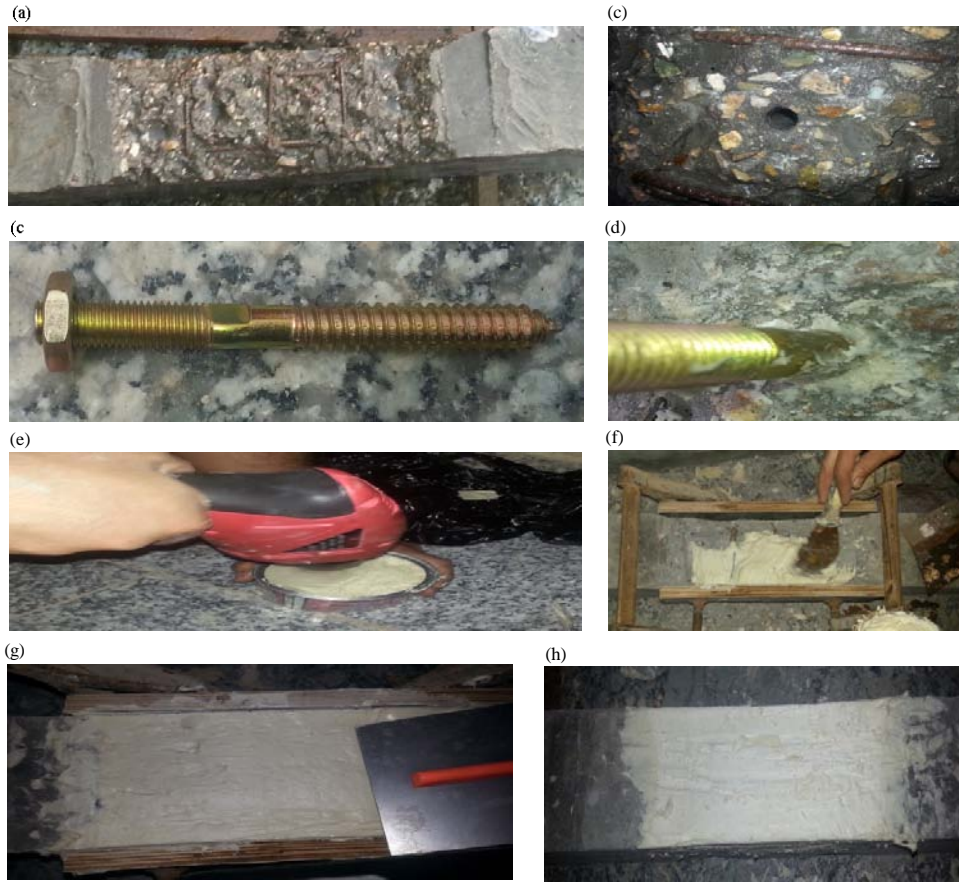
**Strengthening of damaged specimen:** After crashed intended region of beams (3 cm from depth) of compression zone with different length (10, 20 and 30% of tested length of specimen at center), result crushed surface was cleaned by potable water and was left it until dry as shown in Fig. 4a. The φ10 mm holes for shear connectors was drilled along the center line of beam with depth of 5 cm at 7 cm center to center spacing. The shear connectors were fixed to the holes using the same polyester glue line shown in Fig. 4d. The polyester resins were prepared following the manufacturer's directions by mixing two components (resin and hardener components). The hardener was add with 2% of the polyester glue line and mixed using low speed drill. The mixed resin was applied on damaged zone using a trowel as shown in Fig. 4g.

Fig. 4: Repairing with polyester glue line: a) Clean the damaged zone; b) Hole of shear connector; c) Shear connector; d) Fixed shear connector; e) Mixing polyester glue line; f) Pervading polyester glue line; g) Adjustment polyester glue line and h) Repaired damaged zone

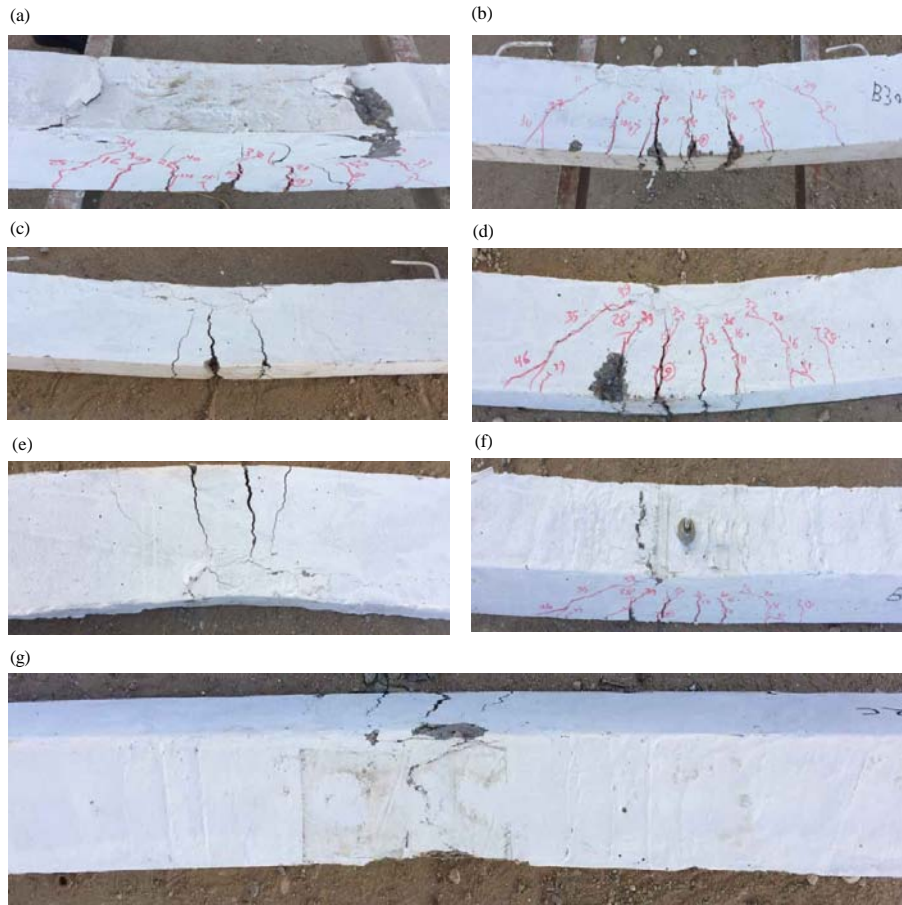
Fig. 14: Beams after failure: a) R30; b) B30; c) R20; d) B20; e) R10; f) B10 and g R

afford slight enhance in the ultimate load and ductility from that obtained of beams without shear connectors while the first crack load was equal as shown in Fig. 9-14.

The failure of all rehabilitated beams occur when the concrete was crushed at the end of polyester glue line as shown. Also, polyester glue line still bonded with concrete after failure for all specimens. Significant enhancing of beams behavior when the polyester glue line was used as compared with other strengthening materials, especially in cost.
