## Chloride Induced Stress Corrosion Cracking (CISCC) of Austenitic Stainless Steel under Thermal Insulation at Ambient Temperature

**Abstract:** Based on recent case study from petrochemical industry vessel leakage incident was taken to investigate failure of Chloride Induced Stress Corrosion Cracking (CISCC) of austenitic stainless steel 304. The objectives of this research was to investigate the reasons for CISCC failure of austenitic stainless steel 304. To simulate CISCC initiation of austenitic stainless steel 304 in different chloride concentration environment at ambient temperature. In this study, ASTM G-30 U-bend standard test method was used to evaluate factors that affect the CISCC of austenitic stainless steel 304. Total of 6 U-bend specimen were prepared with 200, 4000, 5000, 6000, 7000 and 8000 ppm of chloride concentrations. All these specimens were immersed in sodium chloride aqueous solutions for 8 months period to determine the parameters which leads to appearance of initiations crack mode. The laboratory experiment then repeated with the same specimens with 50,000 ppm chloride concentration for another 3 months. However, after cleaning the U-bend specimen and co

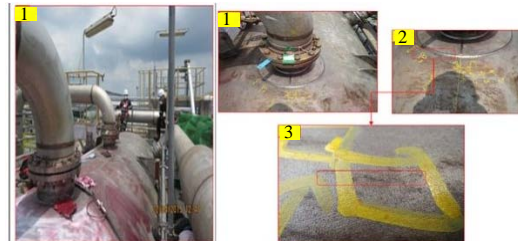
Fig. 5: General view top shell from east plant side. 1-3 typical finding as above

Based on dye penetrant testing on pressure vessel leakage was found from external surface. The pressure vessel was with insulation in operation condition. Failure of the AISI type 304 stainless steel was by leakage. Dye penetrant test was completely carried out at full body and at weld of equipment (accessible area). Based on the inspections conducted on the external surface, linear and rounded indications were found during inspection time. At the external surface of the tanks revealed improper passivation as a results of dye penetrant testing. Few areas was attacked with SCC external surface due to atmospheric corrosion. The inspection results, base and weld metals affected with pitting and crevice corrosion is revealed in Fig. 5.

The results indicated presence of stagnant water in service which supposed to be drained out after the hydrostatic test. In this case, maybe water was stagnant in the vessel. The samples of water should be analysis for CI contents. At a number of places crevices had formed due to weld spatter and excess penetration of weld deposit and gap between reinforcement ring and shell surface (Parrott and Pitts, 2011 a, b).
