Slope Stability Assessment in Semarang Clay: Case Study in Simongan Landslide 2016

¹Untoro Nugroho, ²Haryati Awang, ¹Rini Kusumawardani and ¹Tika Ratnasari

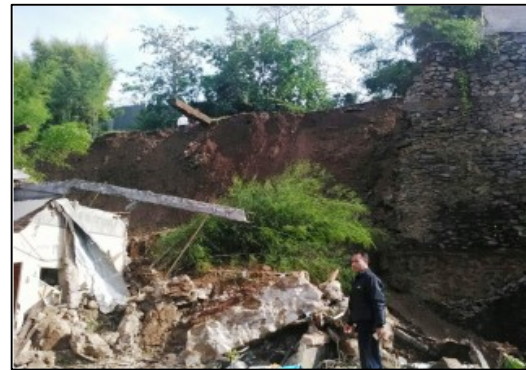
Fig. 2: Landslide occurrences at Semarang city in 2016

about 60° with a slope length of about 5 m and a height of 17 m. Similarly, the land around the slopes is functioned and used as densely populated residential area. The location and geologic map of research is shown in Fig. 1. The landslide cases have detrimental impacts such as damage to residence, displaced residents and human casualties. In addition, rainfall data in this area is very complete because it uses automatic tools with high accuracy and accuracy. The occurrence of landslides and their losses in the study area can be seen in Table 1. In the end of 2016, the disaster was destroy a road which relay a habitant house to the main road. The destruction could be seen in Fig. 2.
