Review of Road Drainage System-A Case Study of Nsukka Town in Enugu State, Nigeria

Abstract: Review in terms of the research undertaken is a formal assessment of the road drainage system in Nsukka town (urban). The eight major roads that convey most traffic were used as case study with the intention of changing or improving them to achieve sustainability. The aim of this review is to evaluate the existing condition of roads and drainage structures, explore the impacts of waste on drainage systems in Nsukka town (urban) and to identify the reasons behind drainage problems in roads focusing on current situation of Nsukka town. Some areas of Nsukka town already have great amount of erosion problem like in Onuiyi-Road and University Road which requires serious attention and this might have occurred due to lack of continuous channelization of drainage systems and on people's opinion on sustainability of these drainage systems. Hence, a conclusion was reached from the product of the research work. Maintenance of many of the existing drainage facilities was found to be poor which has posed a threat to lives and property. Recommendations on both improvements of waste management practices

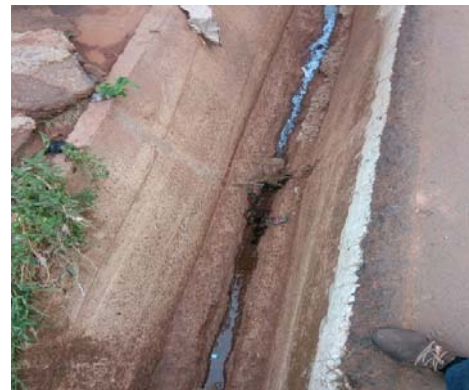
The results of the review are shown pictorially from Fig. 3-25 b. Figure 3 shows depth variation in University-Road. Figure 4 shows width variations in Onuiyi-Road. Figure 5 shows thickness variation in Aku-Road. Figure 6 shows well-constructed drainage

Fig. 3: Depth variation in University-Road

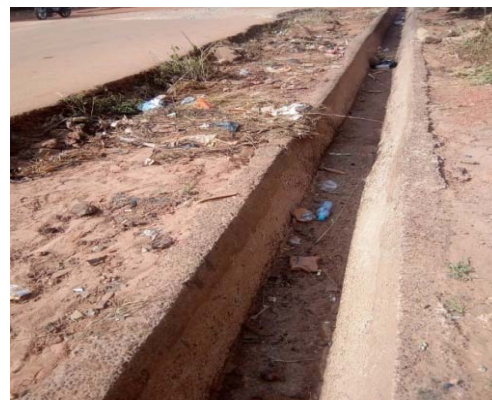
Fig. 4: Width variations in Onuiyi-Road

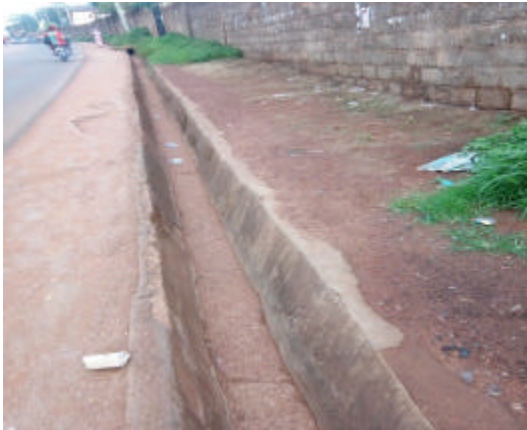
Fig. 5: Thickness variation in Aku-Road

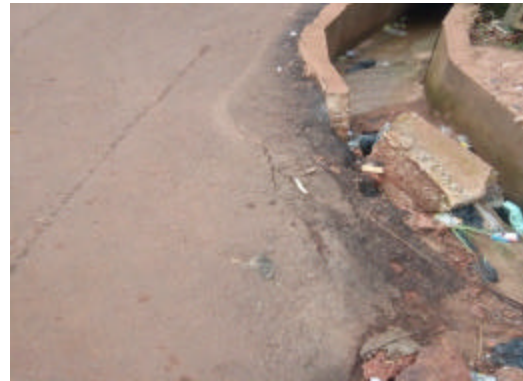
system in Enugu Road. Figure 7 shows section of poorly constructed drainage system in Aku-Road. Figure 8 shows section of poorly constructed drainage system in

Fig. 8: Section of poorly constructed drainage system in Odenigwe-Road

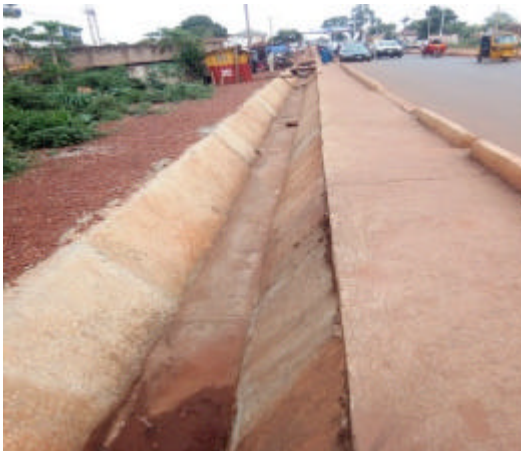
Fig. 6: Well-constructed drainage system in Enugu Road

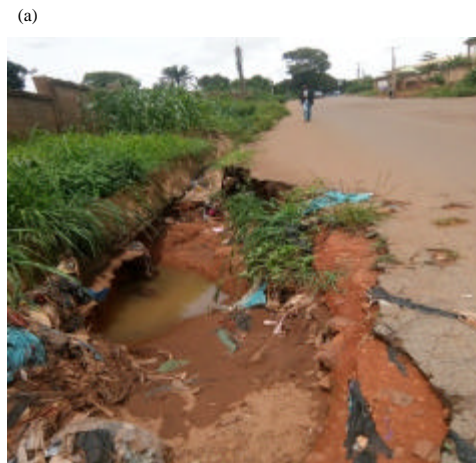
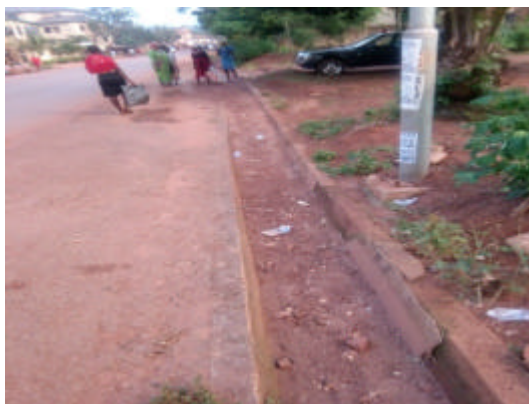
Fig. 7: Section of poorly constructed drainage system in Aku-Road

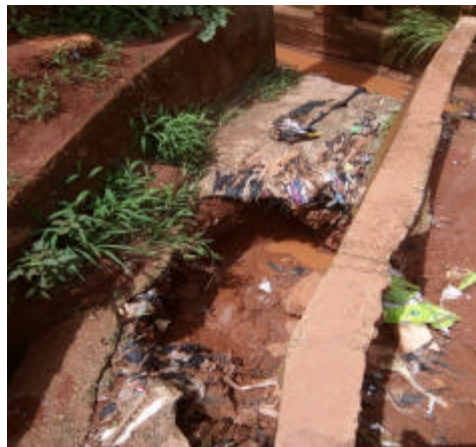
Fig. 9: Sections of failed drainage system in University Market-Road

Odenigwe-Road. Figure 9a shows sections of failed drainage system in University Market-Road. Figure 9b shows sections of failed drainages system in University Market-Road. Figure 10 shows underlying pipe cutting

- Introducing permanent waste sites where needed
- Increasing the number of temporary waste site where they are inadequate
- Improving cycling of the wastes to curtail the effect of poor waste management on Roads
- Maintenance of those drainage systems with severe damages

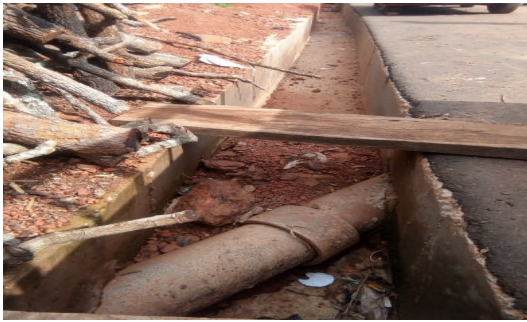
across the drainage system in Odenigwe-Road and University-Road. Figure 11 shows underlying pipe cutting across the drainage system in University-Road. Figure 12 shows drainage section where latitudinal siltation should

Fig. 10: Underlying pipe cutting across the drainage system in Odenigwe-Road and University-Road

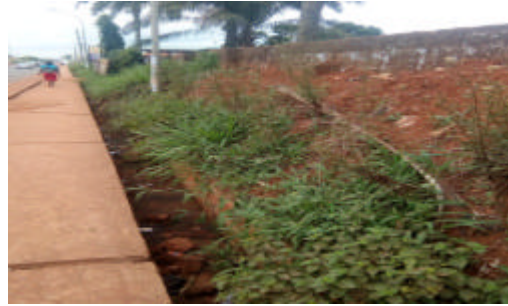
Fig. 13: Drainage section where latitudinal siltation should be prevented in Odenigbo Road

be prevented in University Market-Road. Figure 13 shows drainage section where latitudinal siltation should be prevented in Odenigbo Road. Figure 14 shows drainage section where latitudinal siltation should be prevented in Enugu-Road. Figure 15 shows drainage section where latitudinal siltation should be prevented in Orba-Road.

- Introduction of stone pitching or cementation of exposed soil mass sloping at an angle to the drainage system to avoid latitudinal siltation

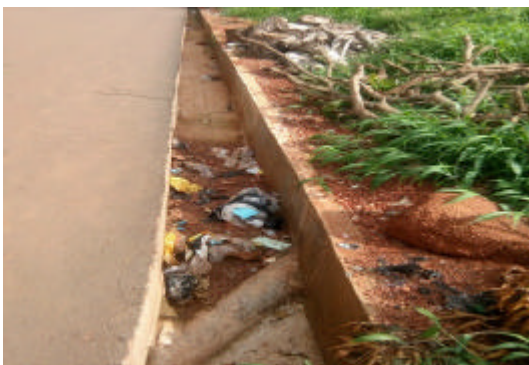
Fig. 11: Underlying pipe cutting across the drainage system in University-Road

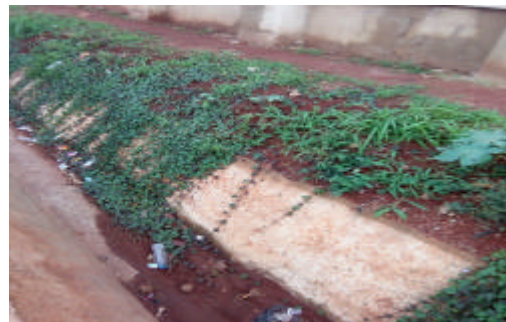
Fig. 14: Drainage section where latitudinal siltation should be prevented in Enugu-Road

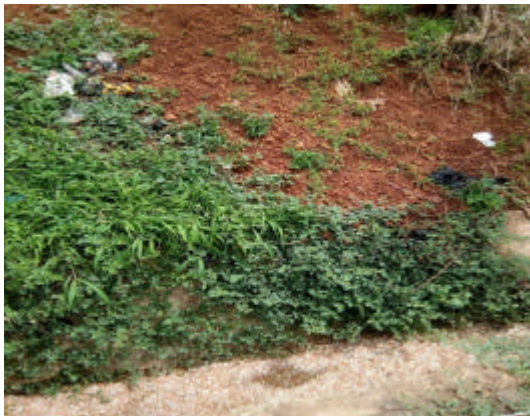
Fig. 12: Drainage section where latitudinal siltation should be prevented in University Market-Road

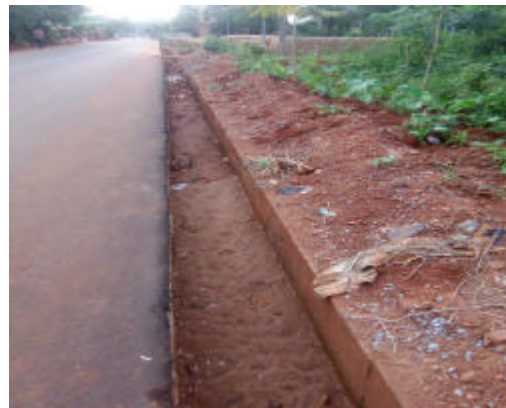
Fig. 15: Drainage section where latitudinal siltation should be prevented in Orba-Road

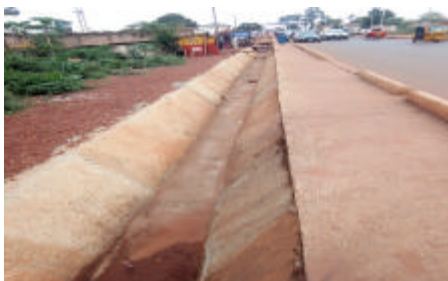
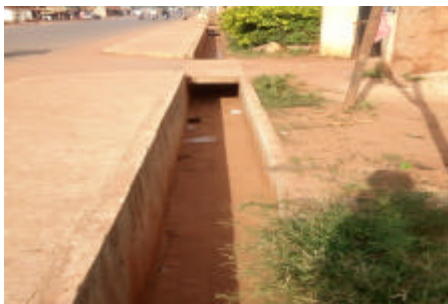
Figure 16 shows farm land along Odenigwe Road that dissipates fine particles into the drainage system during rain. Figure 17a shows Roads with good waste management, good drainage condition and without temporary waste site in Enugu Road. Figure 17b shows Roads with good waste management, good drainage

Fig. 17: a) Roads with good waste management, good drainage condition and without temporary waste site in Enugu Road and b) Roads with good waste management, good drainage condition and without temporary waste site in Orba Road

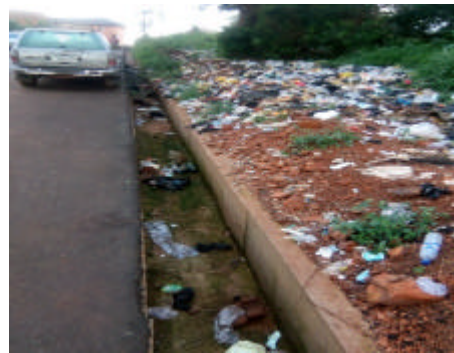
condition and without temporary waste site in Orba Road. Figure 18 shows Road with no temporary waste site, poor waste management and good drainage condition, e.g., Odenigwe-Road. Figure 19 shows Road with temporary waste site, good waste managements and poor drainage condition, e.g., Aku-Road. Figure 20 shows Road with no temporary waste site, poor waste managements and poor drainage, e.g., University-Road. Figure 21a shows Roads with temporary waste site, very good waste managements and very poor drainage condition, e.g., Onuiyi- Road. Figure 21b shows Roads with temporary waste site, very good waste managements and very poor drainage condition, e.g., Onuiyi-Road. Figure 22a shows Roads with temporary waste site, very poor waste

Fig. 18: Road with no temporary waste site, poor waste management and good drainage condition, e.g., Odenigwe-Road

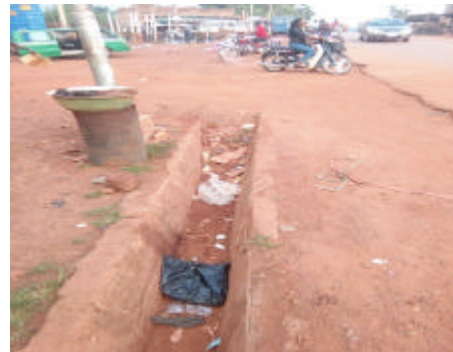
Fig. 19: Road with temporary waste site, good waste managements and poor drainage condition, e.g., Aku-Road

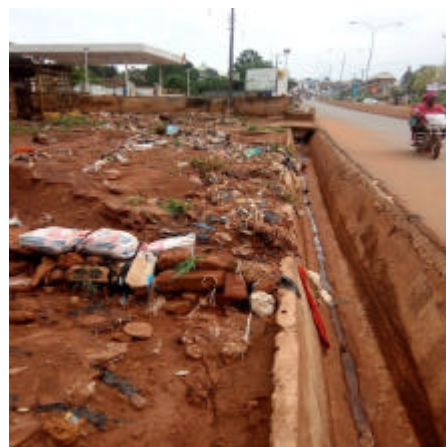
Fig. 20: Road with no temporary waste site, poor waste managements and poor drainage, e.g., University-Road

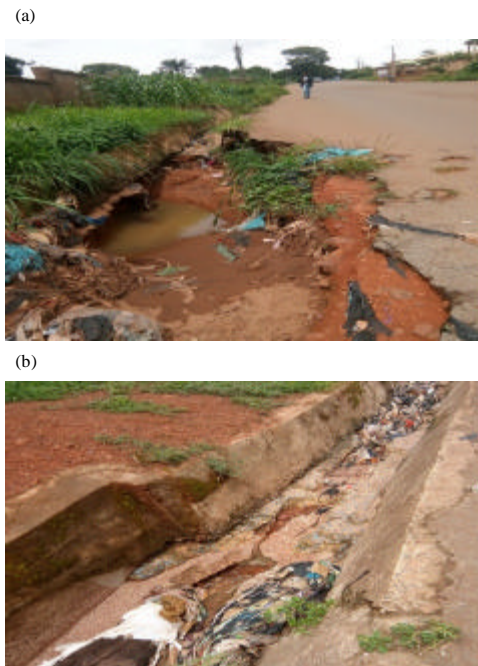
Fig. 22: a, b) Roads with temporary waste site, very poor waste managements and poor drainage condition, e.g., University market-Road

managements and poor drainage condition, e.g., University Market Road. Figure 22b shows Roads with temporary waste site, very poor waste managements and poor drainage condition, e.g., University Market-Road. From the questionnaire, more emphasis on good and sustainable Road drainage system for the Road sustainability is made by the correspondents at the rate of 68% (Fig. 23).

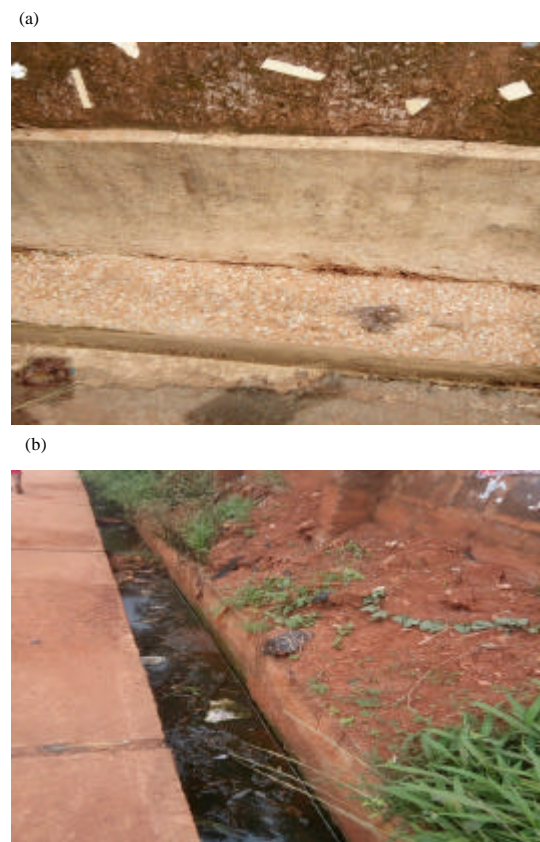
Fig. 24: a) Stone pitching method at University Market-Road and b) Un-stone pitched soil mass in Odenigbo Road

The result of Table 2 shows that the drainage in Enugu Road is in excellent condition with a good waste management even though it has no temporary waste site. Orba-Road drainage system follows almost the same trend. Odenigwe-Road has very good drainage system with a poor waste management, having no temporary waste site. Odenigbo-Road has good drainage system but a poor waste management system with only one temporary waste site. Aku-Road has a poor drainage system with only one temporary waste site but has a good waste management system. University-Road is the worst fitted, having poor drainage system and waste management system with no temporary waste site. Onuiyi-Road has a very good waste management system with four temporary waste sites but a very poor drainage system. Lastly University Market-Road has a poor drainage system and very poor waste management system with only one temporary waste site (Fig. 24 and 25).

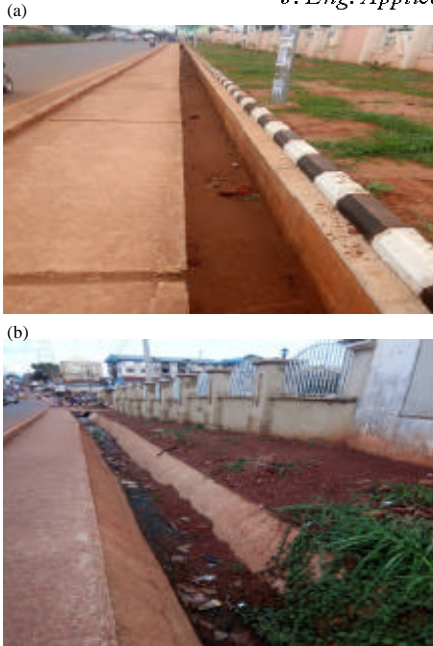
Fig. 25: a) Cementing method with kerb in Odenigbo Road and b) Un-cemented soil mass at Enugu Road
