Geoelectric Study of Dam Site of Federal College of Agriculture Akure Southwestern Nigeria

Abstract: Geophysical investigation has been undertaken at an existing dam site within the campus of the Federal College of Agriculture, Akure. This is aimed at evaluating the geophysical characteristics of the bedrock along the dam axis and its banks. The survey involved the use of electrical resistivity (VES) depth sounding technique. The Schlumberger electrode configuration was adopted for the field study. Thirty-three soundings were undertaken on nine traverses that were established in North-South directions on the Western (W1-W3) and Eastern (E1-E3) flanks and West-East traverses established on the Southern end of the dam (S1-S3). The three major litho logy units delineated are the topsoil, weathered basement and the presumably fresh/fractured bedrock. The geoelectric section revealed a network of lineaments presumed to be fractures on the S1-S3 and W1-W3 profiles. The geoelectric maps show high resistivity contours straddled with low resistivity lines characterizing the eastern flank thus indicating near-surface bedrock straddled with a basement depression or fracture. The presence of

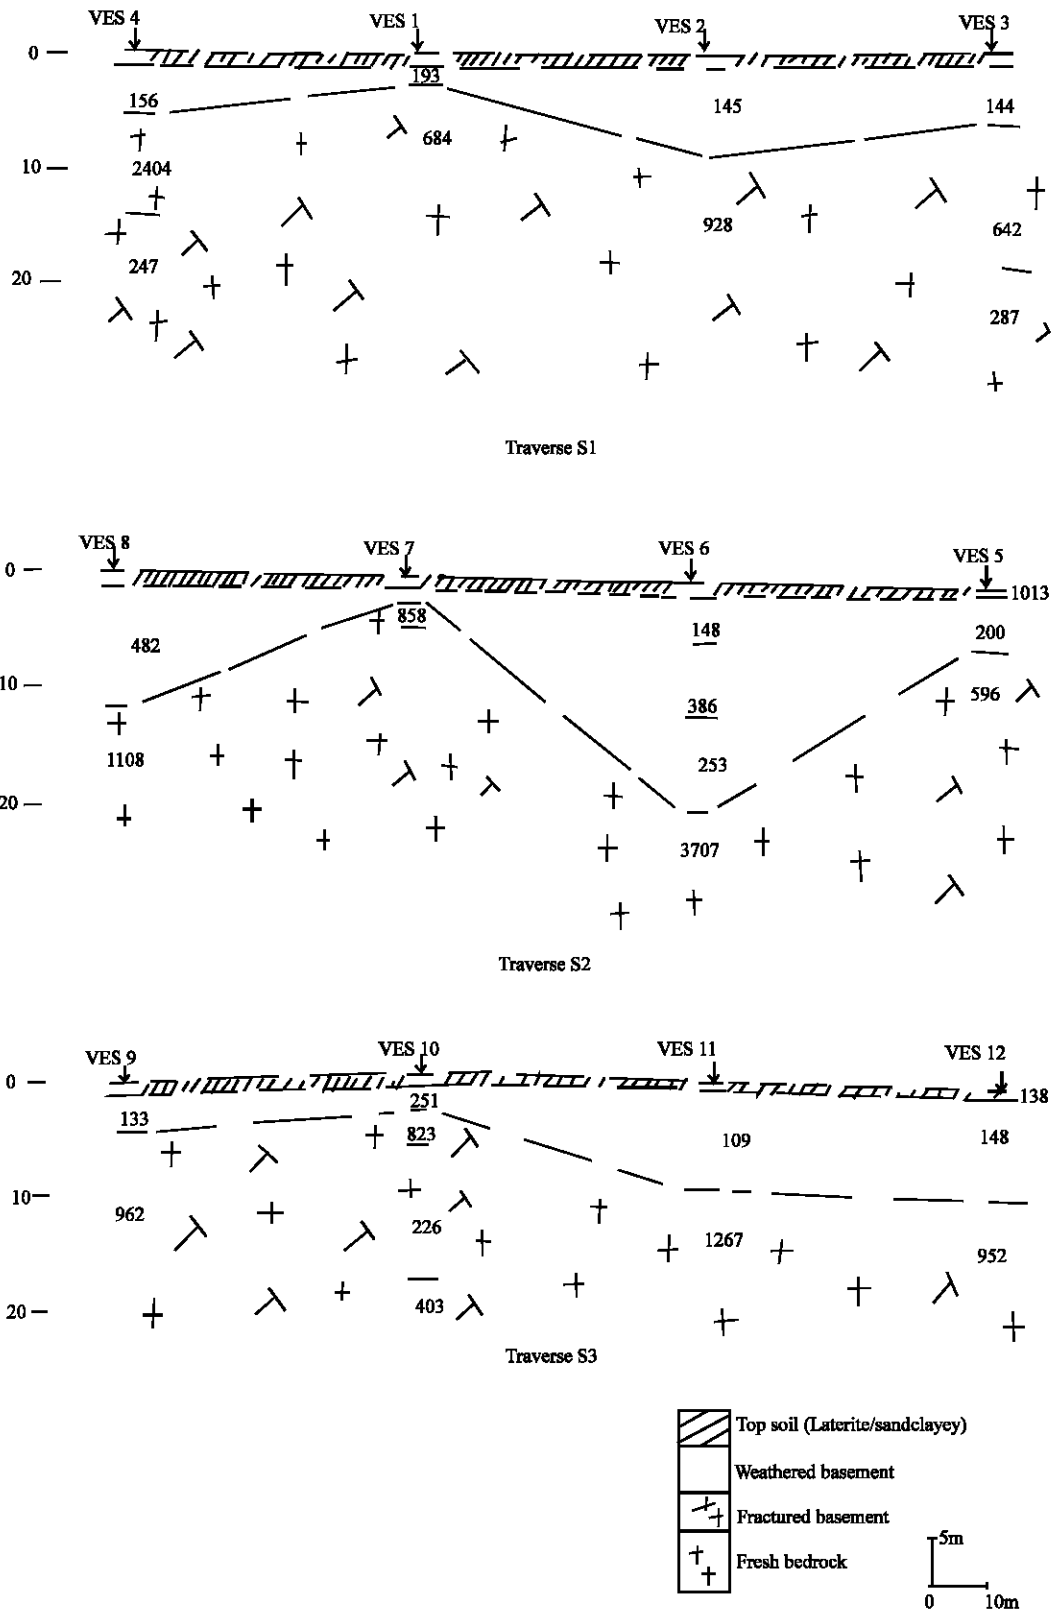
Fig. 5: Geoelectric sections along traverses S1-S3

Geoelectric sections: 2-D geoelectric sections along profiles S1-S3, E1-E3 and W1-W3 are presented in Fig. 5-7, respectively. Three major geoelectric layer units were delineated beneath the sections. These are the topsoil, weathered basement and the fractured/fresh resistive bedrock. The topsoil consists of laterite/clayey sand/sandy clay with resistivity values varying from 136 to 3132 Ω-m. Layer thickness varies between 0.6 and 1.6 m. The weathered layer which has resistivity and thickness varying from 73 to 771 Ω-m and 0.7 to 21.6 m, respectively consists of clay/sandy clay/clayey sand/sand. The third layer constitutes the bedrock.

The granitic nature of the underlying rock is observed on the outcrop within the reservoir at about 8m north of VES 1. The bedrock resistivity values range from 1029 to 52,134 Ω-m (infinitely resistive). This is diagnostic of partially weathered basement to fresh bedrock. Basement fracturing was observed on thirteen locations. They are VES 1, VES 2, VES 3, VES 4, VES 5, VES 6, VES 7, VES 9, VES 10, VES 13, VES 14, VES 18 and VES 21 on profiles S1-S3 and W1-W3. The resistivity values diagnostic of fractures in the dam environment

vary from 110 to 952 Ω-m. Their presence is not considered ideal for good dam performance and dam safety. The existence of fractures is generally accompanied by high fluid streaming potential. Hence, substantial water may be lost through the fractures thus initiating the weakening of the dam foundation. Geoelectric attributes indicative of sandy clay, clayey sand observed in the weathered layer were obtained from curve types associated with thick overburden (i.e., HA, KH and HKH).
