Asian Journal of Animal and Veterinary Advances

# Pacemaker Implantation in Horse with Bradycardia-Tachycardia Syndrome

Soontaree Petchdee, Metha Chanda and Worakij Cherdchutham

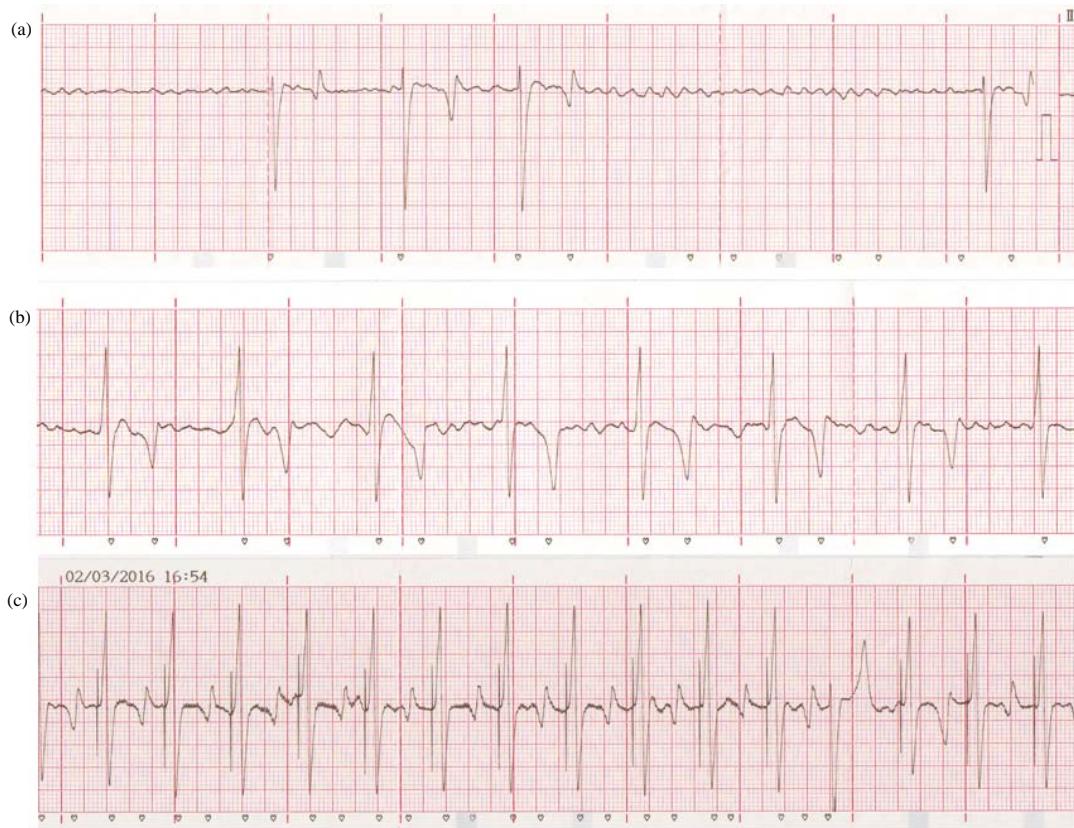
Fig. 1(a-c): Base apex electrocardiogram was recorded, (a) Recording of electrocardiogram after walking for 10 min, after implantation in (b) Regular rhythm of ventricular response and (c) At a pacing rate of  $100 \text{ beat min}^{-1}$  ( $25 \text{ mm sec}^{-1}$ ,  $1 \text{ mV cm}^{-1}$ )

**Electrocardiographic examination:** A base apex lead electrocardiogram (ECG) recording (Kenz ECG 110, Single channel digital Electrocardiographs, Japan) was performed in standing position with a paper speed of 25 mm/sec and calibration of 10 mm for 1 mV. This study was carried out on March, 2016 at Kasetsart Veterinary Teaching Hospital, Kamphaeng Saen Campus. ECG revealed irregular heart rhythm with fibrillating waves. The heart rate calculated from the ECG recording was around 23 beats min<sup>-1</sup> (bpm), which is lower than the normal heart rate of the horse. Therefore, the bradyarrhythmic rhythm from excessive vagal tone was investigated using the electrocardiographic recordings under light exercise conditions (10 min of walking). The ECGs are shown in Fig. 1a. After pacemaker implantation, ECG showed regular rhythm at pacing rate of 50 bpm (Fig. 1b) and 100 bpm (Fig. 1c).
