Forest Damage Caused by Earth Working Operations in Uneven Aged Deciduous Stands

A. Parsakhoo and S.A. Hosseini
Department of Forestry, Faculty of Natural Resources,
Sari Agricultural Sciences and Natural Resources University, Sari, Iran

Abstract: In this study the regeneration and trees damages caused by bulldozer earth working operations were examined for a road construction project in the Lolet Forest, Mazandaran Province, Iran. Damages were assessed within the 10000 m² plot along 400 m roads in each of slope classes 30-40, 40-50, 50-60 and 60-70%. Damaged regeneration were classified into stem wounds, broken stems, leaning and interment and uprooted. Damaged trees were classified into crown injury; stem wounds, felled and uprooted trees. The wounds areas were also classified into 0-300, 300-600 and more than 600 cm². Results showed that the most common type of damage to regeneration was leaning and the majority of this damage occurred in diameter classes of 0-2.5 and 2.5-7.5 cm. In higher slope classes a greater number of regeneration and trees were damaged. Totally, 87% of regenerations were damaged by bulldozer earth working. Fifty percent of trees were damaged in each of s

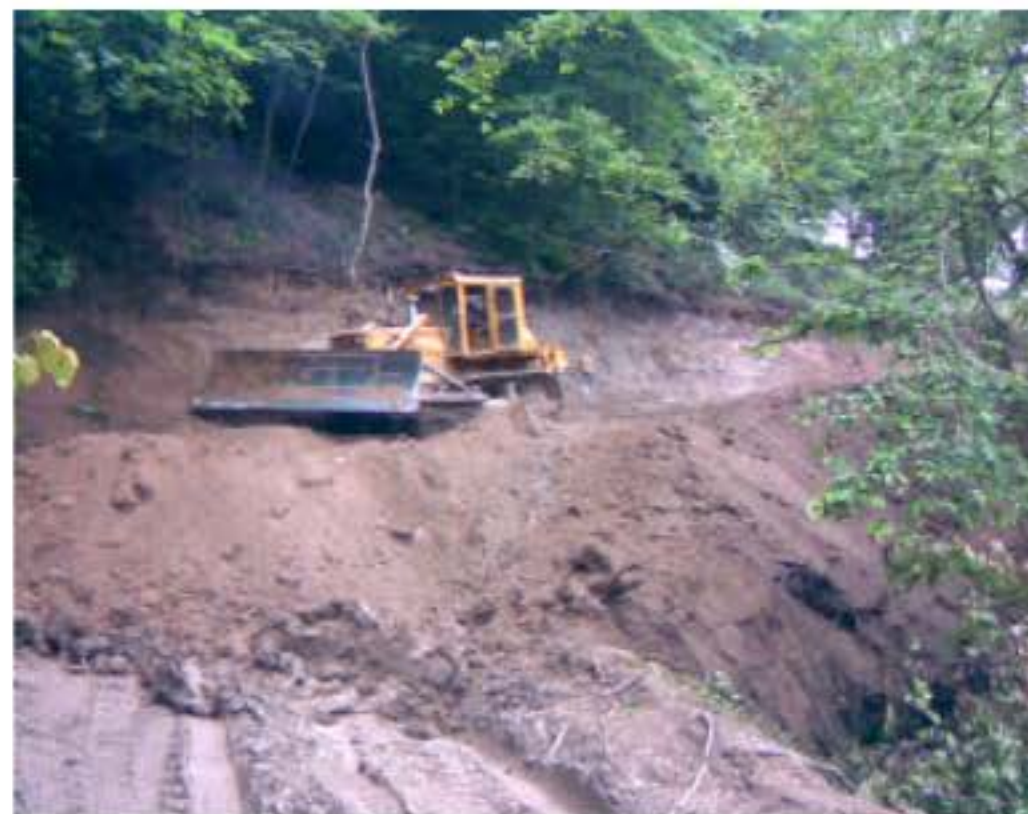
Fig. 3: Bulldozer earth working operation in study area

According to the 25 year, term data given by Soleiman Tangeh Meteorology Station, the nearest meteorology station to the research area, average annual precipitation is 635 mm. The climate of Mazandaran Lolet Forest is mid moist and cold. General texture type of soil in research area is loam. Vegetation period maintains for 8 months in average. Research area is a *Fageto carpinetum* stand. Altitude is 400-900 m, slope is 30-70% and it is in the NE aspect. The road passes through the stand in west-east direction. Earth working operations in the research area have been carried out by crawler bulldozer komatsu D60. The weight of this bulldozer is 17 t, the bucket volume is 5 m³ and the engine power is 220 hp (Fig. 3).
