# Investigative Study of Biodeterioration of External Sandcrete/Concrete Walls in Nigeria

Chidozie C. Nnaji, Uzoma H. Amadi and Rite Molokwu

Department of Civil Engineering, University of Nigeria, 410001, Nsukka, Nigeria

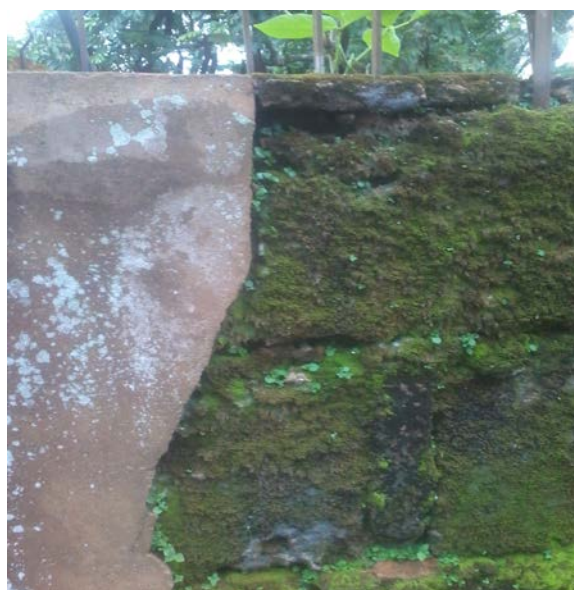
Fig. 5: Effect of surface roughness on the rate of biological growth

microbes. Moreover, since rendered walls are usually smoother than unrendered walls, it is therefore more difficult for the organisms to attach themselves to the wall which invariably leads to relative difficulty in biofilm formation on the rendered walls. Rough walls favour the attachment and subsequent establishment of organisms on walls. The effect of rendering has also been depicted by a picture taken during the study (Fig. 4). Figure 5 shows a fence wall with a segment of the rendering cover peeled off. It can be seen that the exposed sandcrete matrix with very rough surface has been totally colonized by biological growth while the portion that still retained the rendering cover has much less growth. Riba-Silva (1995) noted that surface roughness coupled with the availability of moisture and nutrients facilitate colonization of concrete by microbes. Nutrients can be provided by dust, paint and oil on the surface of the walls, rain water and

atmospheric particles (Pasanen *et al.*, 1993a, b; Chang *et al.*, 1996; Buttner *et al.*, 1999). Roughness can be substantially reduced by rendering and painting. Most of the affected walls were neither rendered nor painted. Besides, painting provides a protective coating that limits substrate availability to these organisms. This means that the protective coating has to be destroyed before sandcrete itself can be exposed to attack. This is similar to the protective function of electroplating on iron.

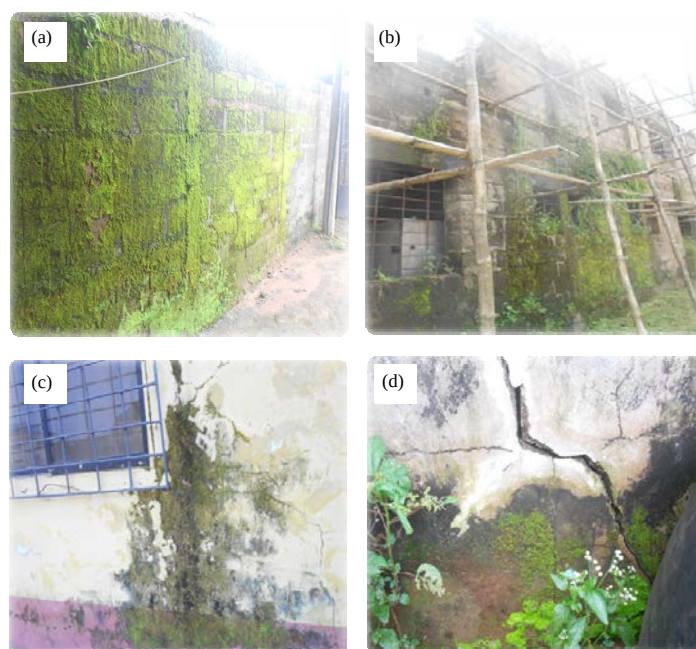
Fig. 9(a-d): Deteriorative effects of biological growth on walls, (a) Fence wall exposed to rain, (b) A building under construction, (c) Biodeterioration of wall paint and (d) Crack due to biodeterioration

Nigeria. It has two distinct seasons: Dry and rainy seasons. The rainy season commences in April and ends in October, followed by the dry season. The annual rainfall ranges between 9372.22433 mm and the relative humidity can sometimes exceed 90%. All the climatic parameters mentioned above, favour the colonization of concrete structures by biological growth. Air humidity and microclimate is critical for sporulation, spore release and survival of spores. The main environmental factors affecting mould growth in building structures are humidity and temperature; moisture being the crucial factor. For most part of the rainy season which spans about nine months, the walls are always kept wet by repeated cycles of rain and drizzles. During the rainy season, it can rain/drizzle twenty six days of the month. The constant rain coupled with the prevailing weather conditions keeps the relative humidity at a high level. Relative humidity of 80-90% is a critical humidity level for growth of mould fungi but also temperature, exposure time and surface of materials are important factors. Laboratory studies have shown that most dust mites require a relative humidity in excess of 45-50% for survival and development but they feed and multiply more rapidly at higher relative humidity (Arlian, 1992). Owing to the prevailing conditions, fence walls are easy targets for biological colonization. Figure 9a is a very common sight in the study area especially if the wall is not rendered or painted. Painted and rendered walls present more resistance

to biological colonization. It is also common to see buildings under construction massively colonized by biological growths, especially if there is prolonged delay in completion (Fig. 9b). The danger of this is that these biological growths appear soon after completion, having established a foothold earlier. Figure 9d shows large cracks appearing in a wall severely weakened by biological growth.
