Investigation of Failure and Corrosion in Pipelines and Tanks used in Ice-Cream Factory: The Case Study

Abstract: This study describes the reasons of failure and corrosion in pipelines and tanks used in ice-cream factory located in Soltanabad Industrial Region, Shiraz (Iran). The present research shows that the chloride level of the water is an important factor in determining the resistance of stainless steel due to crevice corrosion. Laboratory research shows that for the majority of natural, raw and potable water with pH in the range 6.5 to 8; crevice corrosion of 304/304L is rare below about 200 ppm of chlorides. Also crevice corrosion of 316 to 316L with the same pH is rare below about 1000 ppm of chlorides. Chemical analysis of the water of industrial region shows that it contains 386.36 ppm chlorides. So, the stainless steel pipeline type 304, which is used in the factory did not have any resistance against the crevice corrosion and rapidly corroded from those points which were more susceptible such as welded zone. Since the pipes were corroded around the welded zones, metallographic studies were conducted in this area which revealed that the welds were not of high quality a

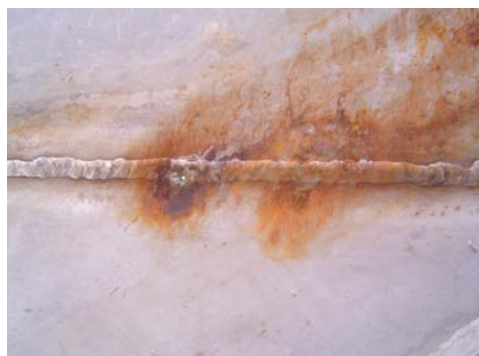
Fig. 1: Corrosion in vessel, around the fillet weld

During plant inspections, information about the pipe and vessel material in ice-cream factory which is located in Soltanabad industrial region on Shiraz, the temperature and kind of fluid running through the pipes and their welding methods were collected. Analyzing the specimens revealed them to be in type of 304 stainless steel. A month after the factory begins its productions, the pipes and vessels carrying water were corroded, whereas ones carrying other fluids remained unchanged and sound. Therefore the temperature, velocity and time of water passage through the pipes were measured. Water passed through a sandy filter before entering the first vessel, after which it passed through a water softener and entered the second vessel. The original water entering the plant, the discharge water from the condenser and the water softener were sampled. The results of analysis are shown in Table 1 and 2. On the other hand, since the corrosion of pipes and vessels were mainly concentrated around the weld fillet (Fig. 1, 2) samples were taken for metallographic studies, results which are shown in Fig. 3 and 4.

different practical methods such as acid pickling the surface of weld, grinding and electropolishing to eliminate and clean the weld of the oxides present in the heat affected zone. Therefore, according to the above discussion there are different methods of corrosion prevention in pipes and vessels of the plant. In case water is only used for washing and not for food products, inhibitors could be used, but application of galvanized steel is more economical and provides higher resistance than stainless steels. Otherwise it is recommended to reduce the amount of chloride in water by modifying the water softener or deoxidizing the feed water of the plant to prevent localized corrosion in the pipes and vessels.

In this study, we showed that the main method of solving the corrosion problems in all parts of this factory was reducing the chloride content of water to an acceptable level by modifying the water softener. Beside, two other solutions were suggested. The first one was using stainless steel type L instead of type 304 and another one using high quality welds instead of the previous ones, but these methods weren't feasible according to the economic condition of that factory.
