Asian Journal of Scientific Research

Investigating of Tool Wear, Tool Life and Surface Roughness When Machining of Nickel Alloy 242 with Using of Different Cutting Tools

Abstract: This study discusses about behavior of cutting tools in term of tool wear, tool life and surface roughness integrity when machining of nickel based alloys 242. Experimental tests were conducted using four different cutting tool materials under wet condition. They are TiAlN, TiCN/TiN, TiAlN/TiN (PVD) and TiCN/Al₂O₃ (CVD). Tool failure modes and wear mechanism for all cutting tools were examined at various cutting parameters. Flank wear was found to be the predominant tool wear for the four types of cutting tools especially with CVD tools. Coating is observed to be delaminated as main phenomena on all cutting tools surfaces. The obtained results have indicated that PVD cutting tools perform better than CVD cutting tools. The thickness of coating layers for CVD is thicker than PVD. Finite Element Analysis (FEA) is used to support this study in term of analysis of cutting tool deformation and cutting temperature.

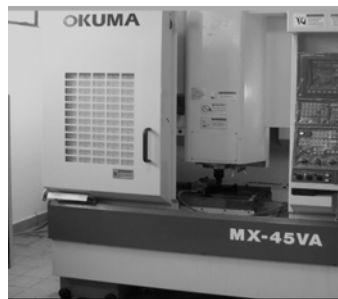
Fig. 1: Okuma MX-45-VA-CNC milling machine

An age hardening nickel alloy 242 as a workpiece material since it is the most commonly used grade in the aerospace and gas turbine industries in size of 170×110×20 mm are used. The experiments were carried out in a very rigid CNC milling machine Okuma MX-45VA with speed ranging from 25 to 100 m min⁻¹ (Fig. 1).

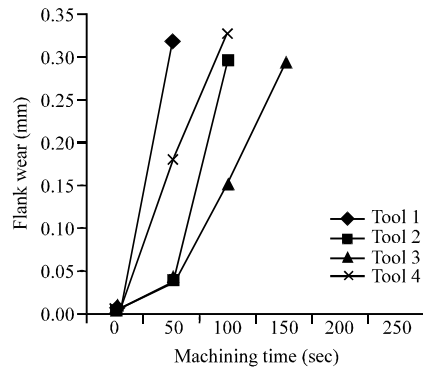
Fig. 2: Flank wear curve when machining at speed of 100 m min^{-1} and feed rate 0.2 mm rev^{-1} with axial depth 0.4 mm

The development of flank wear curve obtained for four cutting tools operated when kept cutting speed constant are shown in Fig. 2-4, respectively. It was observed that during the using of TiAlN, TiCN/TiN, TiAlN/TiN and TiCN/Al₂O₃ cutting tool, flank wear was observed an acceptable result with lower cutting depth of 0.4 mm cutting speed 100 m min⁻¹, were employed. At high cutting depth 1 mm with cutting speed 100 m min⁻¹. The tool worn quite rapidly, resulting in a shorter tool life. Generally all cutting tool worn rapidly at high cutting speed tests and when applied high cutting depth, cutting tools experienced different modes of failure throughout the trails. These were non-uniform flank wear, chipping and catastrophic failure (Fig. 5-8) show images of the failure modes at various cutting parameters for all cutting tools employing. Chipping of the cutting edges was common at high cutting speeds and high cutting depth, perhaps due to when interfacing of cutting tool with workpiece.

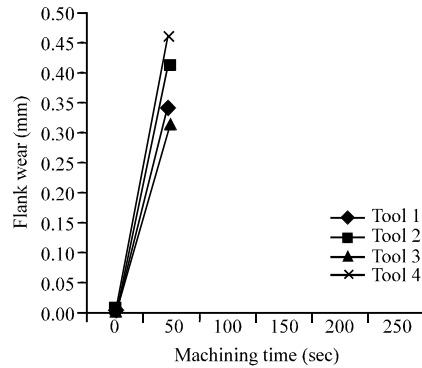
Fig. 3: Flank wear curve when machining at speed of 100 m min^{-1} and feed rate 0.3 mm rev^{-1} with axial depth 0.7 mm

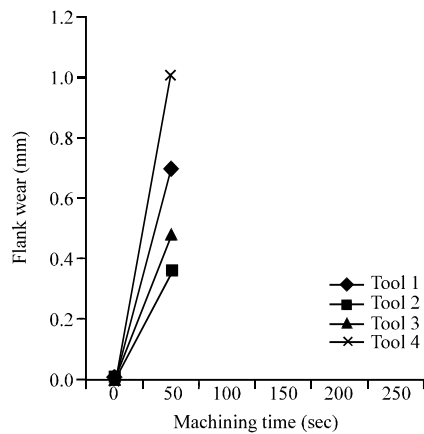
Fig. 4: Flank wear curve when machining at speed of 100 m min^{-1} and feed rate 0.2 mm rev^{-1} with axial depth 1.0 mm

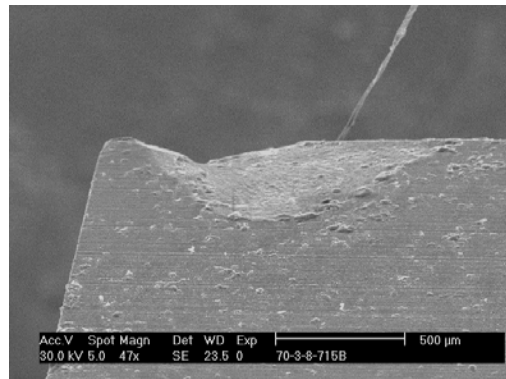
Fig. 5: Catastrophic failure (TiAlN) at cutting depth 1 mm with speed 100 m min^{-1}

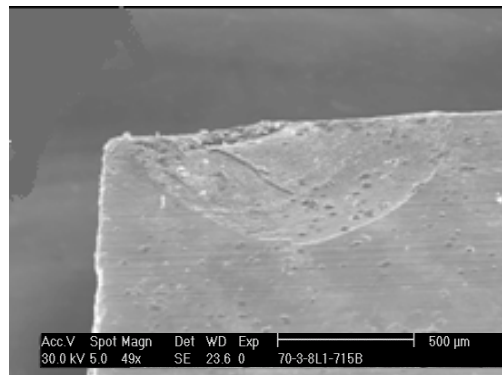
Fig. 6: Non uniform flank wear and BUE, (TiAlN), cutting depth 1 mm speed 100 m min^{-1}

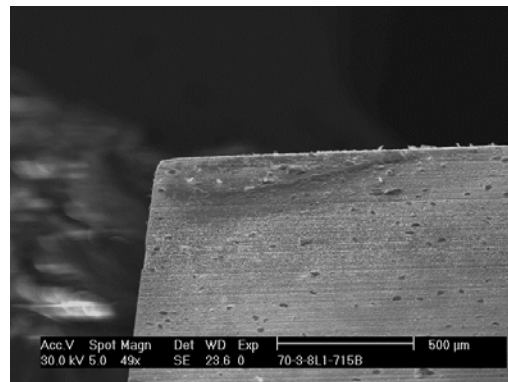
Fig. 7: Uniform flank wear, (TiAlN), cutting depth 0.4 mm speed 100 m min^{-1}

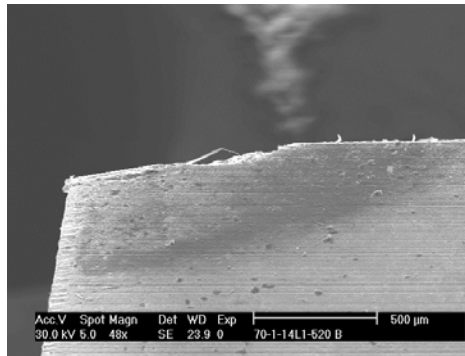
Fig. 8: Chipping, (TiAlN), cutting depth 1.0 mm speed 100 m min⁻¹

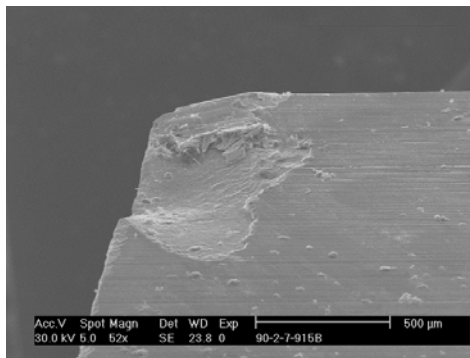
Fig. 9: Catastrophic failure-TiCN/Al₂O₃-cutting tool

Results in term of tool life when machining of nickel alloy by using of TiCN/Al₂O₃ cutting tool are given a clear vision (Fig. 9) this tool recorded very short tool lives with catastrophic failures when carried out of experiments, the maximum tool life for this tool are recorded at medium and low cutting depth, these results concern of cutting forces which played as a significant role in shortest of the tool life for TiCN/Al₂O₃ tools. the results revealed the outstanding performance of all cutting tools at low and medium cutting depth and cutting speed. The longest tool life was recorded for (TiAlN) cutting tool at medium cutting depth when with lower cutting speed.

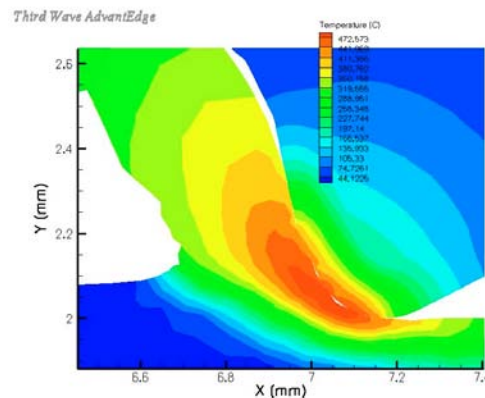
Fig. 10: Cutting temperature and tool deformation with cutting depth 0.4 mm

Figure 10, 11 and 12 shows the distribution of temperature on the cutting edges boundaries with various valued and cutting tools deformations, by using ThirdWave AdvantEdge simulation software

obtained on these figures and results. Observed the influence of cutting depth on cutting temperature in term of tool deformation and the final result for cutting temperature, whereas when applied low cutting depth the deformation and temperature are acceptable with low values these result arise depending on cutting depth, at (Fig. 12) noticed generation and increasing of temperature and higher deformation when interfacing of cutting edge with workpiece.

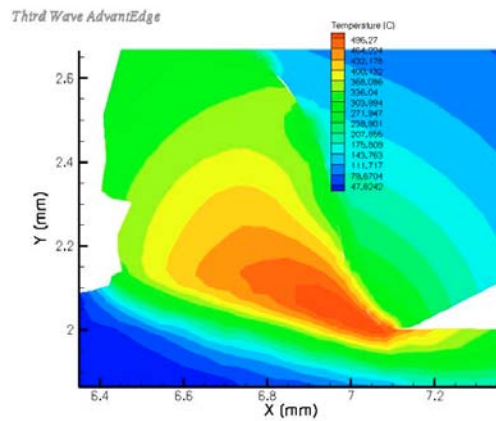
Fig. 11: Cutting temperature and tool deformation with cutting depth 0.7 mm

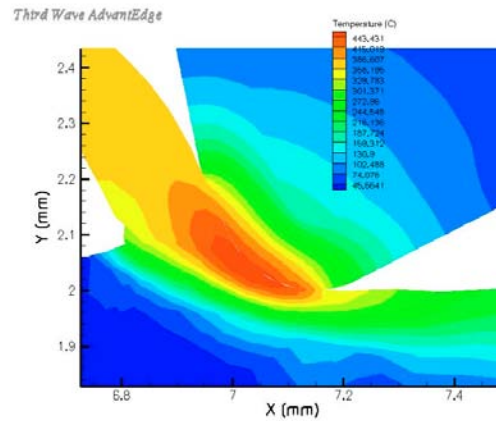
Fig. 12: Cutting temperature and tool deformation with cutting depth 1 mm
