Journal of Applied Sciences

Capabilities of Cermets Tools for High Speed Machining of Austenitic Stainless Steel

Ahsan Ali Khan and Sami Salama Hajjaj

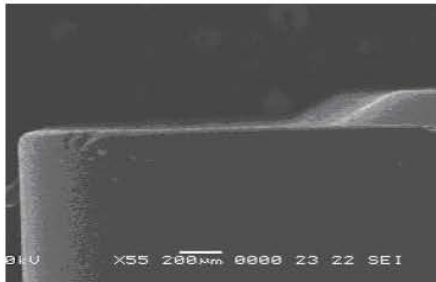
Fig. 2: Effect of depth of cut. ($V = 300 \text{ m min}^{-1}$, feed rate = 0.1 mm rev^{-1} , 10 min of machining)

Figure 2 shows the photographs of tool edges after 10 min of machining at a cutting speed of 300 m min⁻¹ and a feed rate of 0.1 mm rev⁻¹. With an increase in depth of cut, the contact length of the cutting edge with the workpiece increases and wear occurs deeper along the cutting edge. It can be seen that the size and depth of the cracks on the cutting edge not only increase with an increase in feed, but they occur deeper away from the tip of the cutting edge. This is because, due to the increase in the depth of cut, chip width increases and the center of pressure of the chip on the tool face moves away from the tool nose.

(a) depth of cut = 0.1 mm

(b) depth of cut = 0.2 mm

(c) depth of cut = 0.3 mm

(d) d.o.c = 0.5 mm

If the center of pressure moves away from the tool nose, the generated heat is dissipated easily within the body of the tool due to the wedged shape of the cutting edge. This is a positive aspect in terms of heat distribution, but the quantity of heat generated due to the increase in depth of cut is more which causes the increase in temperature at the cutting edge. It should also be noted that, as the chip width increases with the increase in depth of cut, the surface of the chip becomes rougher and the real contact area between the tool face and the chip is reduced resulting localized heat concentration at the contact areas mentioned. Moreover, the increase in depth of cut causes more compressive stress on the cutting edge resulting in rapid fracture of the tool edge.

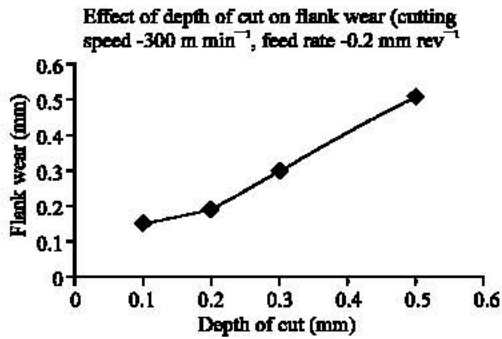
Fig. 3: Effect of depth of cut on flank wear

Figure 3 shows the effect of depth of cut on flank wear after 10 min of machining at a cutting speed of 300 m min⁻¹ and a feed rate of 0.2 mm rev⁻¹. It can be observed that flank wear increases almost linearly with the increase in the depth of cut within the range considered. It can also be observed that cermet tools are not suitable for machining with a depth of cut beyond 0.3 mm with a cutting speed of 300 m min⁻¹ and a feed rate of 0.2 mm rev⁻¹ since the maximum permissible flank wear is 0.3 mm.

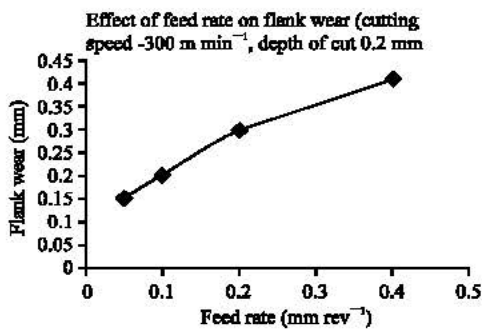
Fig. 4: Effect of feed rate on flank wear

Effect of feed rate: Similar to the change of depth of cut, increase in feed rate increases the size and depth of fracture on the cutting edges. But unlike the depth of cut, increase in feed does not shift the position of the cracks. That is, the crack always occurs near the tip of the cutting edge. Relationship of depth of crater on the tool flank and feed rate is shown in Fig. 4. As the feed rate is increased, pressure on the unit length of the cutting edge is also increased. A higher feed rate increases the chip thickness and makes the chip surface rougher that reduces the real contact between the tool face and the chip. It results on poor heat dissipation at the cutting edge. Moreover, increase in the feed rate may cause vibration in the system which results in fracture of the brittle cermet tools.
