Journal of Applied Sciences

Failure Modes and Stability of Rock Mass Slope Containing Multi-weak Interlayer

Key words: Rock mass slope, multi-weak interlayer, stability, fractured surface, finite element methods

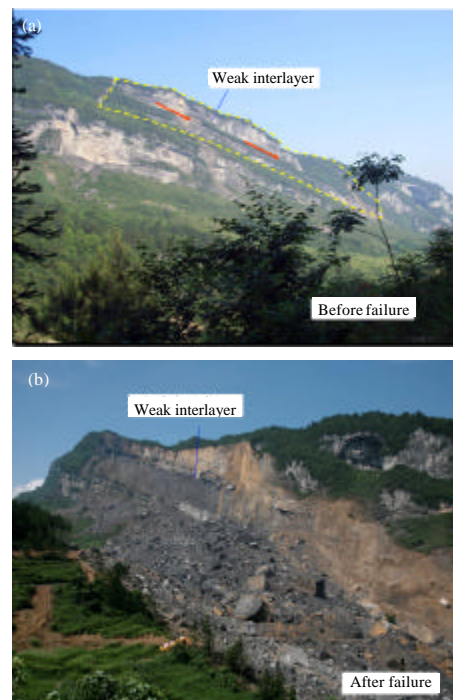
Fig. 1(a-b): Jiweishan landslide in Wulong, Chongqing
(a) Before failure and (b) After failure

Such as at June 5, 2009, more than $700 \times 10^4 \text{ m}^3$ rock and soil slipped at Jiweishan rockslide in Wulong, Chongqing which made 74 people died (Yin, 2010), as showed in Fig. 1. According to the geologic investigation later, the rock of Jiweishan is a typical monoclinical structure, the rock stratum inclination is 20~35°, towards north- northwest. There are carbon and bituminite shale bands continuous distributed in limestone which acting as the multi-weak interlayer of slope and is the latent failure surface of rock mass slope (Xu *et al.*, 2009).

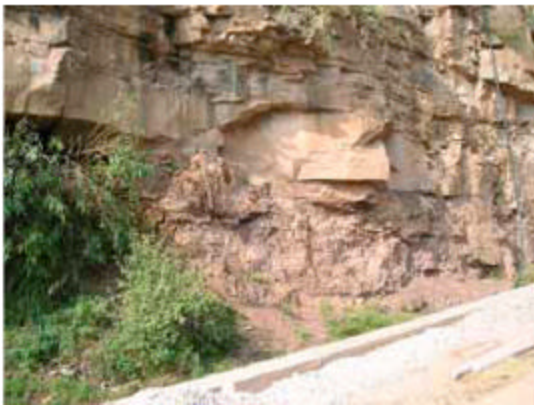
Fig. 2: Interbedded sandstone and mudstone at the base of the sliding mass

At September, 5, 2004, a big landslide more than $2500 \times 10^4 \text{ m}^3$ slipped induced by rainstorm at Tiantai village of Xuanhan, Sichuan which destroyed 2983 buildings and 1097 acres farm field, more than 1255 people were hit by the natural adversity. The landslide belongs to consequent rock slope which slide surface composited with sandstone, with rock stratum inclination of 5~7°, as showed in Fig. 2 (Yin, 2008).

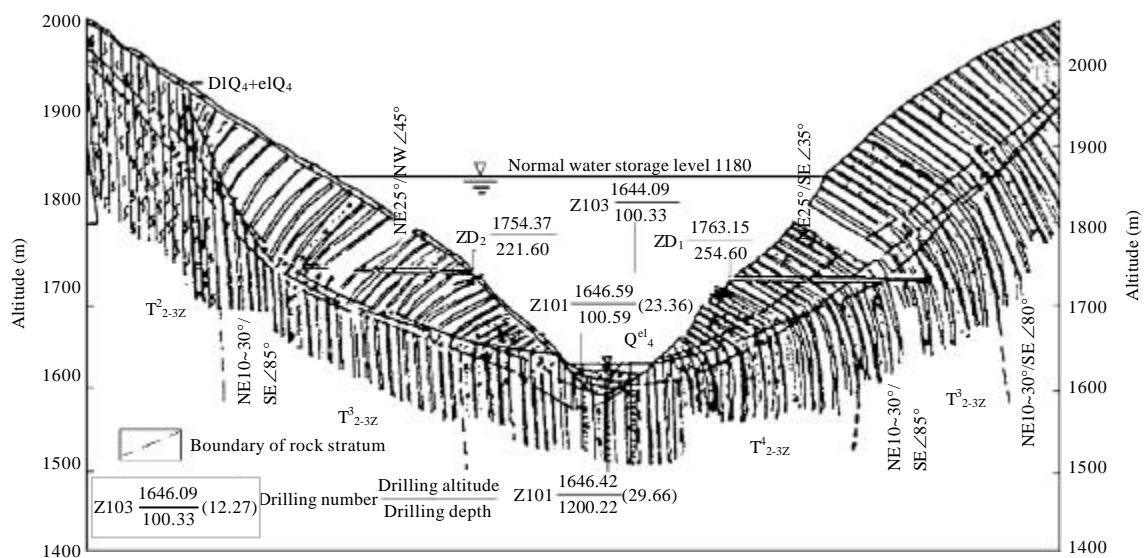
Fig. 3: Engineering geological profile of hydrologic station site in Yalong river (unite: m)

At southwestern high mountain canyon of China, some anti-dip rock slope could also be destroyed as bending, overturning and slipping. Such at river beach of jinping, middle course of Yalongjiang, Sichuang, there is large-scale bending deformation happened along more than 10 km river embankment, as showed in Fig. 2 and 3 big landslides developed at each left and right bank (Huang, 2007; Chongqing 136 Geological Mineral Resource Co. Ltd., 2008).

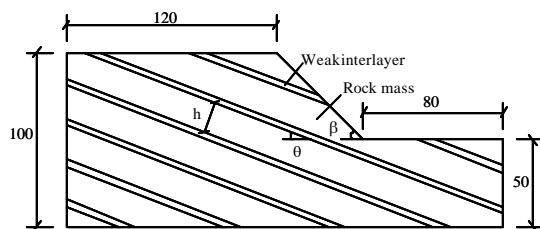
Now a typical model of layered rock mass slope is to be analyzed, the slope angle marked as $\beta(^\circ)$, the rock stratum inclination marked as $\theta(^\circ)$, the distance of structural surface marked as h (m), as showed in Fig. 4. Rock mass and weak interlayer were simulated with solid element with different parameters. This problem can be treated as plane strain model, both rock mass and weak interlayer could be simulated with Mohr-Coulomb failure criterion. The parameters of each layer are showed in Table 1.

Fig. 4: Numerical analysis model (unit: m)

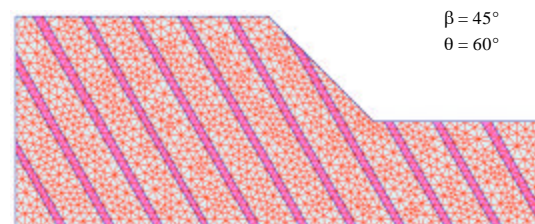
The domain of FEM model should be large enough to eliminate the influence of boundary. The vertical settlement and lateral displacement fixed at bottom of model and lateral displacement fixed at both sides of model. The mesh of FEM is divided by 15 nodes triangle elements, as showed in Fig. 5 with $\beta = 45^\circ$ and $\theta = 60^\circ$.

Fig. 5: Mesh of FEM (elements: 3033)

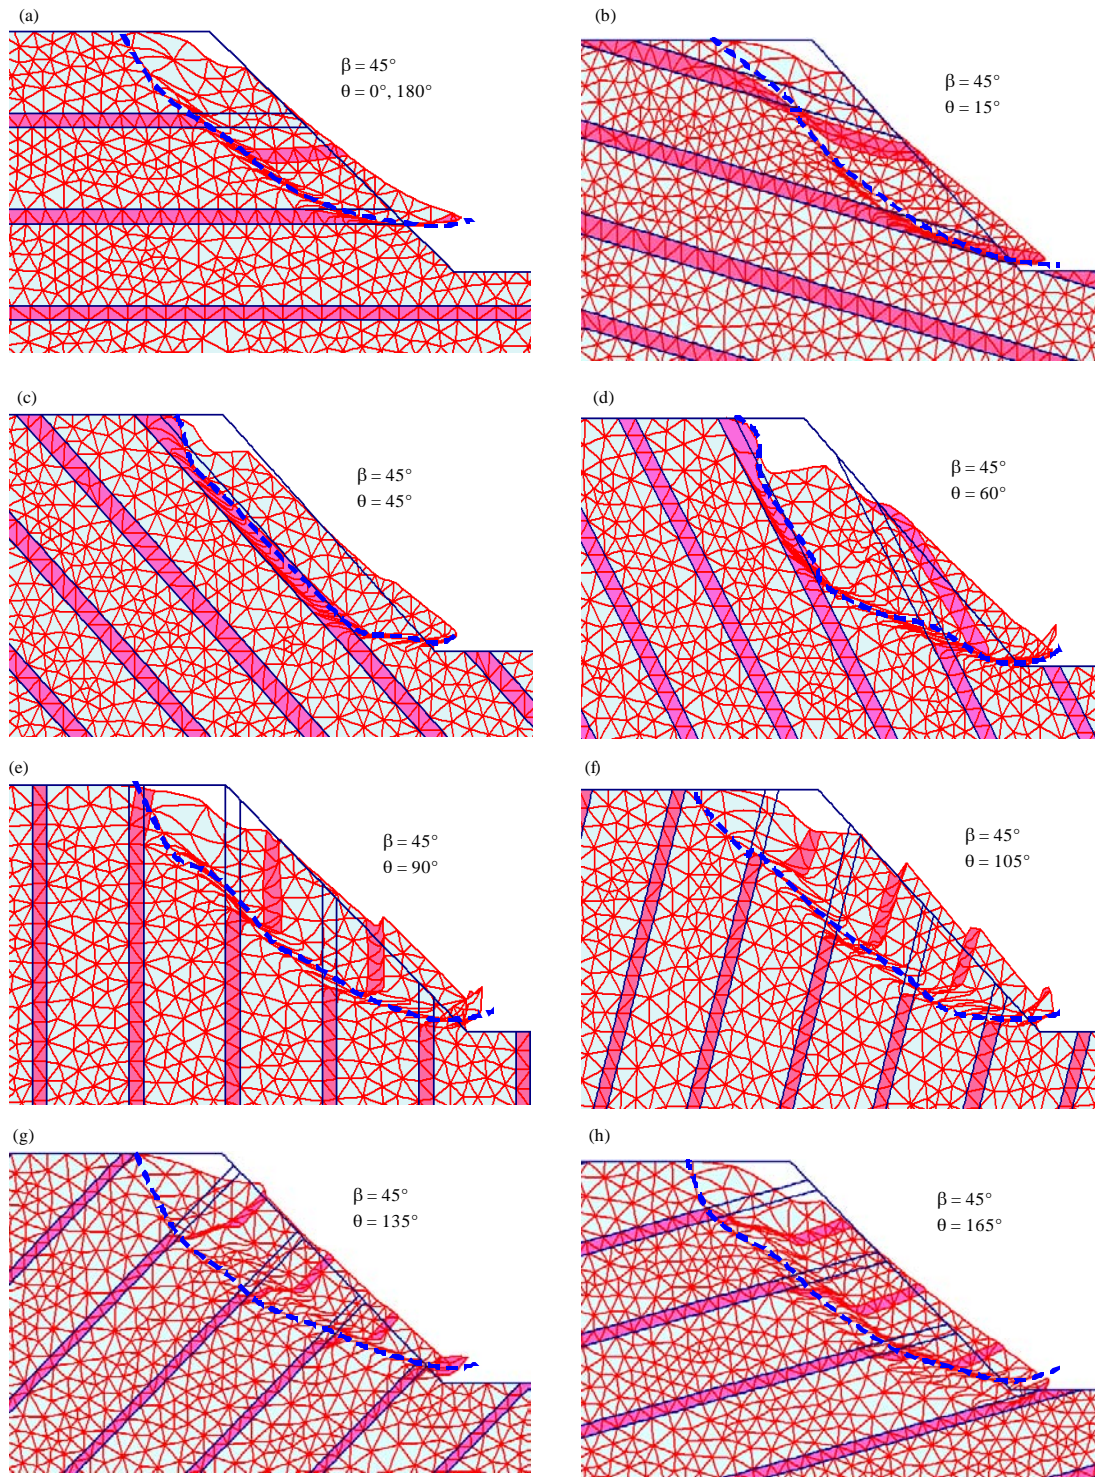
- Slip deformation mainly occurred by gravity in level layered rock mass slope ($\theta = 0^\circ$) and deformation at top of slope is bigger and earlier than that of waist or toe of slope. Cracks happened at top of slope by level tension stress which belongs to press-cut failure, as showed in Fig. 6a
- Consequent rock slope is a slope with rock stratum inclination $0^\circ < \theta < 90^\circ$ which stability controlled by strike of rock stratum, included angle of rock stratum, relationship between slope angle and rock stratum inclination, dimorphism and strength of structural surface and so on

When rock stratum inclination little than slope angle ($\theta < \beta$), slope destroyed by shear along structural surface, with steps of faulted between interlayers, creep deformation along structural surface and sheared along weak interlayer, such as showed in Fig. 6b

When rock stratum inclination equal slope angle ($\theta = \beta$), as showed in Fig. 6c, slope destroyed along weak interlayer, cracks emerged at posterior margin of slope and sheared by compression at anterior border of slope

Fig. 6(a-h): Deformation of slope containing multi-weak interlayers (a) $\theta = 0^\circ, 180^\circ$, (b) $\theta = 15^\circ$, (c) $\theta = 45^\circ$, (d) $\theta = 60^\circ$, (e) $\theta = 90^\circ$, (f) $\theta = 105^\circ$, (g) $\theta = 135^\circ$ and (h) $\theta = 165^\circ$

When rock stratum inclination bigger than slope angle ($\theta > \beta$), as showed in Fig. 6(d), not only slope destroyed along weak interlayer at middle position of slope, but also bending deformation or burst deformation happened at toe of slope, with steps of relaxed by unloading, drawing breakage, expanded by compression and collapsing with whole (Luan *et al.*, 2003)

- Vertical layered rock mass slope ($\theta = 90^\circ$) would be collapsed or ripped by gravity, as showed in Fig. 6e. Bending deformation or burst deformation happened towards surface of slope and cracks emerged at posterior margin of slope which belongs to flexing-collapsing failure
- Anti-dip rock slope ($90^\circ < \theta < 180^\circ$) would be collapsed or ripped by moment of gravity towards outside of slope, followed with local glide and local crack, emerged with disturbed belts by gravity. Slope ruptured when main stress and shear stress bigger than strength of extension of structural surface, as showed in Fig. 6f-h

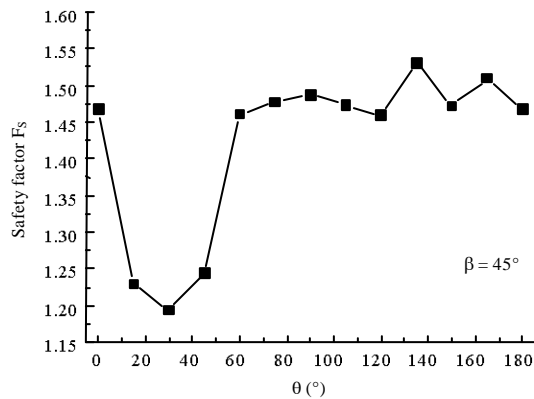
Fig. 7: Relationship between safety factor of slope and rock stratum inclination

- The stability of consequent rock slope ($0^\circ < \theta < 90^\circ$) decreased first and increased later with increasing of rock stratum inclination which got its minimal value at 30° of rock stratum inclination, as showed in Fig. 7. When $0^\circ < \theta < 60^\circ$, the curve of stability is symmetrical distribution at $\theta = 30^\circ$. The stability of anti-dip rock slope ($90^\circ < \theta < 180^\circ$) fluctuated with increasing of rock stratum inclination which got its maximal value at 135° of rock stratum inclination. The stability of anti-dip rock slope is obviously bigger than that of consequent rock slope, with the same other conditions. Therefore, stability of rock mass slope is distinctly influenced by rock stratum inclination

Influence of rock stratum inclination on stability of slope: The relationship between rock stratum inclination and deformation or failure of slope is showed in Fig. 6, with the condition of slope angle $\beta = 45^\circ$, distance of structural surface $h = 20.0$ m and thickness of weak interlayer $d = 3.0$ m. The corresponding safety factor and position of failure surface is showed in Fig. 7 and 8, respectively.

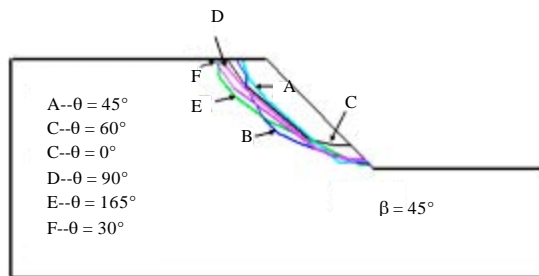
Fig. 8: Position of failure surfaces of slope containing multi-weak interlayers

- The position of failure surface of interlayer slope is greatly influenced by rock stratum inclination, as showed in Fig. 8 which controlled by thickness of rock mass, rock stratum inclination, strength of structural surface and so on

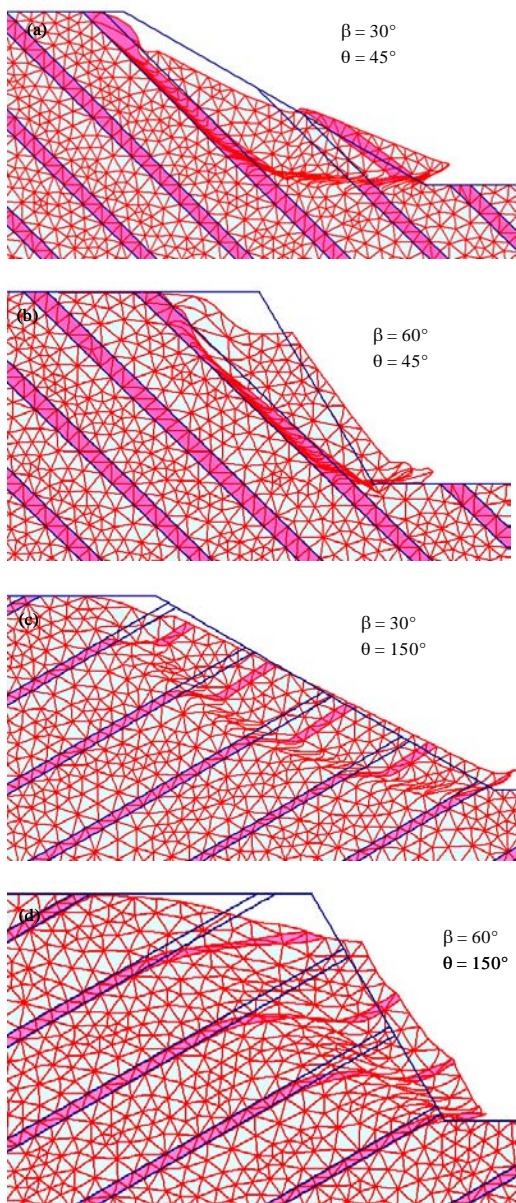
- To the consequent rock slope, as showed in Fig. 9a and b, slope would be destroyed with model of slippage-flexing by gravity at $\beta = 30^\circ$. While at $\beta = 60^\circ$, slope destroyed along weak interlayer by gravity, almost no flexing happened at toe of slope
- To the anti-dip rock slope, as showed in Fig. 9c and d, slope destroyed with the model of overturning by gravity. When slope angle increased, slope would be overturned by gravity more easily

Fig. 9(a-d): Deformation damage characteristics and critical failure surface with different slope angles (a) $\beta = 30^\circ$, $\theta = 45^\circ$, (b) $\beta = 60^\circ$, $\theta = 45^\circ$, (c) $\beta = 30^\circ$, $\theta = 150^\circ$ and (d) $\beta = 60^\circ$, $\theta = 150^\circ$

Influence of slope angle on stability of slope: Slope angle is a key influence factor during design of excavation and supporting of slope. The influence of slope angle on failure mechanism and stability of slope is showed in Fig. 9, where consequent rock slope with $\theta = 45^\circ$, anti-dip rock slope with $\theta = 150^\circ$.

Therefore, there is big influence on failure mechanism of slope with different slope angle.

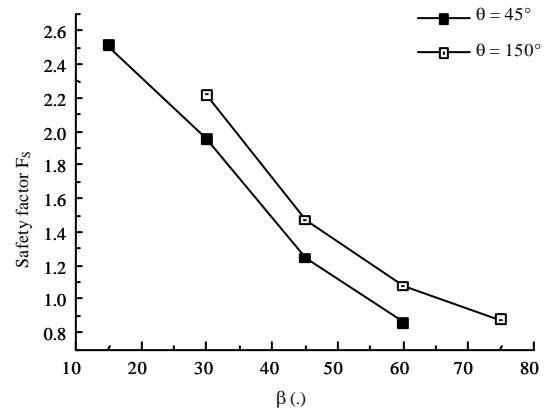
The influence of slope angle on stability of rock mass slope is showed in Fig. 10. It can be found whether consequent rock slope or anti-dip rock slope, safety factor of slope would be decreased with slope angle increased. Therefore, a reasonable and economic slope angle should be designed in excavation of slope with weak interlayer in real engineering.

Fig. 10: Relationship between safety factor of slope and slope angle

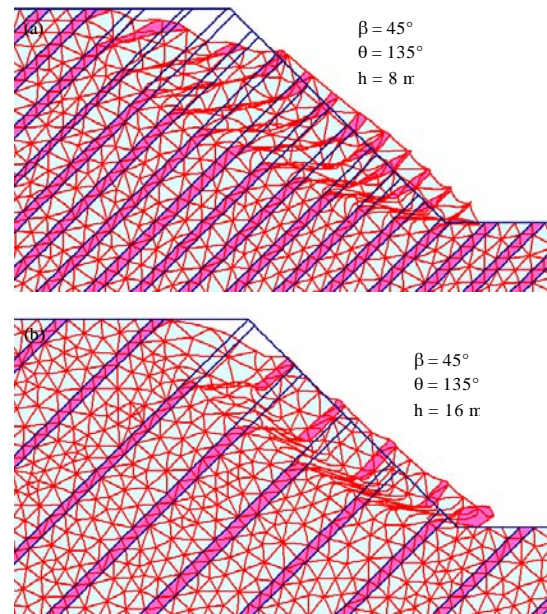
The deformation and stability of multi-weak interlayer slope is depended on the distance or number of structural surface. Strength of rock decreased badly by weak interlayer with small value of distance of structural surface. When the distance of structural surface

Fig. 11(a-b): Deformation and critical failure surface of slope with different distance of structural surface (a) $h = 8 \text{ m}$ and (b) $h = 16 \text{ m}$

increased, the number of structural surface in a fixed scope decreased, so the equivalent strength of whole slope increased and the stability of slope enhanced.

Influence of distance of structural surface on stability of slope: With the condition of $\beta = 45^\circ$ and $\theta = 135^\circ$, the influence of distance of structural surface h on failure mechanism and stability of multi-weak interlayer slope is showed in Fig. 11 and 12, respectively.

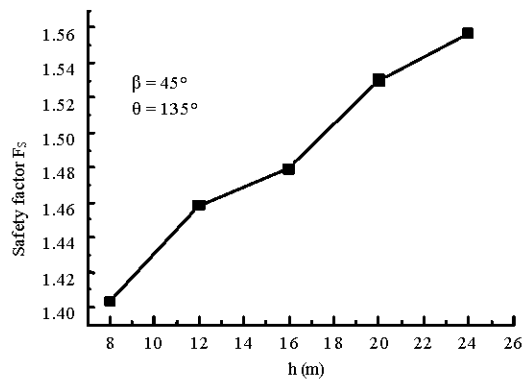
Fig. 12: Relationship between safety factor of slope and distance of structural surface

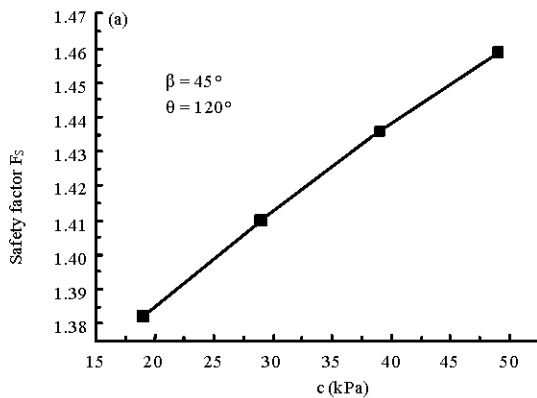
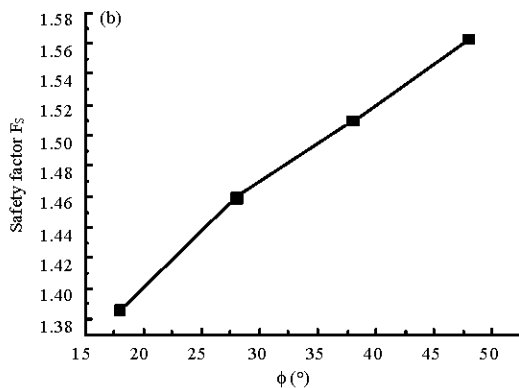
Fig. 13(a-b): Influence of parameter of weak interlayer on stability of slope (a) Influence of cohesive strength and (b) Influence of inner friction angle

With the condition of $\beta = 45^\circ$ and $\theta = 120^\circ$, the relationship between stability of slope and parameter of weak interlayer and rock mass are showed in Fig. 13 and 14, where only the studied parameter changed

and other parameters unchanged. It can be found that the stability of slope enhanced with the value of cohesive strength or inner friction angle of weak interlayer or rock mass increased.

During further contrastingly study, it can be found the stability of slope enhanced 0.00257 when cohesive strength of weak interlayer increased 1 kpa while the stability of slope enhanced 0.00568 when cohesive strength of rock mass increased 1 kpa. On the same way, the stability of slope enhanced 0.0059 when inner friction angle of weak interlayer increased 1° while the stability of slope enhanced 0.02638 when inner friction angle of rock mass increased 1° . It seems the parameter of rock mass is more important than that of weak interlayer. That is, although the stability reduced by weak interlayer, the stability of slope with multi-weak interlayer mainly be controlled by parameters of rock mass.

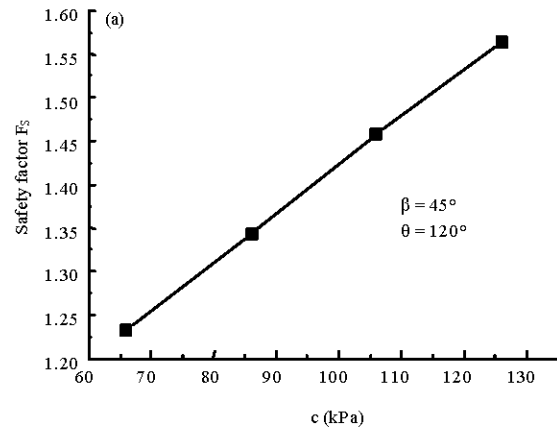
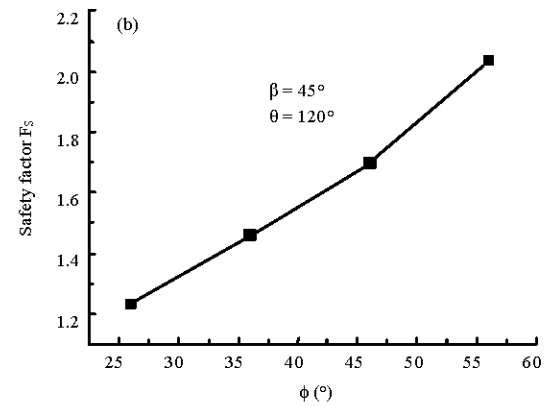
Fig. 14(a-b): Influence of parameter of rock mass on stability of slope (a) Influence of cohesive strength and (b) Influence of inner friction angle
