**Pakistan
Journal of Biological Sciences**

Biodegradation of Natural Rubber by Actinomycete No. 4 in a Continuous Culture System

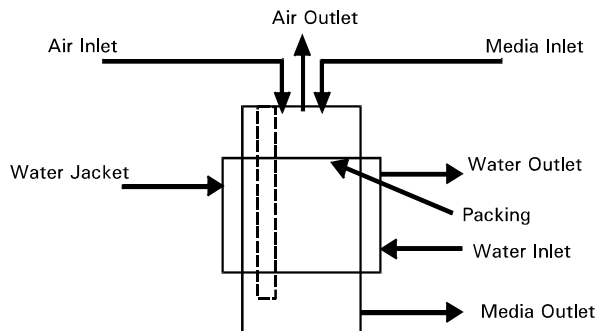
Fig. 1: Schematic figure of packed bioreactor

Bioreactor design and experimental methods: The packed bioreactor consists of several main components, that is a packed reactor, air and media inlets, air and media outlets, a temperature controller and water jacket (Fig. 1). The reactor packing was

stainless steel wire (Amway scrub buds). The biodegradation process was effected at temperatures of 20- 50°C (T20-T50) exposure time of 0 to 3 months (C1-C3) and pH of 5 to 8 (pH 5-8).

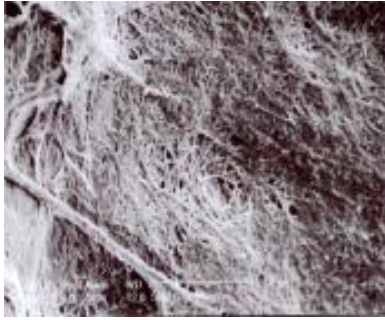
Fig. 2: SMR-L – 0

The effect of temperature on morphology: The NR sample for this particular investigation was observed at a pH 7 and 1 vvm aeration rate. Three morphologies were observed on all samples viz. surface asperities, striations and bulk degradation. The control NR morphology (SMR-L 0) is shown in Fig. 2.

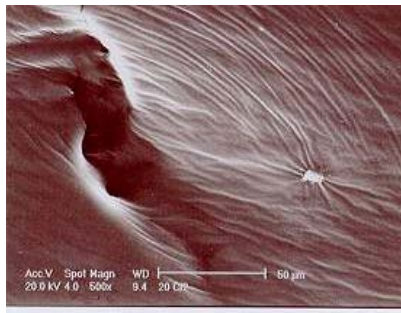
Fig. 3: Temperature 20°C-one month (C1)

Surface asperities: Surface asperities were observed on the second month at 20°C till 40°C (Fig. 3). Surface asperities may be the evidence of sporulation.

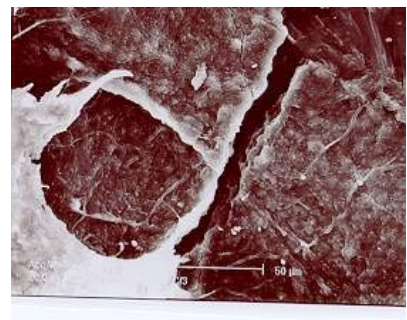
Fig. 4: Temperature 20°C-3 months (C3)

Bulk degradation: Bulk degradation was observed on NR samples at 20°C after 3 months as well as at 30°C after the second month. Bulk degradation is represented by Fig. 4. The micrograph showed degradation, which has penetrated into the bulk structure. Process debris was also observed on the surface. The transition temperature for bulk degradation was at 30°C and transition time was 3 months for the low temperatures. If we were to assume bulk degradation is a manifestation of a degradation mechanism, then the transition points occurred at T20C3 and T30C2. The filamentous morphology was observed by other researchers such as Jendrossek *et al.* (1997) and Tsuchii *et al.* (1990), Tsuchii and Takeda (1985) and Borel *et al.* (1982). In all their reports, the morphological presentation were grooving (asperities) on the surfaces, pebbling and granular structures (asperities and striations). They also observed filamentous growth penetrating into the bulk structure as well as alteration of physical structure. These were similarly observed in our work, which we termed as bulk degradation.

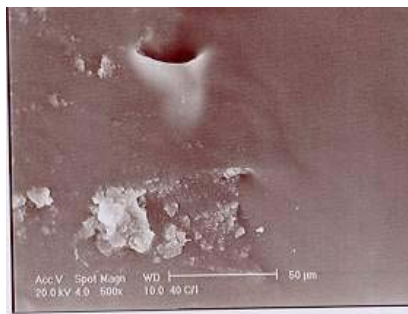
Fig. 5: Temperature 40°C-1 month (C1)

Striations: Striations occurred on samples at T40C3 and continued at T50C1-C3. The transition points for time is C3 while for temperature is T50 (Fig. 6 and 7). The points which striation appeared may be seen as a transition point for process mechanism. Voids were not pervasive although seen at T40C1 (Fig. 5).

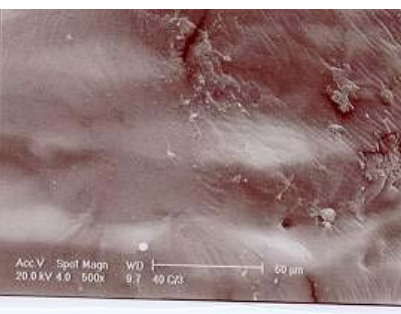
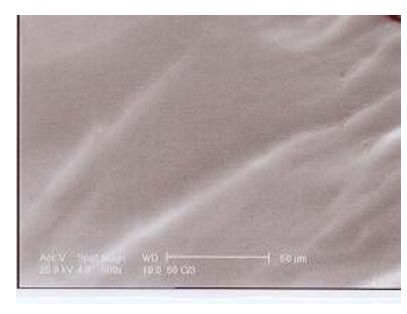
Fig. 6: Temperature 40°C-3 months (C3)

Fig. 7: Temperature 50°C-3 months (C3)

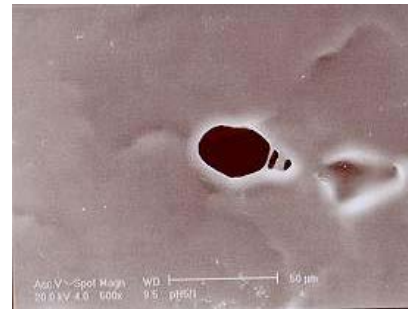
Fig. 8: pH 5- 1 month (C1)

Mesovoids: Mesovoids ($d = 30 \mu\text{m}$) started at pH 5 C1 and were observed on all samples at C1 (Fig. 8). The mesovoids grew with exposure time: pH 5 C3 ($d = 100 \mu\text{m}$), pH 8 C3 ($d = 150 \mu\text{m}$) (Fig. 9 and 10). The growth is filamentous (Fig. 10). It is quite possible with further work to correlate quantitatively the microorganism growth rate to rate of increase in the diameter of the voids.

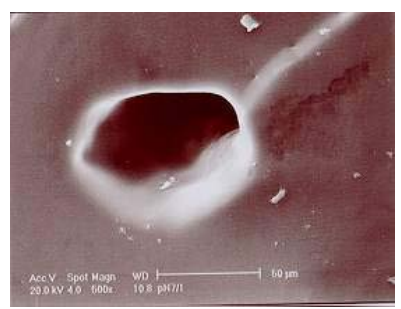
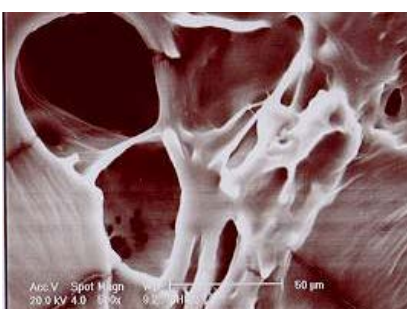
Fig. 9: pH5- 3 months (C3)

Fig 10: pH 8- 3 months (C3)

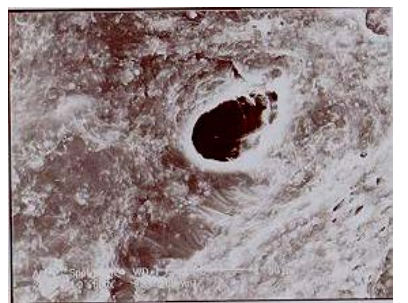
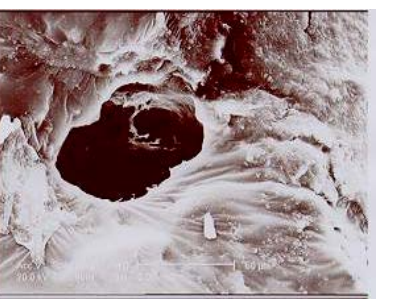
Fig. 11: 0.5vvm- 1 months (C1)

Fig. 12: 0.5vvm- 2 months (C2)

Mesovoids: Mesovoids were observed at 30 days for all aeration rates (Fig. 11). The rate of growth of mesovoids increased with aeration rates, e.g. at C1, 1 vvm ($d = 29.9 \mu\text{m}$) at 0.5 vvm C1 ($d = 22.10 \mu\text{m}$) at 0.3 vvm C1 ($d = 20.3 \mu\text{m}$). With increase in

exposure mesovoids increased in size until bulk degradation was observed: at 0.5 vvm C2 ($d = 39.85 \mu\text{m}$) and at 0.3 vvm C3 ($d = 56 \mu\text{m}$) (Fig. 11 and 12). At 0 aeration rate the NR sample did not manifest any of the degradation mechanism as observed in the other samples even at the maximum exposure time.

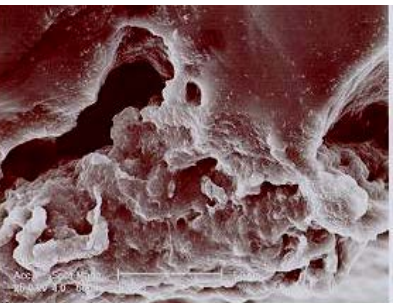
Fig. 13: 0.3 vvm- 3 months (C3)

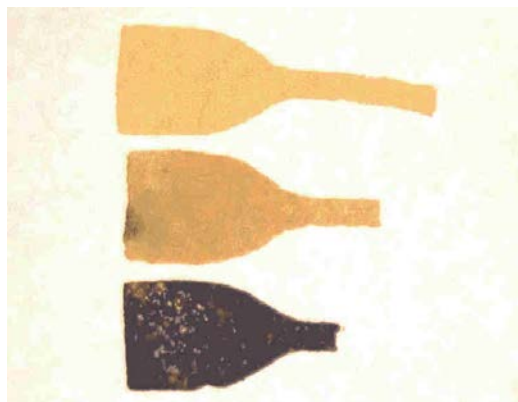
Fig. 14: Photo of NR samples showing change in physical appearance due to the degradation process.

Physical appearance of degraded natural rubber: The appearance of the NR samples subjected to the biodegradation process can be observed from Fig. 14. This appearance was true for all conditions except for the sample at 0 aeration rate.
