## Failure of Superstructures after the “February 03, 2002 Sultandagi-Cay, Earthquake”

M. Y. Kaltakci, M.H. Arslan, H.H. Korkmaz and M. Kamanli  
 Department of Civil Engineering, Faculty of Engineering and Architecture,  
 Selcuk University, Konya, Turkey

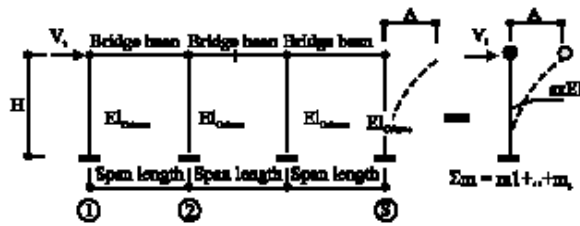
Fig. 12: Displacement of bridge columns under lateral loading

**Building type-5 (lifelines, bridges):** The behavior of major lifelines of the earthquake stricken region consists on roads. The damage to the roads of the region was very low and most of them remained operational. At the bridge, which is on the road of Afyon-Konya, the following damages were observed, shear cracks at the lateral beams, crushing of concrete in longitudinal beams, 2-5 cm lateral displacement and settlement of infills in longitudinal directions were observed (Fig. 11). The earthquake load acted on bridge caused some lateral displacement. But in this case the most important problem arisen is exceed earthquake codes displacement limits. For a bridge type superstructures this limit is (Eq. 3).

Figure 12 represents the finite element (bar) model of bridge under lateral loading. The long span pretensioned beams are assumed having hinged column connection. The bridge columns have fixed support and this column behavior is similar to cantilever beam. In the Eq. 4, the method of lateral displacement calculation is given.
