Geophysical Investigation of Road Failures in the Basement Complex Areas of Southwestern Nigeria

Abstract: Causes of failures on three roadways located in the Precambrian Crystalline Basement Complex area of Southwestern Nigeria have been investigated in this study. The electrical resistivity method involving dipole-dipole and Wenner Vertical Electrical Sounding (VES) techniques were utilized. The failed segments of the roadways are characterized by relatively low resistivity (mostly $< 200 \Omega\text{-m}$) with the stable zones typically resistive ($>> 400 \Omega\text{-m}$). Forms of road failures identified from the study are failures arising from differential settlement on road cut sections that intercept clayey saprolite with high moisture content as observed on Igbaraoke-Igbaraodo roadway; failures precipitated by differential settlements associated with significantly thick, low resistivity clay topsoil as observed on Itaogbolu portion of the Akure-Ado Ekiti roadway and failures initiated and sustained by geological features such as lithological contacts/faults, inclined interfaces between basement rocks and or collapse subsurface strata (e.g., cavity or sinkhole structure)

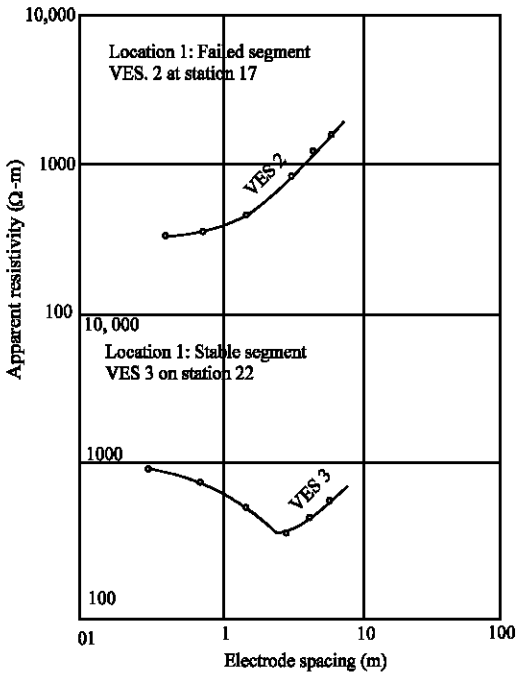
Fig. 6: Typical VES curves obtained at failed and stable segments of location 1

The geoelectric section (Fig. 9c) shows a topsoil with resistivity values varying between 224 Ω -m (sandy clay) at VES 4 (failure zone) and 950 Ω -m (laterite) at VES 3 (stable zone). The thicknesses generally vary between 0.49 m at VES 6 and 1.60 m at VES 2. The layer resistivities within the failed segment (224 - 335 Ω -m) are slightly less than those obtained (345 - 950 Ω -m) within the stable zone.

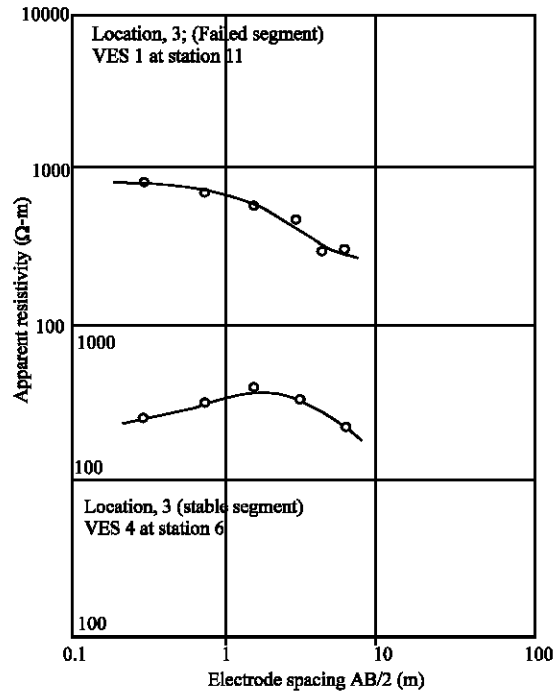
Fig. 8: Typical VES curves obtained at failed and stable segments of location 3

competent lateritic topsoil that was removed due to road cut within the failed segment of the roadway.
