Damage Inspection and Analysis of an Expressway Partial Cable-stayed Bridge

¹Yunjing Nie, ¹Tieying Li and ²Xiuying Liu

Abstract: Damage inspection and cable force test were discussed for an expressway partial cable-stayed bridge in a practical project in this study. Furthermore, the causes of damage were analyzed. The results showed that the repair and maintenance measures should be taken. Finally, the repair and maintenance measures were proposed for the damage of the expressway partial cable-stayed bridge. The cable forces were tested at 2 year (or less) intervals. And the health records of cable forces should be established to provide reliable scientific basis for the analysis of stay cable distribution, structural condition assessment, as well as maintenance and management of the bridge. The box girder of the bridge should be repaired, reinforced and the degree of inclination of the pylons be regularly measured. Anti-corrosion measures should be taken on the various components of stay cable systems. Grease should be filled in the anchorage components. The change in the relative position between the HDPE pipes and the guide pipes should be focused on. These results could also

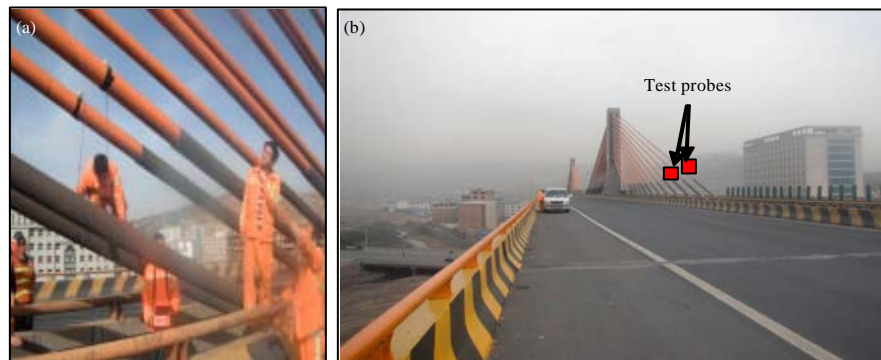
Fig. 2(a-b): Cable force test (a) Cable force measurement and (b) Layout of test probes

A dynamic testing instrument is employed to measure cable forces by ambient vibration. Cable force tests are shown in Fig. 2.
