Landslides Intensity on River Morphology of Jeneberang Watershed after Collapse of Caldera Wall at Mt. Bawakaraeng

Key words: Fault, jeneberang landslides, watershed, caldera of Mt. Bawakaraeng

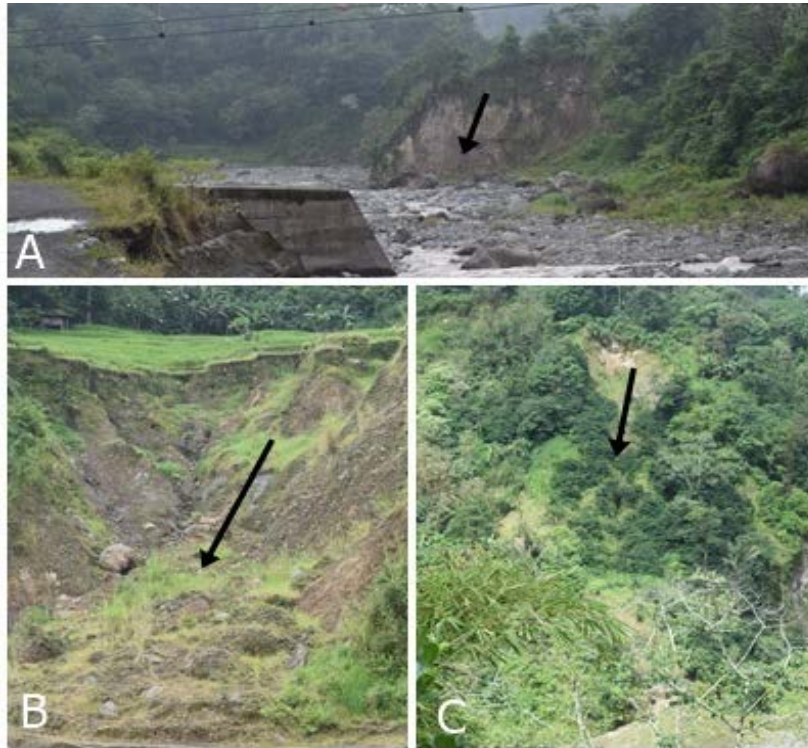
Fig. 2: Landslide on the morphology of the river and the region on a variety of topographic slope

Shallow landslides intense incident occurs (Fig. 2) has added a mass of sediment entering the river channel and can improve the flow of debris, especially in the rainy season. Addition of debris mass can lower the quality and quantity of water in the Jeneberang watershed (Fig. 3).

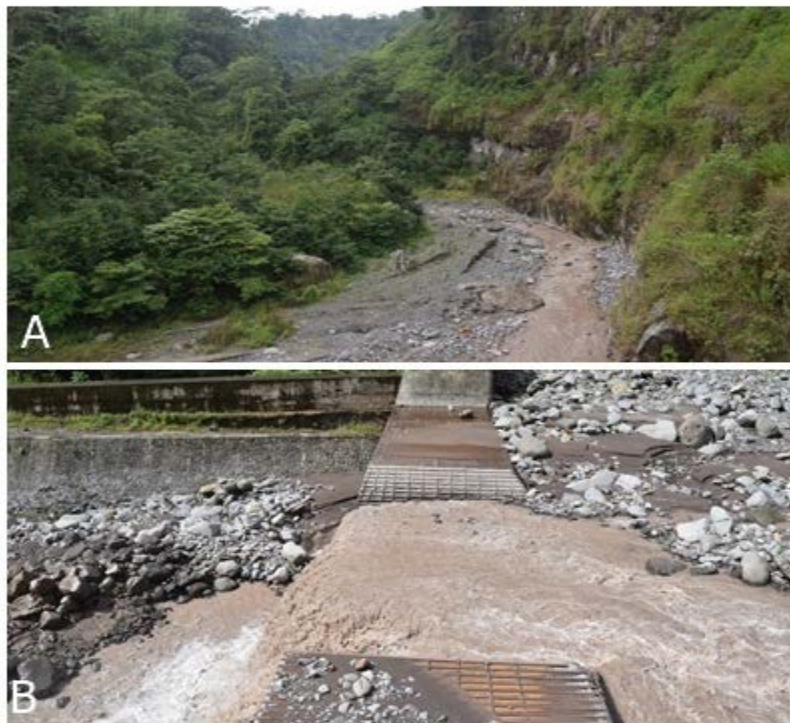
Fig. 3: Silty water along jeneberang river (A and B)
