Landslides Intensity on River Morphology of Jeneberang Watershed after Collapse of Caldera Wall at Mt. Bawakaraeng

Key words: Fault, jeneberang landslides, watershed, caldera of Mt. Bawakaraeng

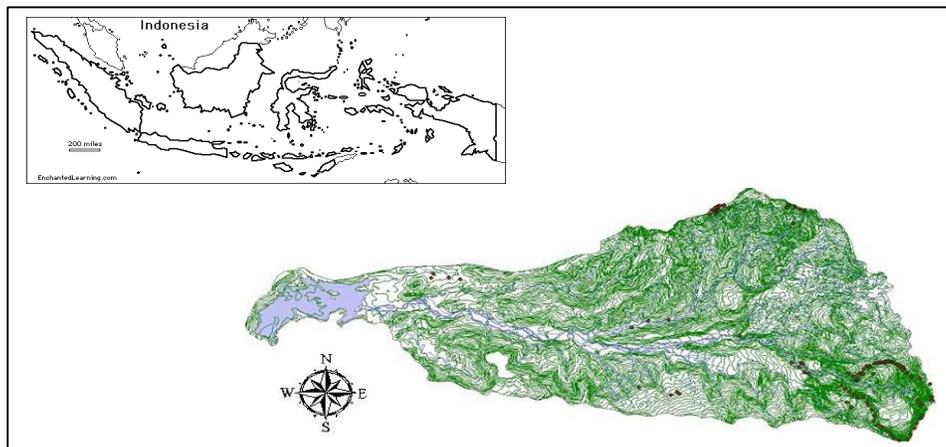
Fig. 1: Map of location landslide point in 2004-2013 as indicated by the black dots

Landslide on the river morphology since March 26, 2004 up to now intense occurred, this is evidenced by many points of the landslide site in the form of shallow landslides on river morphology and Jeneberang basin morphology (Fig. 1).

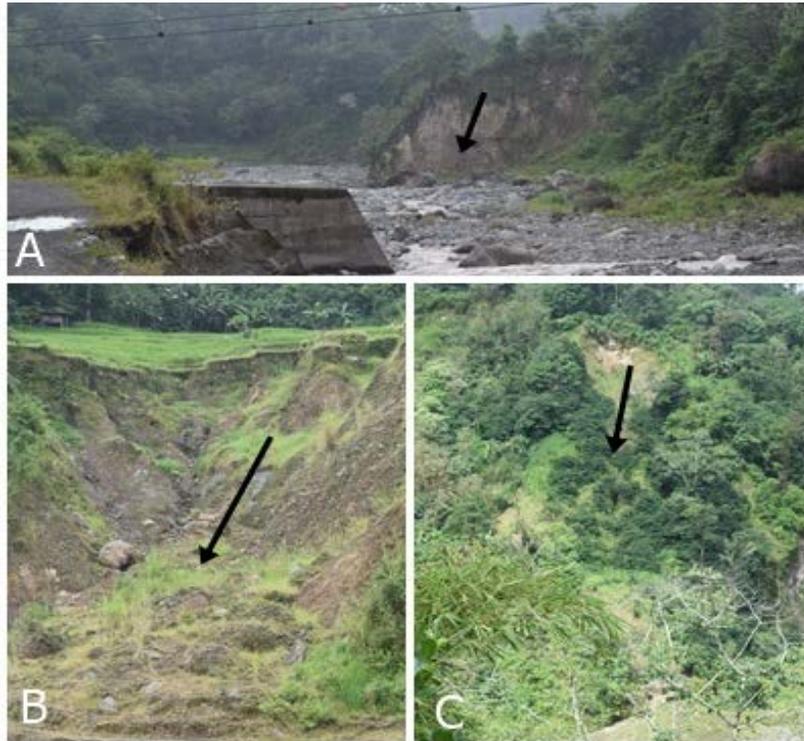
Fig. 2: Landslide on the morphology of the river and the region on a variety of topographic slope

Shallow landslides intense incident occurs (Fig. 2) has added a mass of sediment entering the river channel and can improve the flow of debris, especially in the rainy season. Addition of debris mass can lower the quality and quantity of water in the Jeneberang watershed (Fig. 3).

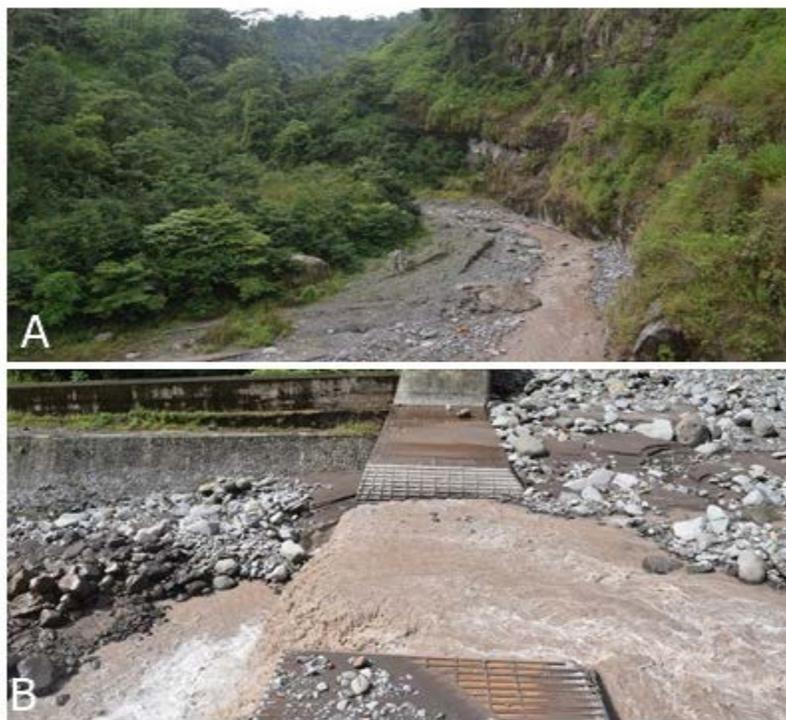
Fig. 3: Silty water along jeneberang river (A and B)

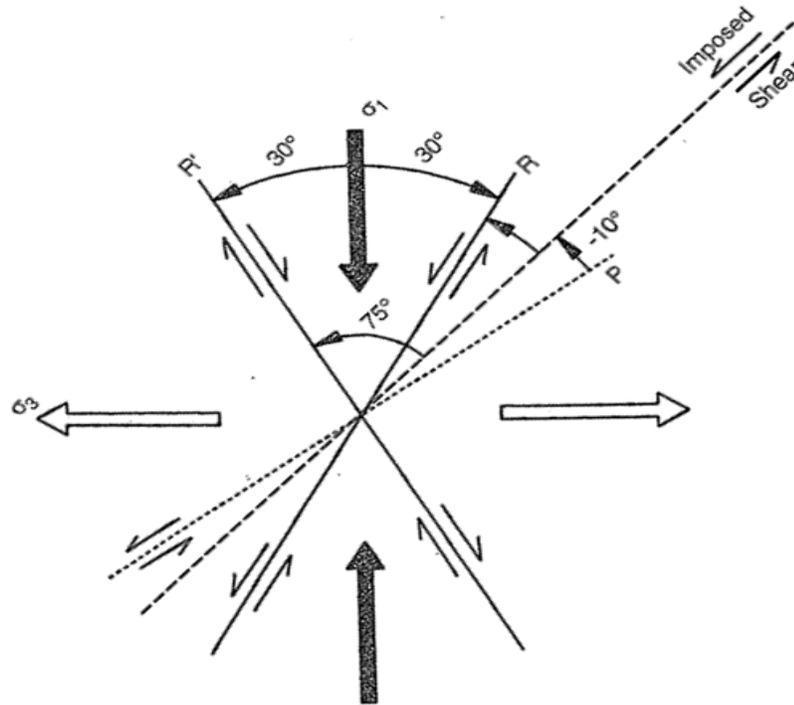
Fig. 4: Metode of Davis and Reynolds (1996) establishment of strike slip fault and the its direction, resembles the geological structure model Jeneberang Watershed

Landslides triggered by heavy rainfall average annual Jeneberang basin, ie 2668-3000 mm year⁻¹ and the slope factor topography. Observation landslides after the collapse of the caldera wall Mt. Bawakaraeng shows the pattern of landslide spread in the Jeneberang watershed follow the pattern of spread of fault that have occurred since the Pliocene-Pleistocene epoch (5-1 m years ago). There are two shift directions of strike slip fault that developed in the study area, namely; Northeast-Southwest and Northwest-Southeast with the main direction of the relative sharpness of North-South. According to Davis and Reynolds (1996), the main shift directions has greatest force among other sharpness. Among the main sharpness are two strike slip fault that is likely to form the smallest angle 60-75° (Fig. 4). This resembles the model of the geological structures in the Jeneberang watershed (Fig. 5). Tectonic processes that occur in the watershed Jeneberang can be classified into five stages, namely:

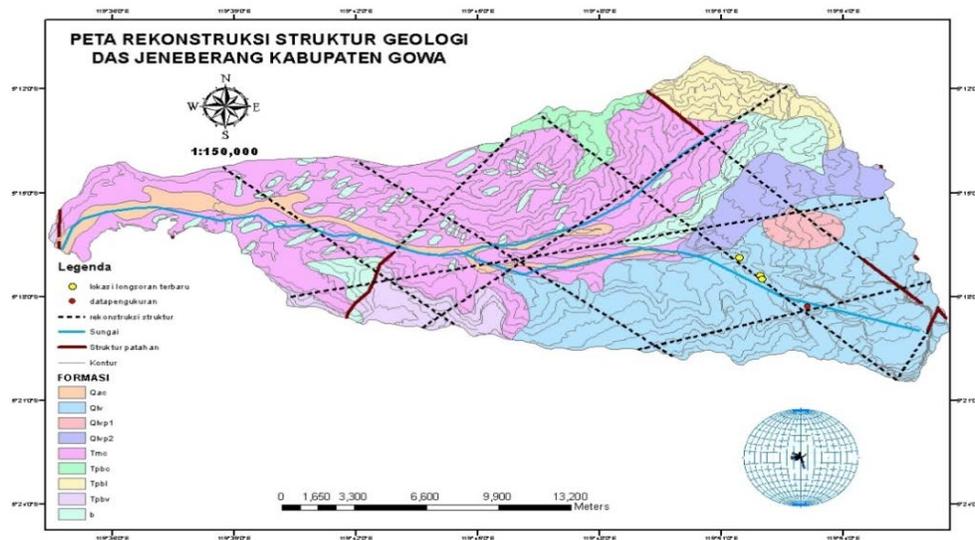
Fig. 5: Map of the reconstruction of the geological structure patterns that lead to the increased intensity of the landslide on the watershed Jeneberang
