Journal of Applied Sciences

Structural Conditions and Improvement Possibilities of Dairy and Beef Cattle Barns in Family Farms Established in the Van Region of Turkey

Abstract: Meat and milk production, which is the main source of human nutrition, can be significantly increased provided that animals are accommodated in barns designed based on the project criteria. Factors such as climate, construction system, construction materials and breeding types should be considered in planning animal barns. In this study, present situation of barns of beef and dairy cattle enterprises in the Van region, where most of people gain their income from animal farming, was determined and the possibilities to improve these barns were investigated. Also appropriate barn design criteria suitable to climatic conditions of the region was determined and was found that long side of the barns should be positioned in the north-south direction for natural aeration, which is one of the most significant environmental factors, of the barns.

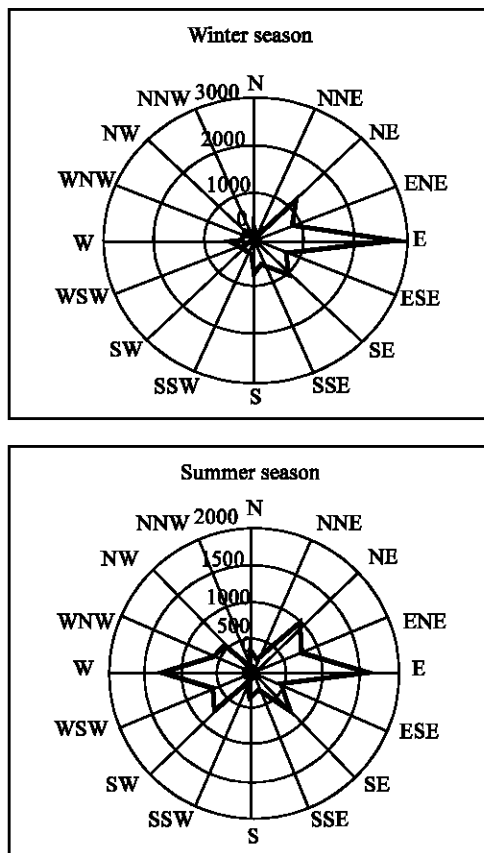
Fig. 1: Wind roses for winter and summer seasons for the city of Van

The average lowest and highest temperatures of the region during the last two decades were recorded as -28.7 and 37.5°C, respectively. The average relative humidity was recorded as 59%, average annual rainfall was 380.6 mm and average snowy days were 80 day/year. Wind roses for winter and summer seasons were given in Fig. 1^[20,21].
