Journal of Applied Sciences

The Effect of Dry Machining on Surface Integrity of Titanium Alloy Ti-6Al-4V ELI

G.A. Ibrahim, C.H. Che Haron and J.A. Ghani

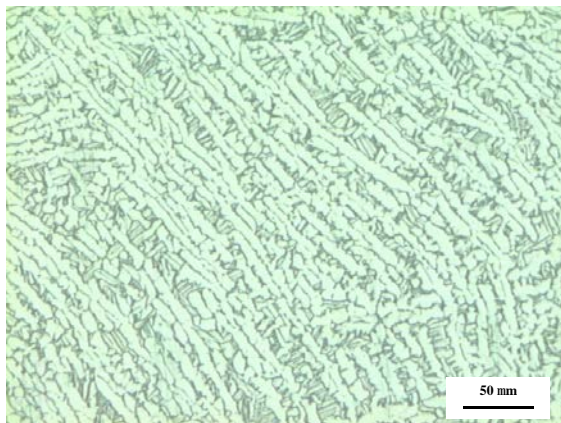
Fig. 1: Microstructure of Titanium alloys Ti-6Al-4V ELI with 10x magnification

Colchester T4 6000 CNC lathe machine based on the selected parameters as shown in Table 1. The workpiece material used in the machining trials was titanium alloys alpha-beta Ti-6AL-4V Extra Low Interstitial (ELI). The microstructure of the material has the equiaxed α phase and surrounding β in grain boundary as shown in Fig. 1. The chemical compositions and physical properties of workpiece material are given in Table 2 and 3, respectively. The size of the workpiece was 100 mm in diameter and 300 mm in length. Three millimeter thickness of workpiece material at the top surface of workpiece was removed in order to eliminate any surface defects and residual stress that can adversely affect the machining result (Kalpakjian and Rchmid, 2001). The cutting tools and tool holders for machining of Ti-6Al-4V ELI were recommended by the tool supplier. Three inserts used were uncoated carbide tool K313 (WC-Co), coated carbide tool with CVD (KC9225) and coated carbide tool with PVD (KC5010). The KC9225 tool consists of multi layer of TiN-Al₂O₃-TiCN-TiN and the KC5010 tool consists of single layer of TiAlN.

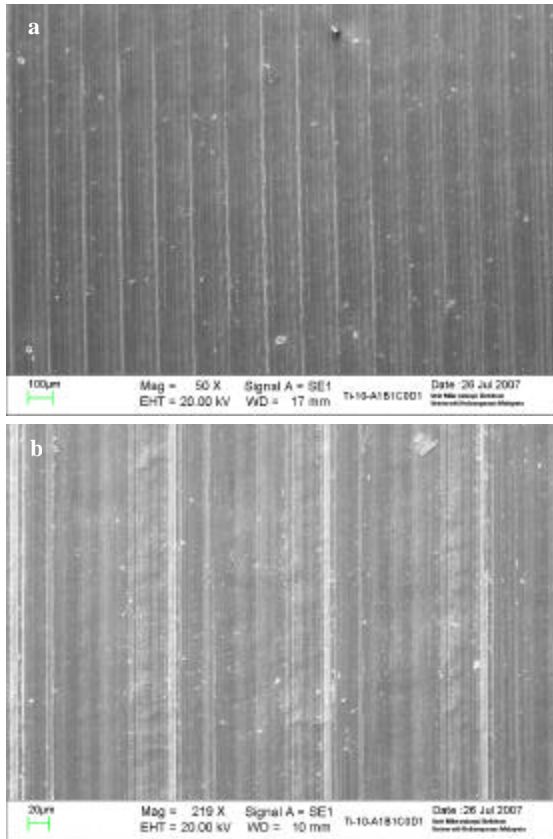
Fig. 3: Machined surface generated when machining Ti-6Al-4V ELI with coated cemented carbide insert under dry machining (a) 50x magnification and (b) 219x magnification

Figure 3 shows a typical machined surface generated when machining of titanium alloy Ti-6Al-4V ELI with coated cemented carbide tools under dry machining. The machined surface generated consists of well-defined uniform feed marks running perpendicular to the tool feed direction. The major surface damage on the machined surface generated observed after machining Ti-6Al-4V ELI with coated cemented carbide inserts are deformation of feed marks and re-deposited workpiece material (chip) onto the machined surface. This result is similar to the Ezugwu's (2007) earlier research that found some damages on machined surface generated when machining

Ti-6Al-4V alloy with PCD tools. Three types of surface damages on machined surface of titanium alloy are deformation of feed marks, micro-pits and re-deposited of workpiece material. Figure 3 does not show any form of micro-pit. It is possibly due to the low cutting speed (95 m min^{-1}) when machining Ti-6Al-4V ELI with coated cemented carbide tool when compare to Ezugwu who turned the Ti-6Al-4V with PCD tools at cutting speed of 200 m min^{-1} . Increasing the cutting speed will generate more heat that can cause more deformation and micro-pits.

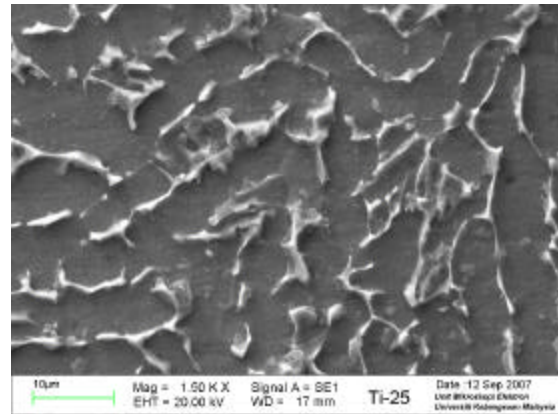
Fig. 4: Microstructure below the machined surface after finished turning with coated cemented carbide insert at cutting speed of 95 m min^{-1} , feed rate of 0.35 mm rev^{-1} and depth of cut of 0.10 mm

Sub-surface damage: Figure 4 and 5 are cross sections perpendicular to the tool feed direction of machined surface after etching. There was no evidence of sub-surface defects such as cracks, laps and visible tears after machining Ti-6Al-4V ELI alloy with the coated cemented carbide tools under dry machining. There was plastic deformation on the top layer of machined surface when machining Ti-6Al-4V ELI alloy at aggressive conditions involving cutting speed of 95 m min^{-1} , feed rate of 0.35 mm rev^{-1} and depth of cut of 0.10 mm . This suggests that severe shear stress generated under aggressive machining conditions coupled with high tool

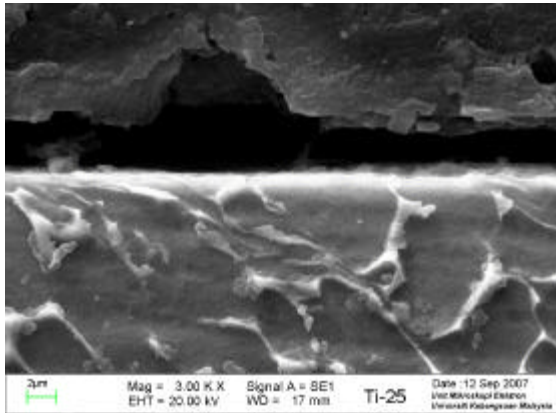
Fig. 5: White layer on top machined surface after finished turning with coated cemented carbide insert at cutting speed of 95 m min⁻¹, feed rate of 0.35 mm rev⁻¹ and depth of cut of 0.10 mm

Figure 5 shows the microstructures of the machined surface produced when machining Ti-6Al-4V ELI with coated cemented carbide tools under dry cutting conditions. It was found that when machining under dry cutting conditions, a thin layer of disturbed or plastically deformed layer was formed immediately underneath the machined surface. The white layer or plastically deformed layer on the machined surface was found at cutting speed of 95 m min⁻¹, feed rate of 0.35 mm rev⁻¹ and depth of cut of 0.10 mm and at the end of the tool life. The thick of white layer formed was about 1.8 µm. Similar result was also found by Che Haron (2005) when machining Ti-6Al-4V with straight tungsten carbide tools (CNMG 120408-883-MR4 tools) under dry cutting conditions and at cutting speed of 100 m min⁻¹, feed rate of 0.25 mm rev⁻¹ and depth of cut of 2 mm. This was probably due to prolong machining with near worn tool and therefore generate severe plastic deformation and a thicker disturbed layer on the machined surface as shown in Fig. 5.

The white layer or plastically deformed layer on the machined surface was found when cutting operation at cutting speed of 95 m min⁻¹, feed rate of 0.35 mm rev⁻¹ and depth of cut of 0.10 mm and at the end of tool life.
