# Journal of Applied Sciences

## The Wear Characteristics of Cemented Tungsten Carbide Tools in Machining Oil Palm Empty Fruit Bunch Particleboard

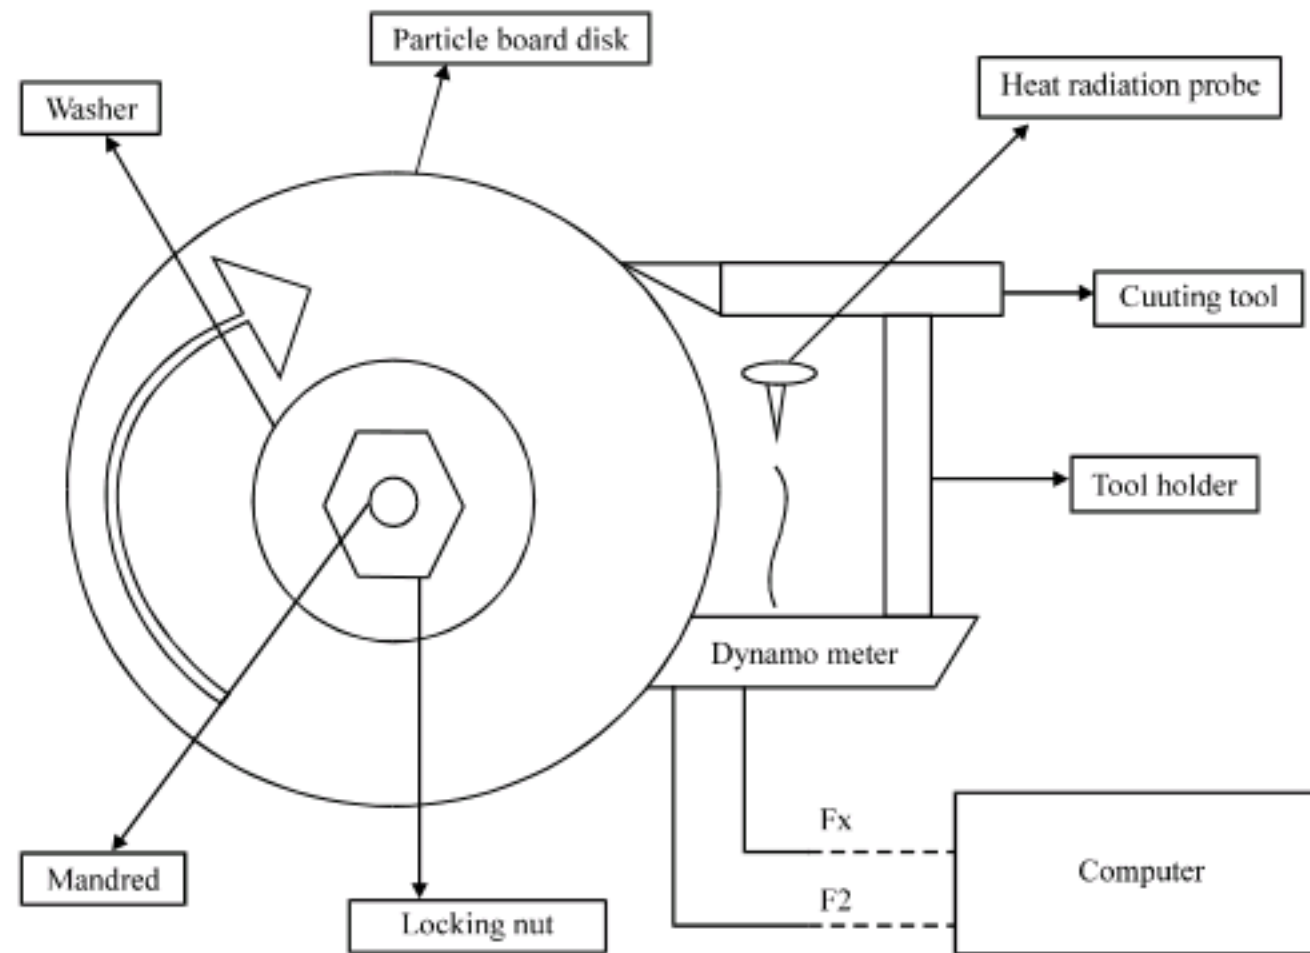
Fig. 1: Experimental set-up

1.0 μm. This composition was recommended by Ratnasingam *et al.* (2008), in an earlier study. The tool in the form of an insert of 30 mm in length, 12 mm in width and 1.5 mm in thickness, was attached to a tool holder as shown in Fig. 1. The sharpness angle of the tool insert was 65°. The tool wear experiments were conducted on a high-speed lathe and the machining conditions were as shown in Table 1. The experiments were carried out from May to October of 2008 at the experimental facility of Tool Technology (M) Sdn. Bhd., in Sungai Buloh, Malaysia. Machining was carried out in such a manner that the tool cutting edge was parallel to the axis of rotation of the OPEFB particle board disk and the feed direction was perpendicular to the axis of rotation of the OPEFB particle board disk. This ensured that as the diameter of the particle board disk was reduced, the orthogonal cutting conditions were maintained throughout the experiments. Each insert was used in machining OPEFB particle board until failure occurred, or for a total cutting distance of 2200 m. A total of five inserts were used to obtain the average tool wear measurements. The extent of tool wear was evaluated by measuring the cutting edge-recession at intervals of 100 m and the cutting edge was examined under a stereo-microscope to characterize the morphology

of the worn surface at the end of the test, as described in the previous study by Ratnasingam *et al.* (2008). The power consumption during the machining experiments, were obtained from the tool forces measured continuously using a piezoelectric dynamometer attached to the motor and a PC based data acquisition system, as previously described by Ratnasingam *et al.* (2008). The temperature of the cutting tool during the machining experiments was measured by a portable heat radiation detector supplied by the National Instruments Inc., which was attached to the tool holder, as shown in Fig. 1.

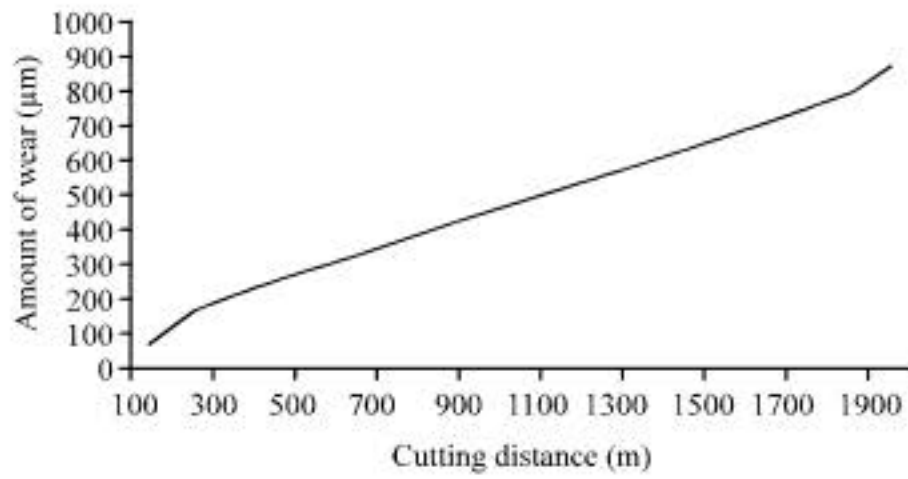
Fig. 2: Tool wear over cutting distance

**Rate of cutting tool wear and power consumption:** The extent of wear experienced by the tungsten-carbide tools over the cutting distance until failure occurred is shown in Fig. 2. It is obvious that the tool wear pattern of tungsten-carbide tools in this study exhibited three distinct stages, the initial unsteady wear stage, followed by a steady wear stage and finally the catastrophic failure stage. Such a wear pattern is similar to the findings reported by other researchers (Sheikh-Ahmad and Bailey, 1999). Complete cutting tool failure occurred at the cutting distance of 1980 m, indicating that the usable tool life for tungsten-carbide tools when cutting Oil Palm Empty-Fruit Bunches (OPEFB) particle board is about 2000 m. The average wear land value at the tool edge, at failure was

0.2 mm, which suggest micro-fracture and abrasive wear as the primary mechanism of tool wear (Klamecki, 1979; Ratnasingam and Scholz, 2006).

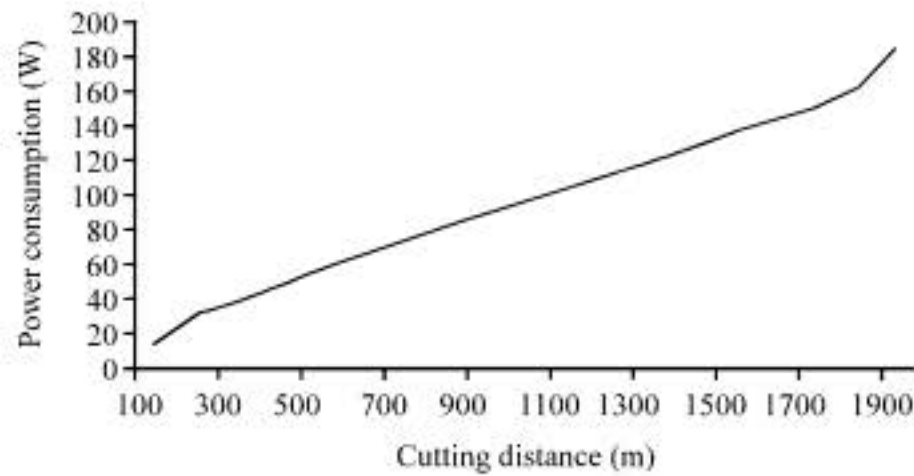
Fig. 3: Power consumption over cutting distance

The power consumption curve during the machining experiments also depicted three distinct stages (Fig. 3), which was similar to the tool wear pattern observed. Since the rate of tool wear has a direct bearing on power consumption (Klamecki, 1979), monitoring power consumption during the machining experiments can also be used as a technique to measure tool wear. On the basis of the stock removal rate used in this experiment, the total power consumption to machine 1 m<sup>3</sup> of Oil Palm Empty- Fruit Bunches (OPEFB) particle board is 615 kW, as opposed to 240 kW for 1 m<sup>3</sup> of Rubberwood (*Hevea brasiliensis*), as reported by Ratnasingam and Scholz (2006). On this account, it appears that oil palm empty-fruit bunch particle board is almost 3X more energy demanding compared to solid wood resources, which could be attributed to its high content of silica, adhesives, etc. (Ratnasingam and Scholz, 2006). Further, the higher board density resulting from the compaction of the board during manufacturing, also contributes to the higher energy demand during the machining of the material (Klamecki, 1979).

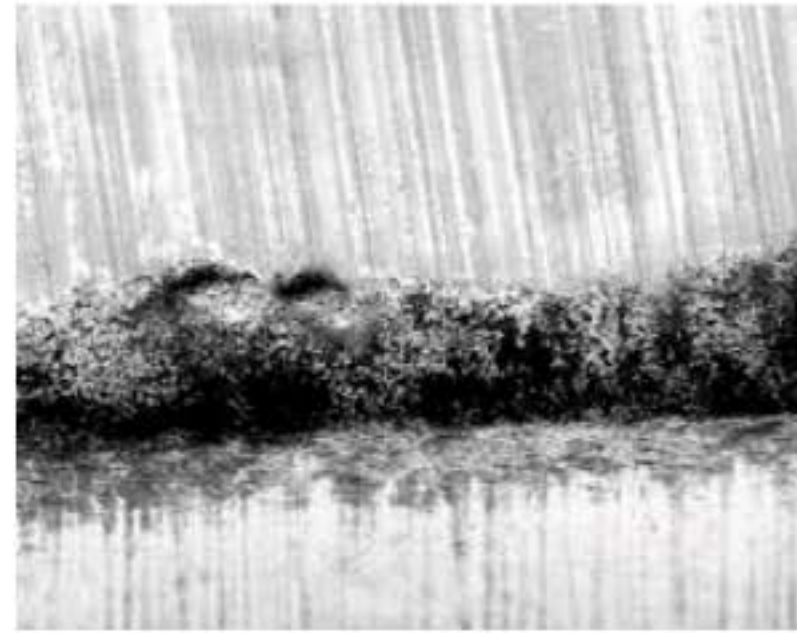
Fig. 4: Mechanical abrasion and indentation at tool edge after 500 m of cut (100X)

**Microscopic examination of the tool edge:** Microscopic examination of the tool edge revealed that wear occurred primarily as a result of indentation, micro-fracture and

mechanical abrasion (Fig. 4-6a, b). This wear mechanism has been suggested previously by Bayoumi and Bailey (1985), who reported that the presence of silica, adhesives and other hard impurities in the work-piece, resulted in the removal of the binder followed by the loss of carbide grains from the cutting tool. Further, this is in line with the study by Ratnasingam *et al.* (2008), who found that higher chromium content in the tool matrix and smaller carbide particles improved the wear resistance of tungsten carbide tools. In this context, machining OPEFB particle board requires the use of highly wear resistant cutting tools such as tungsten carbide tools, in order to optimize the process.

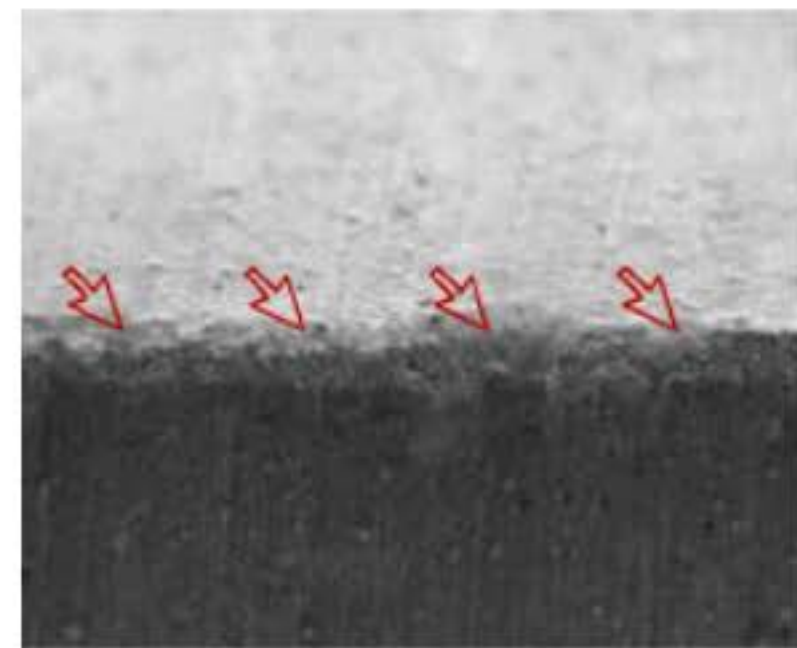
Fig. 5: Micro-fractures at tool edge after 1500 m of cut (100X)

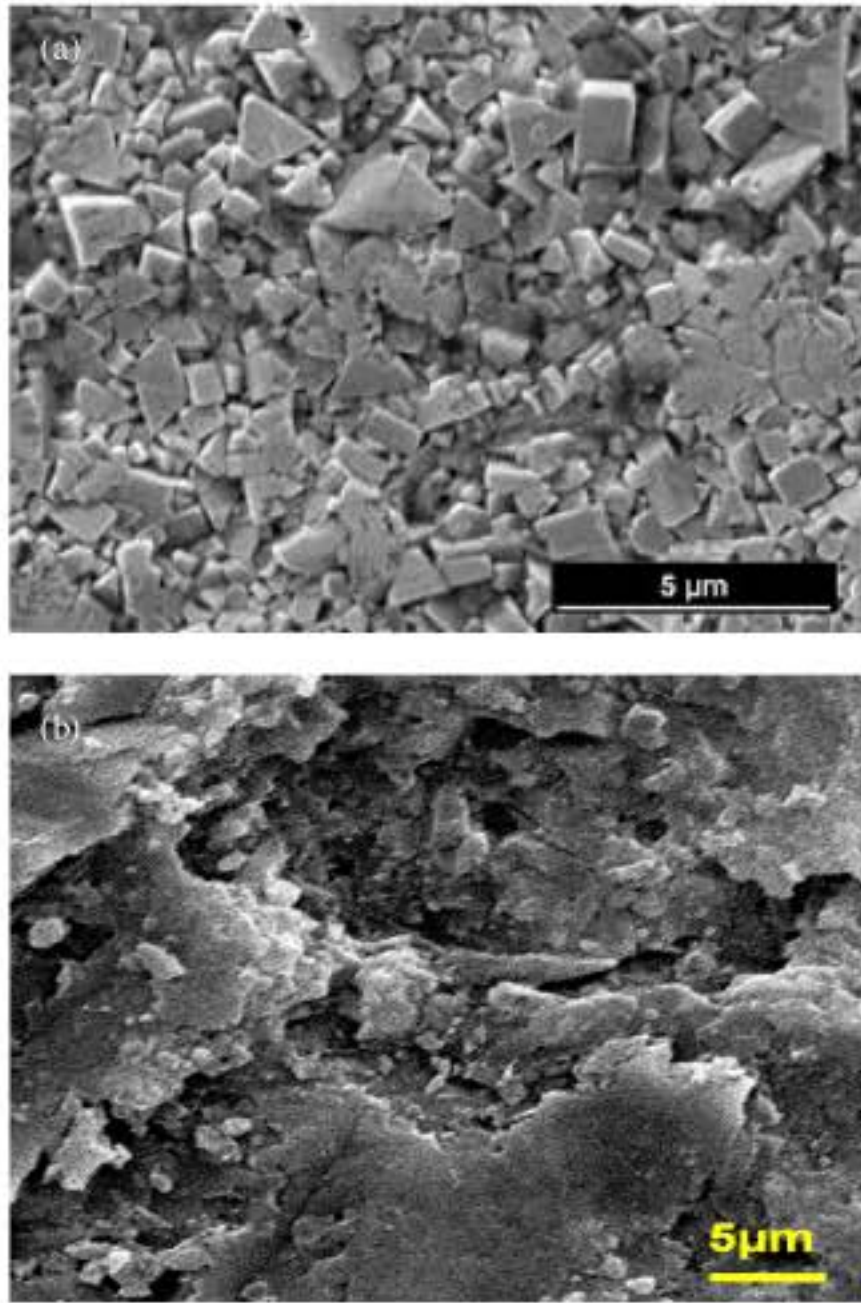
Fig. 6: Tool surface under the microscope, (a) new and (b) worn
