## Study on the Earthquake Action of Old Masonry Structures

P. Mihai, I. Gosav and B. Rosca

**Abstract:** In this study, the behavior of three historical buildings under earthquake was evaluated with experimental and numerical methods and numerical model was correlated with the experimental results. Many old masonry buildings are historical monuments and their preservation is a priority for every nation. Earthquakes are a serious threat to historical monuments because they were not designed with the current level of structural elements knowledge. Old structures were only designed to withstand gravitational loads and the horizontal loads weren't included in this process. In the earthquake evaluation process, according to EUROCODE 8, a behavior factor,  $q$ , is included. This behavior factor accounts for the energy dissipation capacity and its value varies according to the type of structure. Because the walls are made from masonry in this study, in theory, the behavior factors have values between 1.5 and 2.5. In practice, this is not true because existing buildings can have cracks, moisture and damage that affect the dissipation capacity of the structure. In this case, the value o

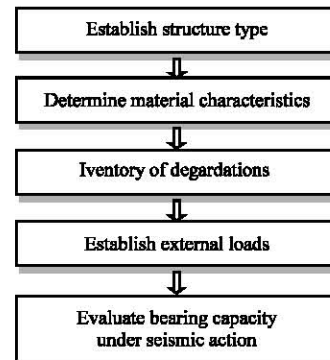
The safety degree evaluation has five steps, which are shown in Fig. 1. To get a reliable result, each step must be performed carefully.

Fig. 1: Steps to establish the safety degree of old historical monuments
