# Journal of Applied Sciences

## Experimental Study of the Stability of Spur Dyke for Different Types

**Abstract:** The stability of spur dyke directly affect the regulation effect of waterway and therefore how to choose more suitable structures and materials of the spur dyke become the concerns of many scholars. Though flume tests, firstly the stability problem of enrockment dams which are used frequently now by comparing the cross-section of the dam body type was researched, pointing out that the arc-shaped cross-section of the the dam body structure is more stable than the trapezoidal structure under the same flow conditions and obtaining the boundary conditions lead to water damage of enrockment spur dyke. Secondly, comparison and analysis research of the stability of the two new types of spur dyke (dam body is riprapping and dyke furface is concrete hinge; dyke body is riprapping and dyke furface is concrete and dry-laid pitched stones revetment) under different water level drops before and after groins in the flow conditions obtained above are given in this study and proposed that the size of drop water height is one of the restriction factor of dyke's damage. It points out

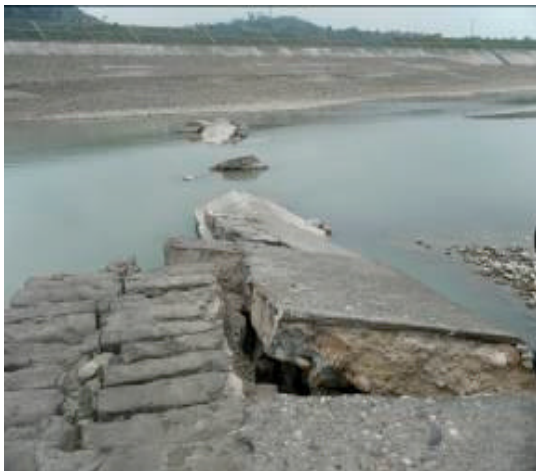
Fig. 2: Spur dyke water damage photos on xiaomitan

**Test scheme:** In preliminary research, found that a certain section of the dam body (xiaomitan) was severely damaged on the spur dam, even a whole section of the dam body washed away or collapsed occurred (Fig. 2).

scoured by currents constantly during withdrawal of water period, scour hole occurred at dam heel, leading to local dam foot rubble in suspending state, thus dam body loosening occurred, plus the following year flood, at this time spur dyke was scoured by flood in the mainstream scouring position, so repeatedly caused local dam body and dam surface rubble to be washed away.

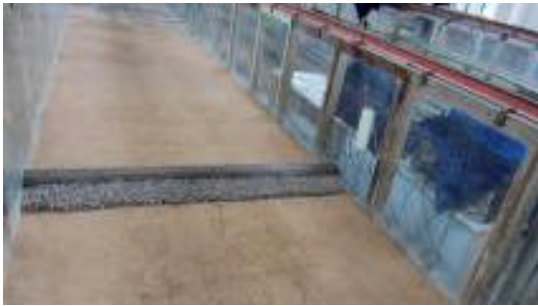
Fig. 6: Photos of the ballast of concrete and grouted rag model

In the regulation of Chuan River, about 1 m of the groyne's coat and head were grouted by cement and the other place built by thrown rubble. The model bulk of the enrockment dam is 10 cm high in the whole, 7.5 cm wide in crest, 1:1.5 in upstream Slope and 1:2 in downstream. In order to compare the two structures' stability, partial enlarge the ballast of concrete and grouted band under the condition of the overall model data constant, changing cement mortar paste build of the upper groyne from 1 cm to 2.5 cm and the lower dam with scattered riprap to 7.5 cm high (Fig. 6). Size distribution of the bed material median size is 1 mm.

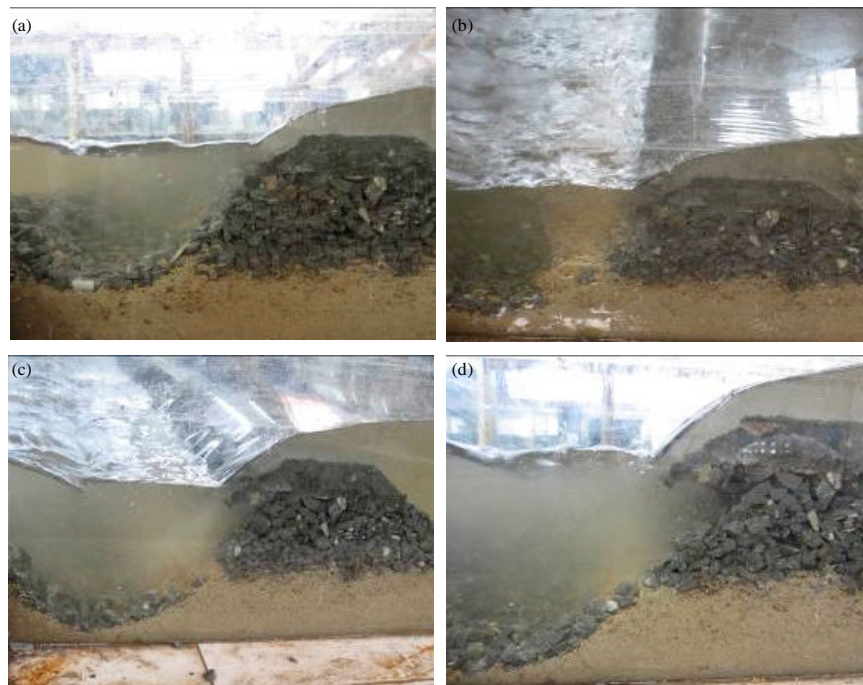
Fig. 7(a-b): Photos of the ballast dam body with concrete and grouted rag water damage process (a) Water head before and behind the spur dyke is 4.5 cm (b) Water head before and behind the spur dyke is 5.5 cm (c) Water head before and behind the spur dyke is 6.1 cm and (d) Water head before and behind the spur dyke is 7.1 cm

As shown in Fig. 7a, basically the dam surface has not been destroyed, therein just the back water slope and its toe has a certain degree of erosion and the spur dyke is still available, indicating that the groyne's stability have been markedly improved after ballasted with concrete and grouted band.

current after the dam scour pit constantly undercuts the gravel and sand foundation of the back water slope (Scattered riprap structure) under the ballast of grouted band, as time went on, the whole dam crest in the second half of the part is in an impending state (Fig. 7b-d); When a drop height of 7.1 cm, turn dam water flow's velocity is huge and ground bottom trend is very apparent, making the back water slope and slope foot's washing more and more serious, so that as the scour development to a certain degree the base ballasted with grouted band is mainly empty; With the development of flushing process,

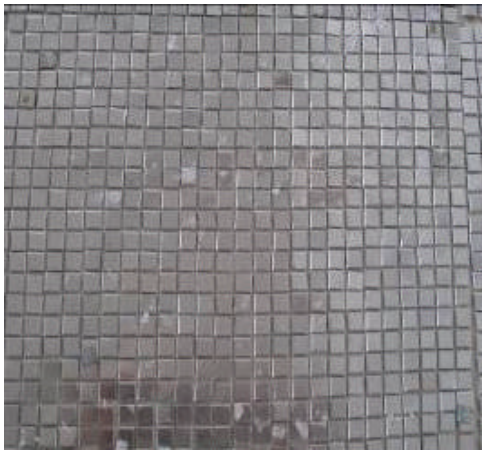
Fig. 9: Model of concrete block hinge rank

The model structure of concrete block hinge rank protective facing spur dyke is like this, the dam body still consists of cast loose gravel (6-12 mm) and the size of the dam is similar with 3.2, the surface of the dam is covered and ballasted with the row body model that is advance production (Fig. 9) and embedded 7-8 cm row body extend to the bed surface in the toe of face water slope as well as the back, they are shown in Fig. 10.

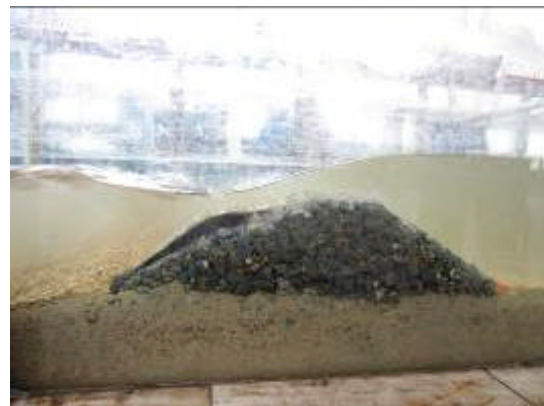
Fig. 11: Sediment deposition and row body bulge in the back water slope

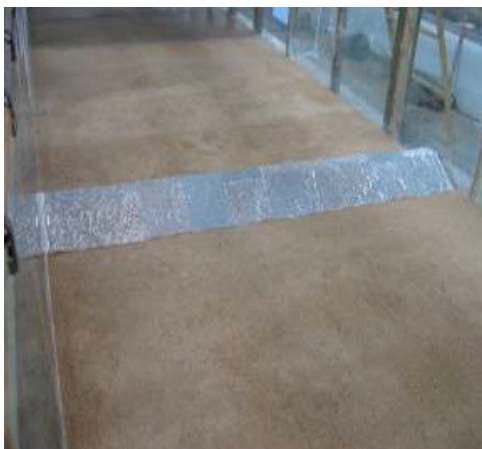
Fig. 10: Model of dam body with concrete block hinge rank protective facing

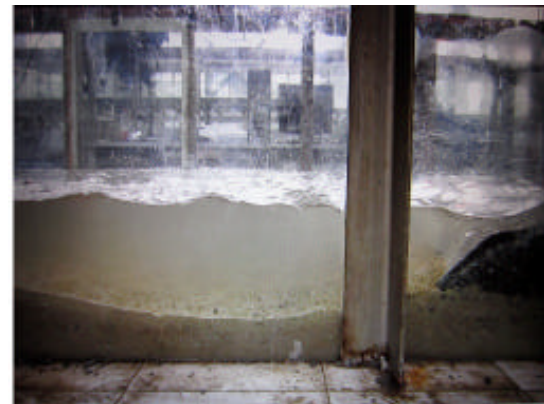
Fig. 12: Scouring pit in dam downstream

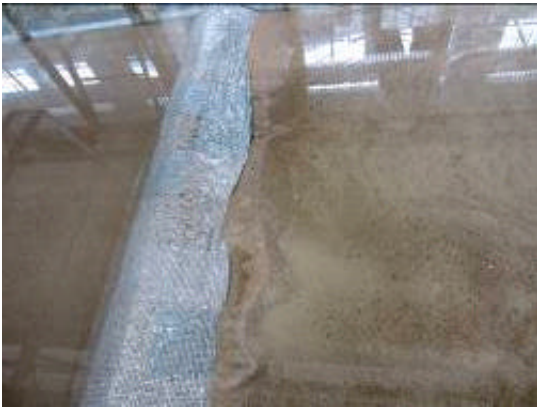
Fig. 13: Photos after scouring under the condition of 5 cm drop height before and after the dam
