## Engineered Cementitious Composites for Repair of Initially Cracked Concrete Beams

**Abstract:** The current research addresses Engineered Cementitious Composites (ECC) as a new alternative for retrofitting damaged concrete beams. Twenty-one plain concrete beams with pre-defined artificial cracks were prepared and repaired using different combinations of ECC alone or together with Carbon Fiber Reinforced Polymers (CFRP). The study showed that replacement of the inferior layer from the bottom of the deteriorated beams with a thin layer of ECC could be able to restore the beam to a condition better than its original state. Moreover, the repair with ECC was found effective in enhancing the member ductility as well. It was also shown that pasting CFRP directly over ECC substrate resulted in shear failure rather than the undesirable interfacial debonding mode of failure that typically occurs in case of concrete substrates.

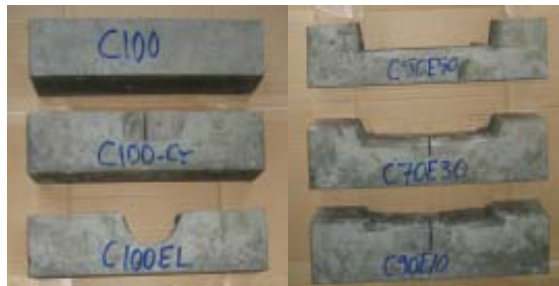
Fig. 1: Specimens before repair

Twenty-one scaled down plain concrete beams with dimensions (depth×width×length) equal to (100×100×400 mm) were prepared. Small size beams were selected to minimize the cost of the used ECC. The specimens contained artificial cracks, 50 mm depth and 2 mm width, located at their mid-spans. The cracked beams were designed so that their load carrying capacity should not exceed 20% of the sound specimens. The above condition was confirmed by conducting many side experimental tests. The cracks were conducted by placing separators in the moulds before casting the concrete. The combined concrete/ECC beams were prepared through two stages; first, the concrete was cast leaving a free space in the moulds as shown in Fig. 1, second, after 28 days of water curing to the concrete, ECC with different thicknesses was added to fill the remaining free spaces in the moulds. ECC was placed locally around the crack, or with thicknesses of 10, 30 and 50 mm from beam bottom. For more details about the notation of specimens as well as the number of replications for each case, refer to Table 1. After casting ECC, the final repaired specimens were again kept for curing in water for another 28 days.

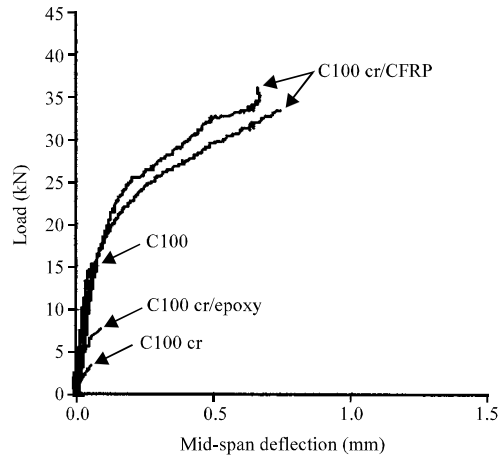
Fig. 2: Load-deflection curves for the traditional repairing methods

The load-mid-span deflection curves for the conventionally used methods are shown in Fig. 2. The current repairing methods are shown in Fig. 3 and 4. Noticed enhancement in the section capacity was observed. Specimen repaired only with traditional epoxy injection (C100-cr-epoxy) showed a 130% enhancement in the section capacity over the cracked specimen (C100-cr). It, however, failed to reach the section capacity of the beam original state (C100). It was also noted that the traditionally used repair technique (C100-cr/CFRP) exhibited a section capacity 133% higher than the target beam (C100). In the current research, the repair with ECC alone was found more effective. Both the loading capacity and the ductility of the repaired beams were enhanced. For (C100-EI), ECC was only applied locally, around 100 mm at the beam base and extended to the full crack depth. The enhancement in the section capacity was 220% more than the damaged state (C100-cr). Although this combination was still not able to reach the initial original state of the beam; it was found better than the traditional case (C100-cr/epoxy). The low loading capacity might be attributed to the relatively small contact area between ECC and the base concrete at a zone of extremely high normal stresses. The application of ECC layers, with different thicknesses with a longer distance among the beam soffit, improved the flexure performance a lot. It was observed that ECC acted as a bridge to convey the internal forces between both sides of the crack. Retrofitting of the damaged beams with ECC showed that the original integrity was not only restored but enhanced as well. The section capacity for (C90E10), (C70E30) and (C50E50) was found 12, 42 and 75%, respectively, more than the target specimen (C100) and 505, 640 and 790% higher than the damaged specimen (C100-cr). Generally, the increase in ECC thickness led to the increase in the section load carrying capacity.

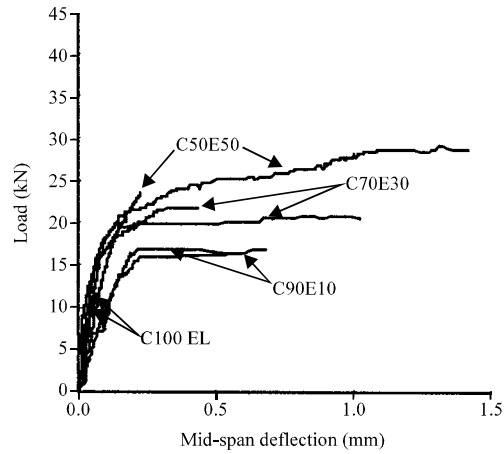
Fig. 3: Load-deflection curves for repair using ECC Only

Ductility is the ability of the repaired beams to carry deformation under peak load without full collapse. Figure 3 shows also the enhancement in the member ductility with the increase of ECC thickness. The maximum deflection was also noted and shown in Table 6. It was clear that the undergone deflection was directly proportional to the ECC thickness. The application of CFRP showed only minor changes in the maximum deflection achieved by the specimens. The decrease in the maximum deflection of (C70E30/CFRP) and (C50E50/CFRP) was due to the occurrence of shear failure that prevented the beams from reaching their ultimate deflection limits. It was however suggested to carry out similar combinations again after confining the high shear stress zones so that the comparison would be more realistic.

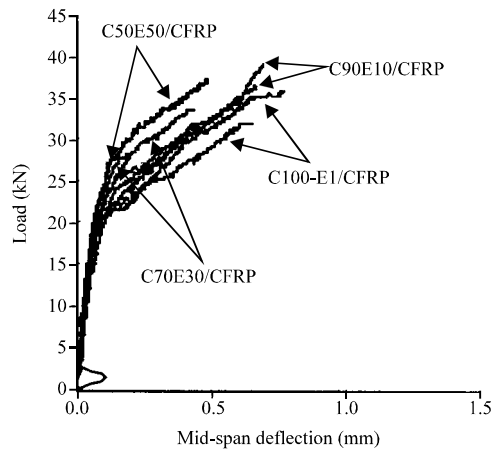
Fig. 4: Load-deflections curves for repair using combinations between ECC and CFRP

The same combinations were again repeated after applying CFRP sheets at the beam soffit. The results showed that the mitigation in the section capacity for (C100EI/CFRP), (C90E10/CFRP), (C70E30/CFRP) and (C50E50/CFRP) over the target beam (C100) were 127, 153, 115 and 119%, respectively. The previous values did not show substantial variation and a little bit lesser than that of (C100-cr/CFRP) except for the case where ECC was of minimum thickness. The application of CFRP led to an increase of the absorbed energy by the beam until failure. This energy was in the form of high loading capacity accomplished with small deflection. That was the reason for having small variation in the load carrying capacity for all the specimens incorporated CFRP. Table 6 shows the flexure test results for all the examined specimens. Moreover, it was noted that 30-50% reduction in the effective shear resisting cross-section for both (C70E30/CFRP) and (C50E50/CFRP), respectively, was behind the observed pure shear failure and the reduction in the total load carrying capacity.
