Water Construction in Undermining or Otherwise Bylubranization Adversely Affected Environment

Marek Teichmann, Natalie Szeligova, Petr Srytr and Frantisek Kuda
Department of Urban Engineering, Faculty of Civil Engineering,
University of Ostrava, Ludika Podeste 1875/18 Ostrava-Poruba 70833, Czech Republic

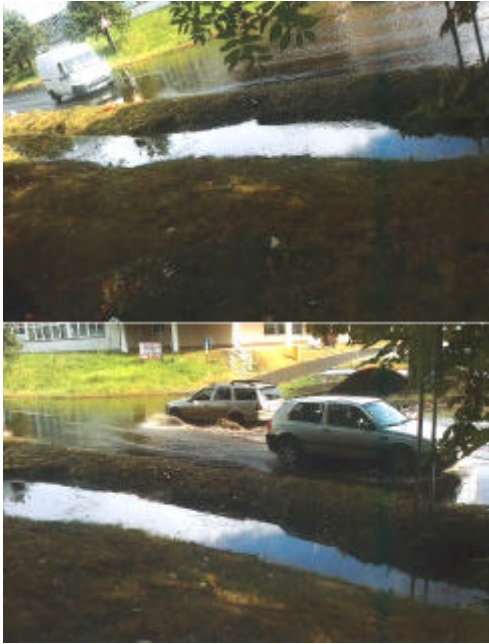
Fig. 1: Photo documentation-the photos showing the emergency state, common danger state at the Kaufland shopping centre caused by insufficient of the Local Road Space Catch Drain (LRSCD) at Jirasek and insufficient function of the follow-up concentration and transfer object of the (LRSCD) and the relief sewer

The state of drainage in the area of interest and in its neighbourhood shows the state of disrepair which was confirmed by results of its reconnaissance. Next, Fig. 1-3 photo documentation. Within the framework of reconnaissance of the area of interest, the Building Authority at Litvínov Municipal Office and the Branch office of Severoeseke vodovody a kanalizace a.s. were contacted. with the aim of getting more exact information to the drainage systems in the given area. In both cases, this information was not available as to the sufficient extent and accuracy; no particular satisfactory background data on structure and function of the drainage systems, drainage elements or objects in the area of lots No. 2287/12, No. 2288/2 in the cadastral district of Horní Litvínov and in their surroundings, adjoining to both sides towards Jirasek street was acquired. This area is characterized by morphology of the ground space inclined to Jirasek street on both of its sides (Fig. 2).

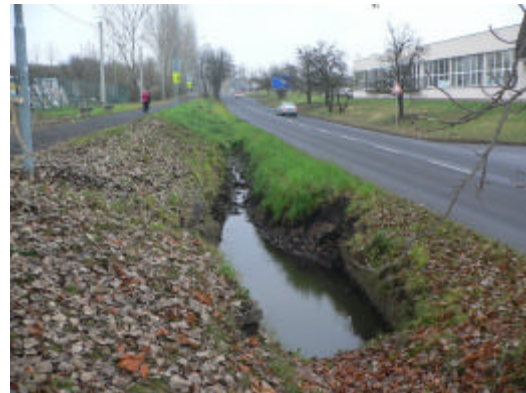
Fig. 3: Photo documentation - general view of the LRSCD in the direction of the roundabout at the connection of Jirasek-Lomska-S.K. Neumann streets; the catch-drain is not maintained. With proper function of the pipe underpass, the water should be transferred to the opposite side of the local road and further through the concrete DN 200 relief sewer into the Divoky potok stream; however, this important concentration and transfer object is in a poor state; the inlet to the pipe underpass and to the following relief sewer is not secured against inlet of sediments which in connection with absence of operational maintenance had a harmful influence on the permeability of the pipe underpass and to subsequent relief sewers
