On the Water Absorption and Corrosion Rate of Concrete Using Calcium Stearate

¹Agus Maryoto, ²Buntara S. Gan, ¹Nor Intang Setyo Hermanto and ³Rachmad Setijadi

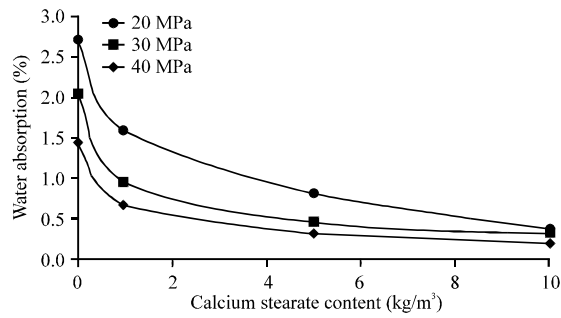
Fig. 3: Water absorption of concrete

Water absorption: Figure 3 shows the relationship between calcium stearate in the concrete with water infiltration. Based on Fig. 3, the amount of water absorption decreases as the amount of calcium stearate in concrete increases. The decrease follows the quadratic equation. The decline of water absorption occurs in the quality of concrete, 20, 30 and 40 MPa.

Increasing the amount of calcium stearate in the concrete caused the formation of compounds that resemble many waxes. Therefore, this treatment affects to increase the hydrophobicity of concrete. As a result, water is difficult to get into the concrete by capillary formation.

One other thing that can be observed from the Figure that is the higher quality of concrete the water absorption getting smaller. This occurrence is related to the water

cement ratio. The higher the quality of concrete, the lower the water cement ratio. The lower the water cement ratio, water that evaporates in number is small so that the capillaries are formed too little. The effect is the water that infiltrate into the concrete by capillary is also too little.

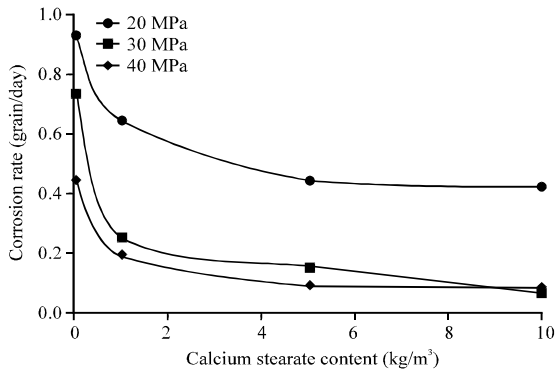
Fig. 7: Corrosion rate of various concrete grade

Corrosion rate: Table 4 shows corrosion rate of specimen with and without calcium stearate in reinforced concrete. The corrosion rate on the concrete grade 20 MPa can be observed by using Table 4, Column 1, No. 1 until 4. Corrosion rate of reinforcement in the concrete with calcium stearate 0, 1, 5 and 10 kg are 0.93, 0.65, 0.45 and 0.43 g/day, respectively. The tendency of corrosion rate is presented in Fig. 7.

According to Fig. 7, the trend of corrosion rate of concrete grade 20 MPa declines when the addition of calcium stearate in concrete increase. The decreasing of corrosion rate occurs as well on concrete grade 30 and 40 Mpa. This is because the sizes of voids and capillaries are considerably smaller and partially infilled with cementitious materials in the specimen with calcium stearate. Micro cracks and few voids are infilled with calcium silicate hydrates gel in concrete. These are most probably due to the addition of calcium stearate in the ordinary cement concrete. The use of calcium stearate as additive in concrete can enhance the strength and durability of concrete due to better microstructure, formation of additional Calcium Silicate Hydrate and infilling pores (Singh *et al.*, 2009).

By comparing among the curves of concrete grade 20, 30 and 40 MPa in Fig. 6, it shows that concrete grade 20 MPa has the largest corrosion rate. The lower corrosion rate is then occurs on the concrete grade 30 MPa. The slowest corrosion rate takes place on the specimen with concrete grade 40 MPa.

The higher concrete grade, corrosion rate reduces. It is because affected by water cement ration in the concrete mixture. The water cement ratio are 0.52, 0.44 and 0.35 for concrete grade 20, 30 and 40 MPa, respectively. Cement needs water around 25% of the cement weight to form Calcium Silicate Hydrate. Remain water in concrete due to water cement ratio more than 0.25 is utilized for workability and finally evaporates. During evaporation process, million capillaries pore form in the concrete. The higher water cement ratio, the amount of capillary pores increases pointedly. Concrete with high water cement ratio, the permeability increases. Consequently, water and ion chloride infiltrate easily into concrete. As the result, corrosion rate in the concrete rises as well.
