## Construction System for Single-Family Homes using Load Bearing Straw Bale Walls Quivillungo Community, Bolivar, Ecuador

**Abstract:** This study begins by describing how our team chose an area in the Ecuadorian Andean Region where a prototype single-family home using load bearing straw-bale-walls could be successfully built. The criteria used in this search were based on results from geographic information systems. The next section describes the design and manufacture of a baler machine which is essential to the feasibility of the strawbale home construction procedure. The study then goes on to explain the features of the most important elements of the single-family home structure: foundations, straw walls, wall crowns, roof and structural plaster. The prototype home was built in accordance with existing standards from other countries, taking into account the high seismic hazard of the geographic region and applying the specific capacities of the Quivillungo community. The construction was validated using analytic models that show the existence of relatively low stresses and deformations and highlight the structural importance of the plaster.

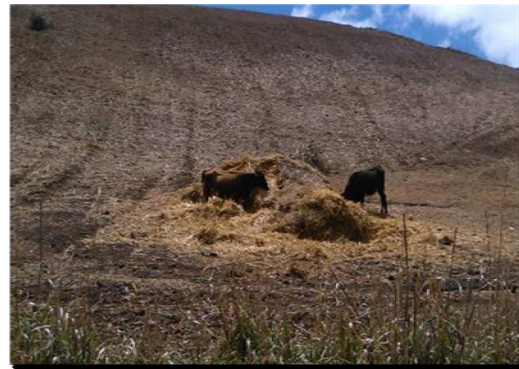
Fig. 1: Raw material: wheat straw in the Andean area of Ecuador; Thesis (Pachala Curi and Rosero Munoz, 2016)

**Raw material for the strawbales:** Figure 1 shows wheat is one of the most important products in the Ecuadorian diet. Its consumption has increased notably as a result of rapid population growth (1.2% per year), changes in consumption habits and relatively low prices of wheat grain products.

use traditional farming systems while 53.74% use semi-technical systems. Only, 8.1% use technical farming systems. Wheat production is used for making bread, noodles, crackers and cookies and animal feed. However, wheat straw (Fig. 1) is not put to any technical use and usually is burned.

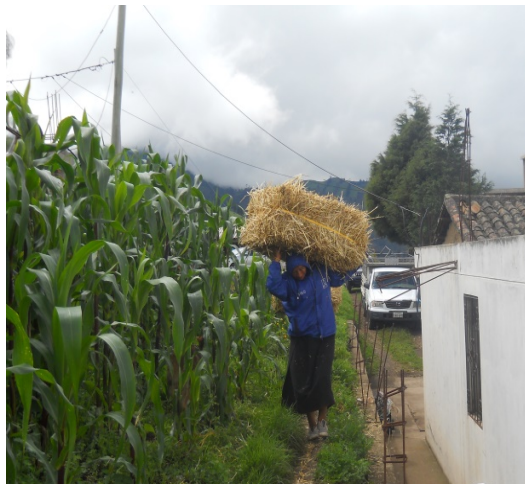
Fig. 4: Strawbales

**Strawbale characteristics:** To be able to use wheat straw in bales for housing construction an artisanal baler machine had to be designed and built. This design was based on strawbale specifications and dimensions defined by Minke and Mahlke (2006). These dimensions are: length =  $80 \pm 2$  cm, width =  $50 \pm 2$  cm, height =  $35 \pm 2$  cm (Fig. 4). Additionally, wall overlaps require strawbales with the following dimensions: length =  $50 \pm 2$  cm, width =  $50 \pm 2$  cm, height =  $35 \pm 2$  cm.

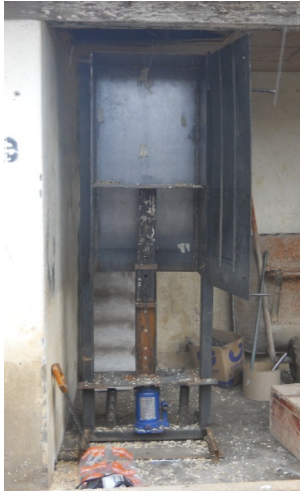
Fig. 6: Baler machine used in the project

Figure 6, shows a photograph of the built machine. When operated, the front cover closes and an initial amount of straw is introduced through the top where there is also a cover. With the help of the hydraulic jack, the straw is compressed. The jack piston is lowered, more straw is added and the process is repeated until achieving the final bale dimensions.

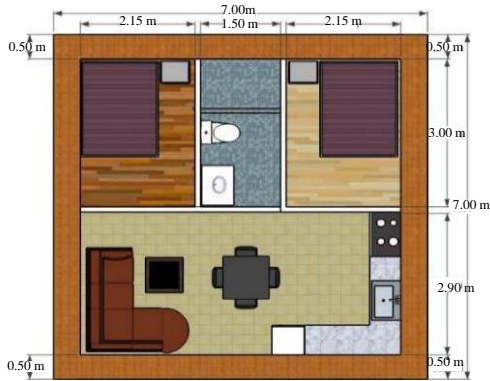
Fig. 7: Architectural floor plan of the single family home

**Architectural design:** The architectural proposal for a single-family home with straw bearing walls has the minimum dimensions specified in Chapter 4: standards by type of building, first section: home buildings, taken from ordinance 3457 of the Quito Metropolitan Council Architectural and Urban Planning Standards. The floor plan dimensions are  $7 \times 7$  m. Figure 7-10 show the floor plan and architectural side views.

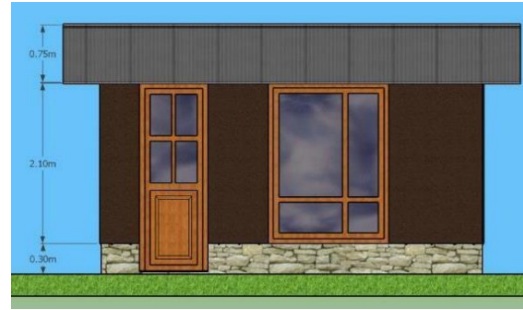
Fig. 9: Front of the house

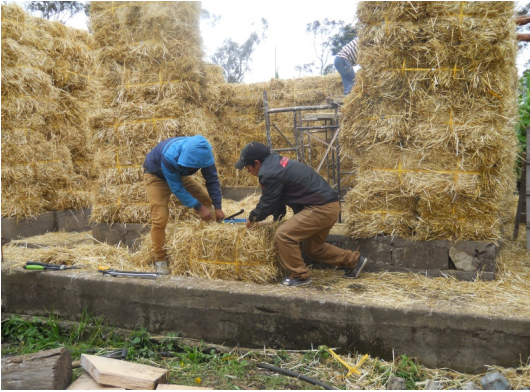
Fig. 11: Foundation and shaping of the structure's straw walls

**Construction system:** The foundations are made up of a platform of packed down Earth with concrete blocks along the edges a 5 cm thick lean concrete surface with chains of cyclopean concrete measuring 60 cm at the base and 30 cm high. This type of foundation had to be adapted during construction as a solution to the mud produced by heavy rains. The bales are placed on top of these chains as shown in Fig. 11.

The straw bales overlap by including half a bale every other row. The D12 (12 mm in diameter) pins were also driven in about every 150 cm.

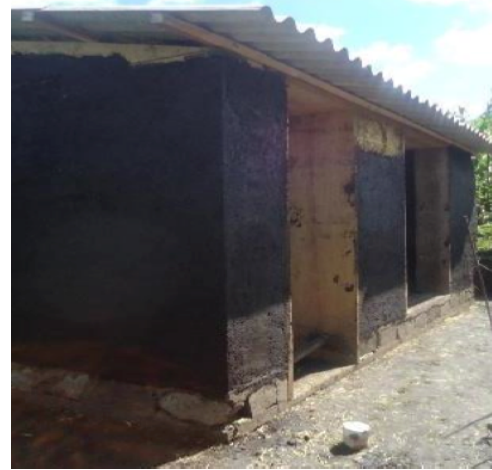
Fig. 14: Home with the plaster applied

Finally, Fig. 14 shows the roof, made of eternit (asbestos-cement sheets) on wooden strips, along with the door and window frames and plastering on the straw walls. The plaster included a first layer with dirt having a

high content of clay and straw and then a second layer of terroccement in 1:3 proportions. It was laid over hexagonal wire mesh secured to the surface of the straw bales and

with a thickness of 4 cm. The characteristics of this plaster coating was also developed by the community during its installation.

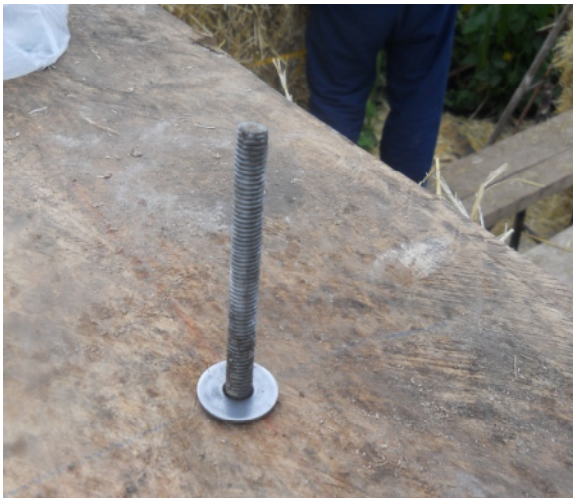
Fig. 12: Detail of the joint between the wooden planks and the bales the screw is missing

Figure 12 shows wooden planks that are tightened against the bales using washer and nut in a special working on the d12 mm pins which as mentioned above are driven in and through-tied to hold the bales in position. This specific working is an original solution providing a certain level of compression and stabilizing forces to the bales.

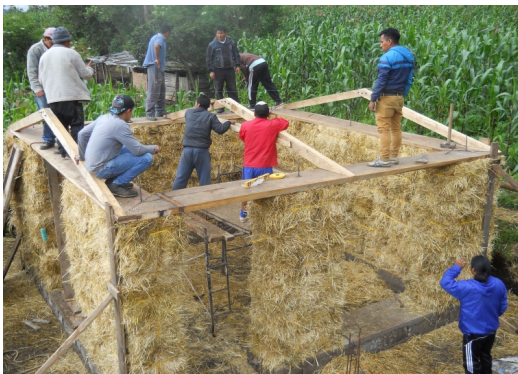
Fig. 13: Perimeter beams and wooden trusses

Figure 13 shows the wooden beams that make up the crowning section of the walls and support the roof's wooden trusses.
