A Case Study of the Ground Collapse Mechanism Due to Excavation-Induced Groundwater Level Disturbance

Abstract: Cities are now experiencing accidents with unpredicted ground collapses adjacent to the existing properties. Such ground collapses, caused by natural or artificial factors, may harm the assets in dense urban areas. This study discusses the ground collapse induced by groundwater level disturbance in an excavation site. The subsurface condition was characterized by geophysical methods; ground loosening region around the excavation site was detected and analyzed by Real Time Kinematic (RTK), Ground Penetrating Radar (GPR) and Electrical Resistivity Tomography (ERT). To overcome the unreliability or ambiguity problems in the interpretation results, interpretations of the ERT and GPR data are compared and then, integrated for detection of the water leakage in this case study. The survey results showed a wide range of adjacent ground was loosened due to groundwater drawdown. A numerical analysis in MODFLOW was carried out to simulate the groundwater flow on the site. Finally, it can be concluded that the soil erosion due to water leakage and the positive groundwater discharge

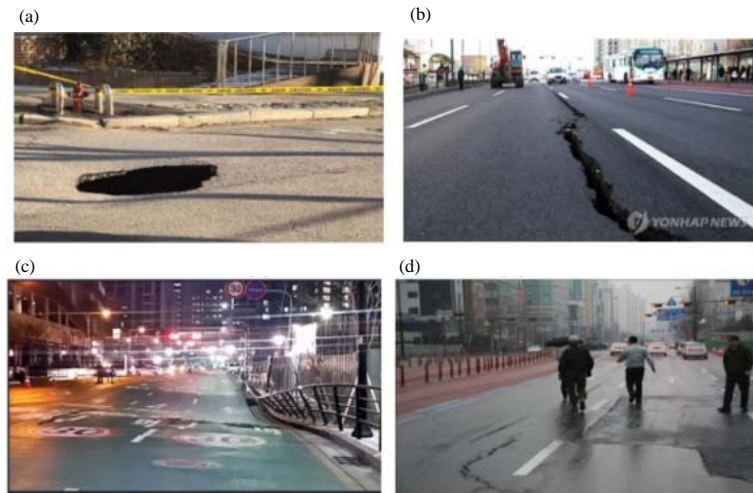
Fig. 3: Ground sinking occurrence site in the OO area in South Korea: a) First ground sinking; b) First road crack; c) Second road crack and settlement and d) Third road crack

In the first stage of the ground sinking and road crack, groundwater was discharged from the first water leakage joint of the diaphragm wall that is 20 m below the ground surface (Fig. 2) at around 2:40 p.m., February 6, 2017 and the groundwater level decreased by 1.0 m. In the first ground sinking occurrence region (Fig. 3), a ground sinking of 3 m in length and 30 cm in depth took place and a crack of 30 m in length and 0.05-0.1 m in width was formed (Fig. 3b).

In the second stage of the road crack and settlement, groundwater was discharged from the second water leakage joint of the diaphragm wall that is about 20 m below the ground surface (Fig. 3a) at around 6:30 pm., February 14, 2017, during the reinforcement work in relation to the first accident and the groundwater level decreased by about 6.0 m. In the second ground settlement occurrence region (Fig. 3b), a road crack and settlement that was 100 m in length were formed (Fig. 3c). In the case of the third road crack event, a crack that was 20 m in length and 0.03-0.05 m wide was formed in the same region where the initial ground sinking event occurred at around 3:20 pm, February 22, 2017 (Fig. 3d).

The analysis showed that the groundwater level was lowered in areas B and C of (Fig. 2) due to the first leakage (February 6, 2017) (Fig. 11), resulting in cracks and subsidence on the road near to the excavation site as

shown in Fig. 3a and b. The second leakage (February 14, 2017) significantly lowered the groundwater level in area A of Fig. 2 (Fig. 12), resulting in subsidence on the roads around the excavation site, as shown in Fig. 3c.

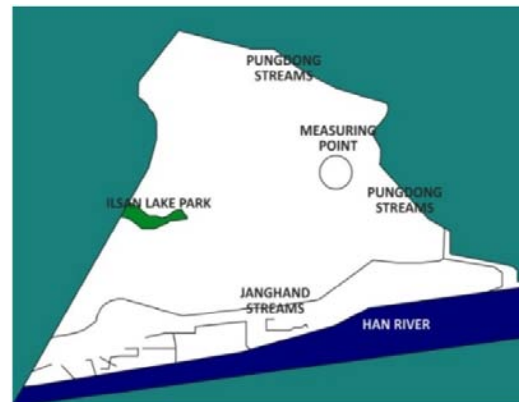
Fig. 5: Boundary condition setting

The analytical domain is near to the boundaries representing Dochon Stream, Pungdong Stream and Janghang Stream with the excavation location at the center. The mesh for the modeling was 6.4 km long in the East-West direction and 5.6 km long in the North-South direction including the excavation area. The mesh was generated as an irregular mesh including 5 m grids around the excavation area and 10, 20 and 40 m grids in the areas that are not significantly affected by the groundwater discharge. The riverbed boundaries and the boundary conditions set for the model were no-flow boundary condition, considering the groundwater divide along the ridge line from the zenith (Mt. Jeongbal). In addition, Ilsan Lake Park was set as a general head boundary and the Han River was input as a river boundary. Small streams such as Dochon Stream, Pungdong Stream and Janghang Stream were set as drain boundaries (Fig. 5).

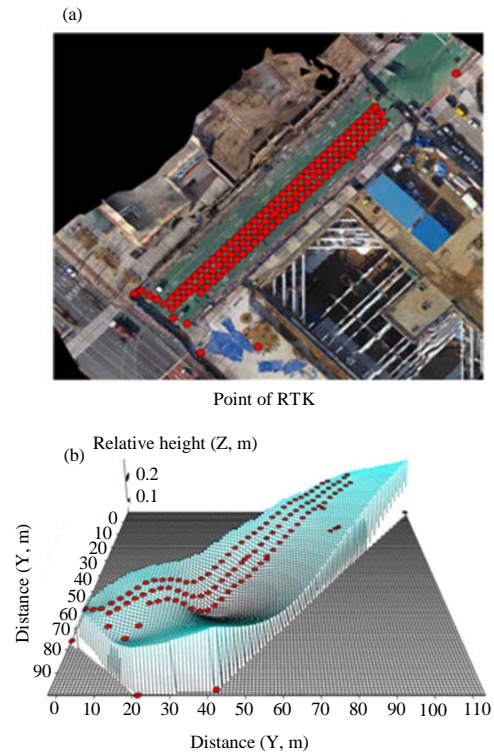
Fig. 6: a, b) RTK survey result

Geophysical surveys results: An RTK (Real Time Kinematic) survey was conducted for the area A shown in Fig. 6. The elevations of the ground surface were measured for the dots as shown in Fig. 6. The result showed that the ground surface had sunk and formed a bowl shaped surface.

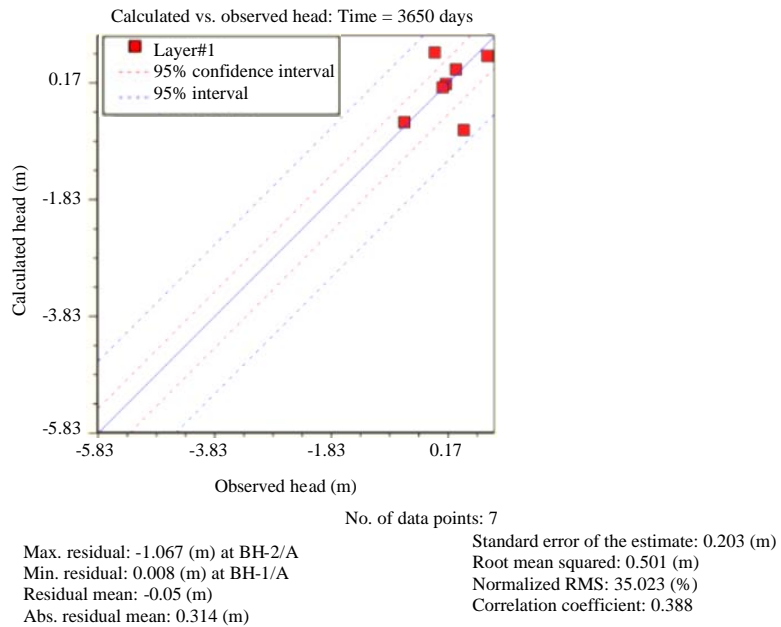
Fig. 9: Result of model correction for non-steady state

head and the calculated head. As shown in Fig. 9, the average residual was -0.05 m and the average error was 0.203 m indicating that the present analytical model well-reflected the groundwater level of the excavation area to appropriately predict the groundwater level variation during excavation. To simulate the non-steady state of the groundwater level variation in the surrounding areas due

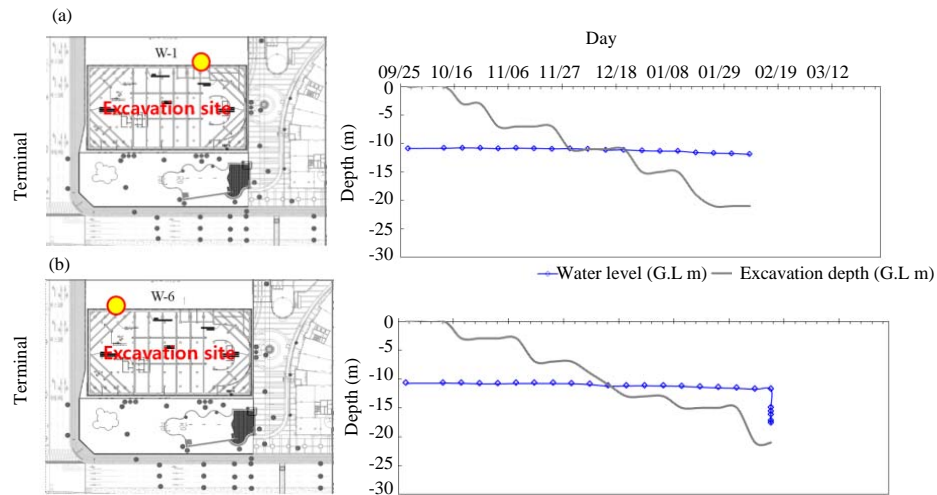
Fig. 10: Groundwater monitoring result

The observation head (Fig. 10) was set up as the initial groundwater level for the non-steady state to analyze the variation of the groundwater level depending on the ground improvement work leakage on the individual days of water leakage (Fig. 11 and 12).
