Asian Journal of Plant Sciences

Research Article

Soil Micromorphology of Land Cover in Landslide Susceptibility Area in Kelara Subwatershed, Jeneponto, Indonesia

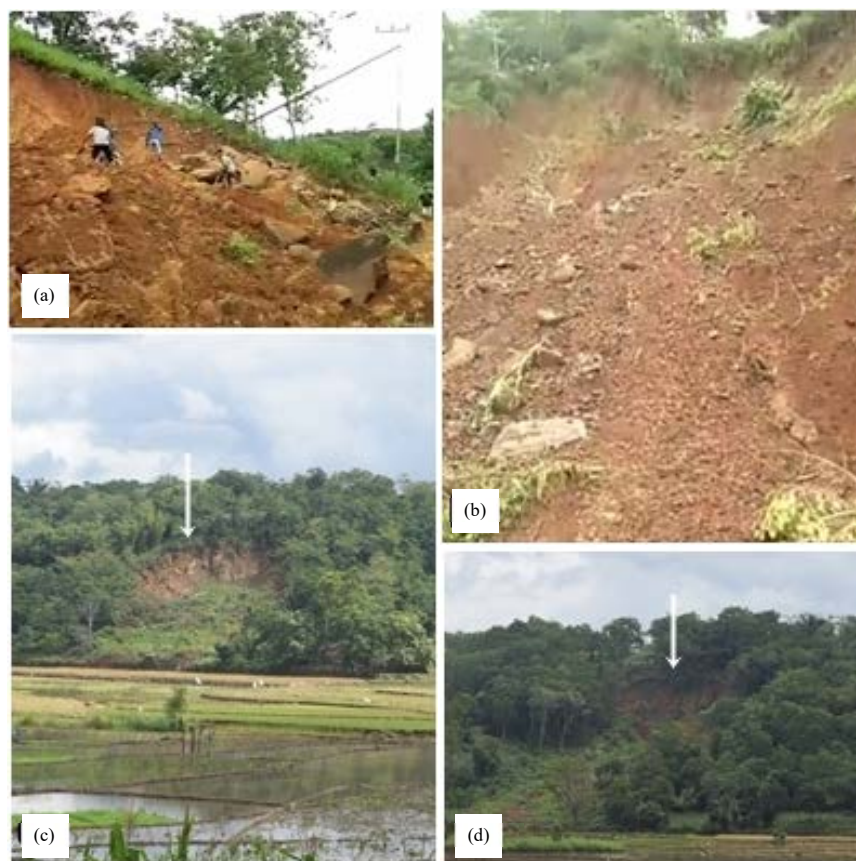
Fig. 9(a-d): (a) Appearance of several landslide events at sites 3 and 4 (b, c and d) On mixed plant land use in Rumbia District, Jeneponto Regency (the white arrow is landslides point)

ability of the soil to pass water has caused plane voids (Fig. 8a, b), internal micro-shifts (Fig. 8c, d) and increased susceptibility to landslides. Landslides occurred on mixed plant land use for coffee, banana, teak, timber and mango plantations at sites 3 (Fig. 9a) and 4 (Fig. 9c, d) on slopes >15%. Meanwhile, according to research results^{32,33}, tree roots can stabilize the soil against the shear strength of the soil in sloping areas. It is inversely proportional to the incidence of landslides at the study site, where landslides are more common on slopes of 15-25% on mixed plant land use with various taprooted plant species that can stick firmly in the soil. We also found different facts in the study area, where land use for horticultural crops on slopes >25% so far has not found any landslide activity. It indicates that plants with larger stem diameters can be a burden on the soil in sloping areas if the condition of the clay content of the soil increases, to increase the shear strength of the soil, which has the characteristics of being easily saturated. According to Bibalani *et al.*³⁴, shrub's roots can increase the critical shear plane and caused slope failure to trigger a landslide in Northwest Iran.
