Journal of Applied Sciences

Impact of Mechanized Harvesting Machines on Forest Ecosystem: Residual Stand Damage

Abdullah E. Akay, Mustafa Yilmaz and Fatih Tonguc

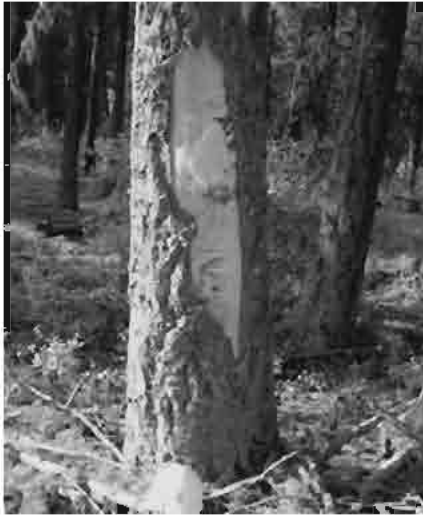
Fig. 1: Residual stand damage from a thinning operation

The risk of damaging the residual stand is very high during thinning operations (Fig. 1). However, the type of the harvesting systems used in thinning operation can reflect the amount of residual stand damage (Filip and Schmitt, 1990). Bettinger and Kellogg (1993) reported that the damages on the residual stand can be reduced by using cut-to-length thinning systems. Besides, well trained and motivated machine operators can be a significant factor in keeping the amount of stand damage under the tolerable level.

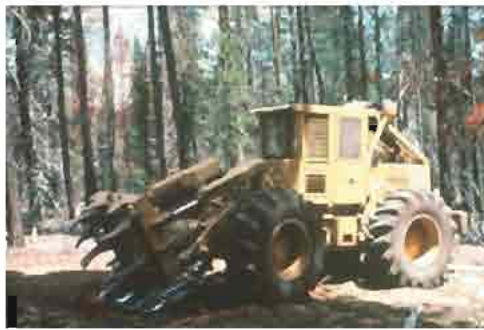
Fig. 2: A rubber-tired feller-buncher in felling operation

Feller-bunchers: The feller-buncher cuts the tree using a hydraulic powered cutting head with chain saws, circular saws, or shears. Then, the entire tree can be lifted and accumulated in a bunch using its hydraulic arms (Fig. 2). The trees are then transported full-length with a skidder to the landing, where a processor delimbs and bucks the tree into logs. Trees can be felled uphill to enable downhill skidding, which improves skidder productivity. The feller-bunchers are not only much faster than fallers working with chain saws but also they provide a much safer environment for the operator compared to manual felling. Even though there are some advanced feller-bunchers

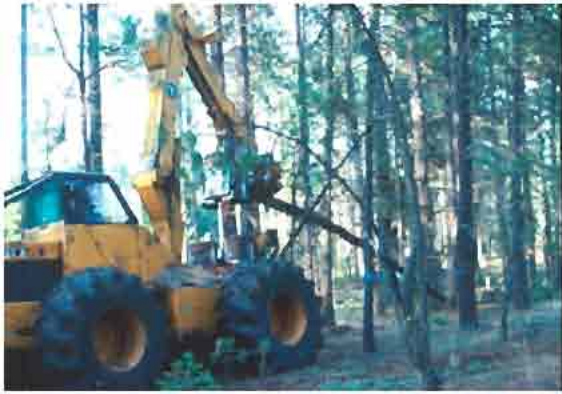
Fig. 3: Delimiting and bucking the trees with double-grip harvester

Harvesters: Harvesters are commonly used in mechanized cut-to-length (log-length) systems in which the harvester fells and processes trees into log lengths and a forwarder transports the logs to the roadside. Harvesters are divided into two groups: single-grip harvester and double-grip harvester (Fig. 3). Single-grip harvester both fell and processes with a single unit (Kellogg *et al.*, 1992). Double-grip harvester severs the tree with a boom-mounted head unit and places it in the carrier-mounted processing unit for delimiting and bucking (Kellogg and Brinker, 1992). According to a study conducted by Kellogg and Brinker (1992), single-grip harvesters have become more popular than double-grip harvesters.

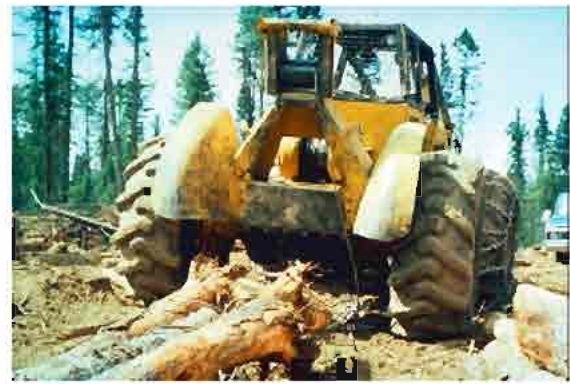
Fig. 4: A rubber-tired chained skidder in skidding operation

Skidders: The skidding operations are usually done by using a grapple to hold the load ends clear of the ground, or by dragging logs using wire rope to hold the load. Skidders are divided into two types; rubber-tired skidders that are equipped with an articulated frame and crawler tractors that are equipped with steel track (Fig. 4 and 5) (Kellogg *et al.*, 1992).

Rubber-tired skidders are less expensive, faster and lighter than crawler tractors. Their traction can be improved by installing chains over the tires. Rubber-tired skidders have the advantages of operating with higher production rate and lower unit costs; however, they can cause significant amount of residual stand damage and

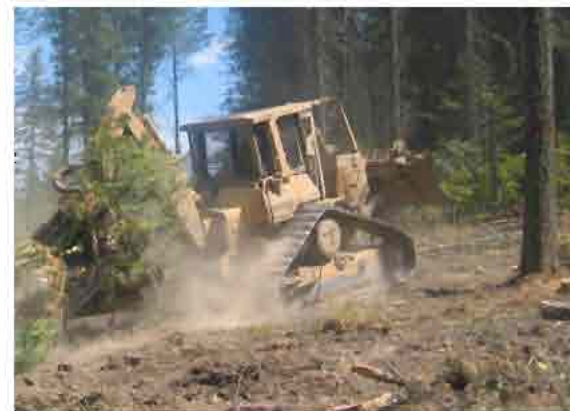
Fig. 5: Ground skidding with a crawler tractor using grapple

Crawler tractors have a lighter ground pressure than rubber-tired skidders due to larger ground contact area, which leads to reduced soil compaction (Martin *et al.*, 1985). They have better traction and maneuver ability in mud, on slippery soils and in heavy brush. With better traction and heavier machine weight, they can pull more load than rubber-tired vehicles. However, crawler tractors are limited to maximum uphill ground slope of 15%, while rubber-tired skidders can operate up to uphill slope of 25% (Martin *et al.*, 1985). They also have a higher potential to damage residual trees in thinning operations. Han and Kellogg (2000b) investigated characteristics of stand damage from four different thinning systems including; skyline, crawler tractor, cut-to-length involving a harvester and a forwarder, skyline and helicopter. The results indicated that ground-based system using crawler tractor generated severe root damages. Besides, crawler tractor logging can also cause relatively larger scarring on residual trees than that of other three systems.

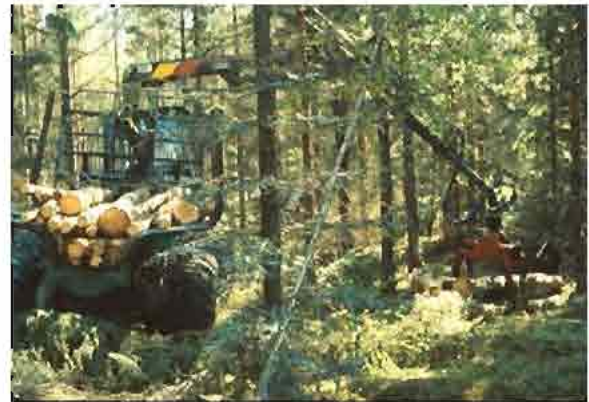
Fig. 6: Forwarders equipped with a hydraulic grapple loading arm

Forwarders: Forwarders are rubber-tired machines that carry short logs to the roadside (Fig. 6). They are equipped with grapple loading arm, which can pick up logs from the side of the trail and load truck trailers at the landing or place the logs on the side of the road (Martin *et al.*, 1985). Forwarders are commonly used in a cut-to-length system combined with a harvester (Kellogg *et al.*, 1992). They can travel at higher speed than rubber-tired skidders; therefore, forwarders require a higher quality trail than the skidder. Since the harvester leaves limbs and tops on the trail, the forwarder travels on the slash, which may significantly reduce soil compaction and rutting (Akay and Sessions, 2001). Optimal forwarding operations usually consist of longer traveling distance, which reduces the trail density and generates less overall soil disturbance. Besides, forwarding larger payloads at higher speeds along the longer trails can provide higher production rate and lower unit cost, compared to skidding operations. However, larger payloads may cause more soil damage than that of a skidder or a tractor does (Kellogg *et al.*, 1993). The forwarders are limited to maximum ground slope of 30% (Martini *et al.*, 1985).
