Journal of Applied Sciences

Challenges and Spatial Distribution of Water Infrastructures (Boreholes) in Okene Town, Kogi State, Nigeria

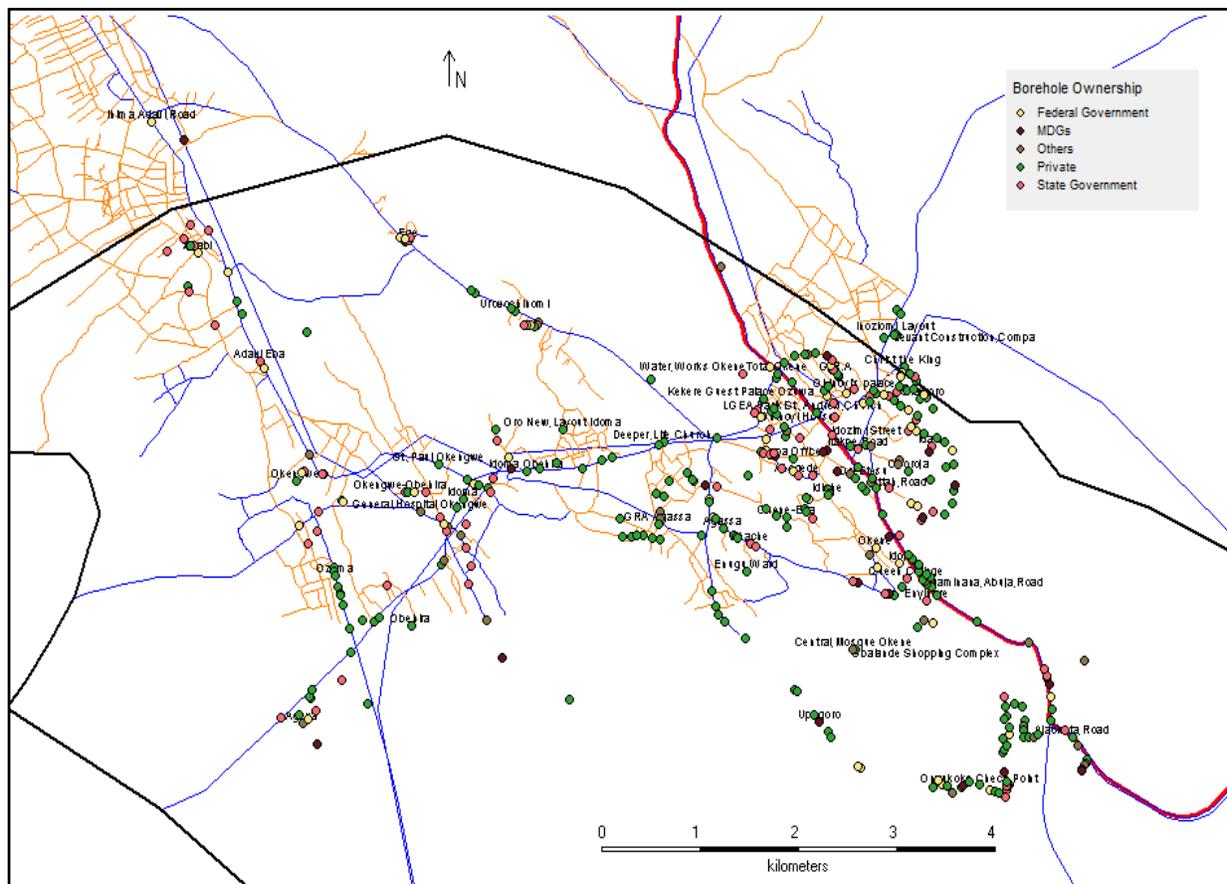
Fig. 1: Spatial distribution of boreholes in Okene town
 Source: Authors using DIVA-GIS version 7.5 software

Demographic: A total of 285 boreholes were examined in Okene town (Agassa, Agassa G.R.A, Aache, Bariki, Enyinare, G.R.A, Idoji, Idozumi, Idogido, Idare Okene-eba and Ozuwaya). Out of these 285 boreholes, 161 boreholes (56.5%), 49 boreholes (17.2%), 36 boreholes (12.6%), 18 boreholes (6.3%) and 21 boreholes (7.4%) were owned by Private, State Government, Federal Government, MDGs and others (donations), respectively (Fig. 1, 2). A total of 279 (97.9%) of the boreholes were operated using motorized pumping system with only 2.1% (6 boreholes) operated manually. The boreholes distribution was uneven with large concentration within the town centre.

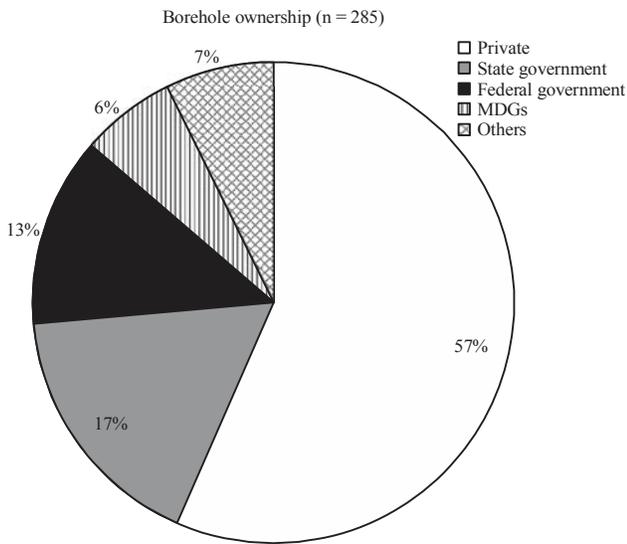
Fig. 2: Distribution (%) of boreholes ownership

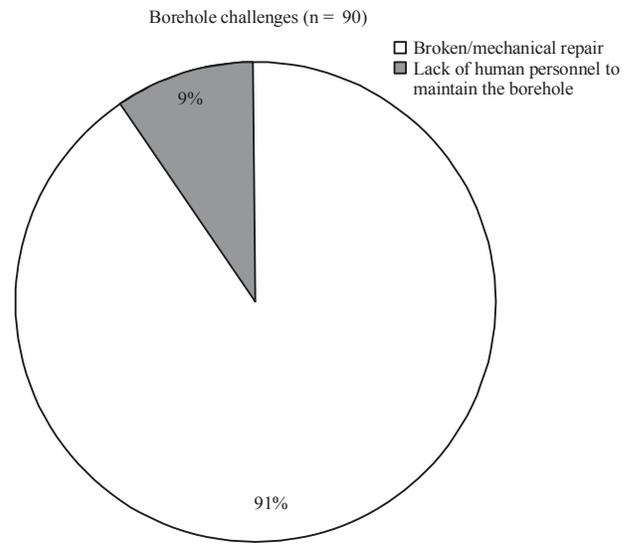
Fig. 4: Distribution (%) of borehole challenges

Challenges encountered: A total of 90 boreholes were found not to be functioning. Two factors were responsible for non-functionality of the boreholes in Okene town, broken/mechanical repair led to 91.1% (82 boreholes) of the boreholes not functioning while lack of human personal to maintain the boreholes led to 8.9% (8 boreholes) of the boreholes not functioning (Fig. 4).

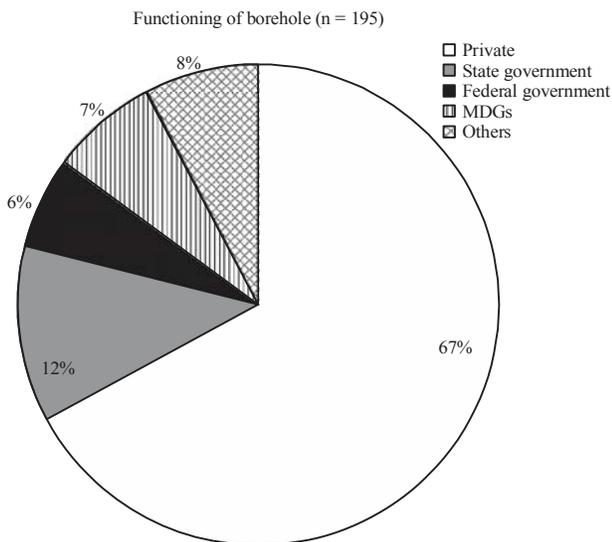
Fig. 3: Distribution (%) of functioning boreholes

while 90 boreholes (31.6%) were found non-functional in Okene (Table 1). A total of 67% of the functioning boreholes were privately owned, while 12, 6, 7 and 8% were owned by State Government, Federal Government, MDGs and others (Donations), respectively (Fig. 3).

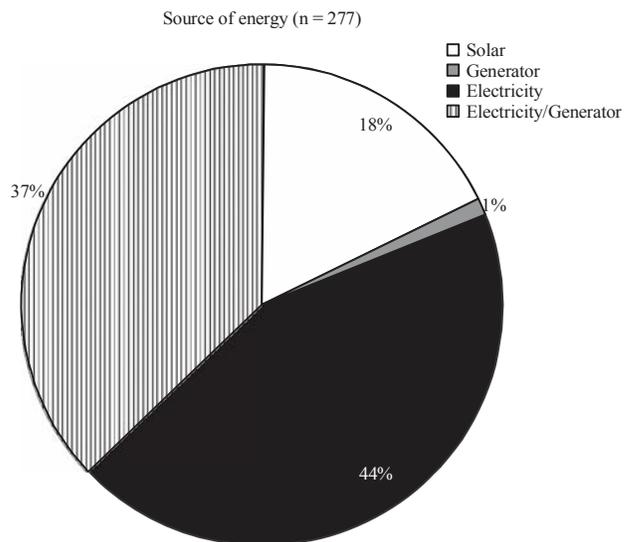
Fig. 5: Distribution (%) of source of energy of the boreholes

manually, 122 boreholes (44.0%) uses electricity only, 103 (37.2%) uses electricity and generator, 49 boreholes (17.7%) uses solar while 3 boreholes (1.1%) uses

generator only. Significant difference ($\chi^2 = 54.84, p < 0.05$) was observed on the power source used by the boreholes (Fig. 5).

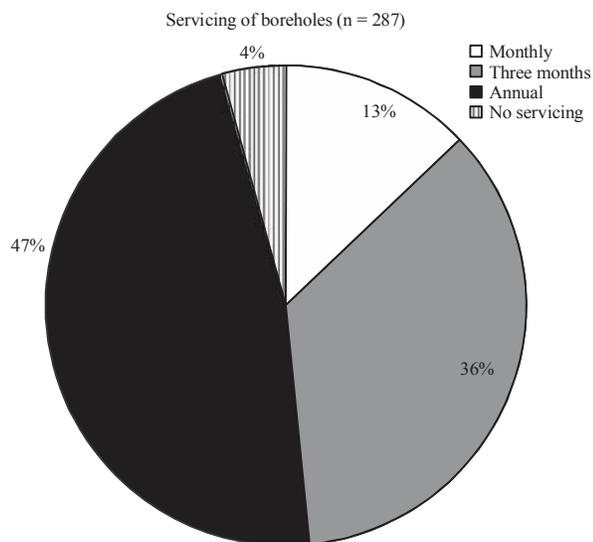
Fig. 6: Distribution (%) of servicing of the boreholes

Servicing of boreholes: Majority of the boreholes were serviced annually (136 boreholes, 47.4%), while 35.5% (102 boreholes) and 12.9% (37 boreholes) were serviced in 3 and 1 month, respectively (Fig. 6). A total of 12 boreholes (4.2%) were not serviced.
